### **APPENDIX 3: Photographs of test setup**

#### **Radiated Spurious Emission**

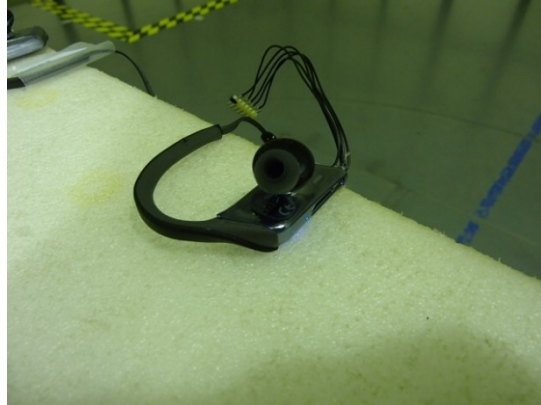
**X-axis**

### **Worst Case Position**

Above 1GHz (Horizontal: X-axis/ Vertical: Z-axis)

Below 1GHz (Horizontal: X-axis/ Vertical: Z-axis)
