### **APPENDIX 3: Photographs of test setup**

#### **Radiated Emission**

## Worst Case Position

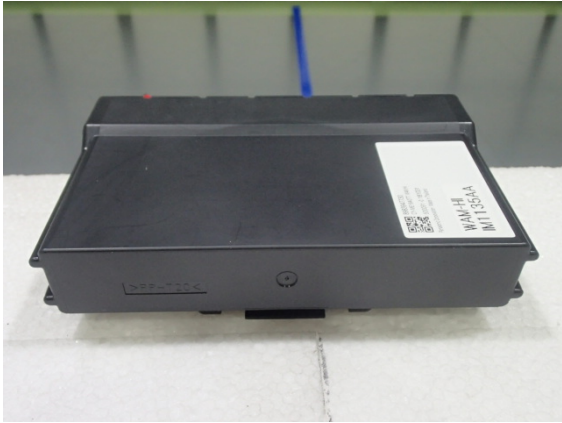
### ECU

Below 30 MHz: X-axis

Above 30 MHz

Horizontal: X-axis / Vertical: X-axis  
X-axis

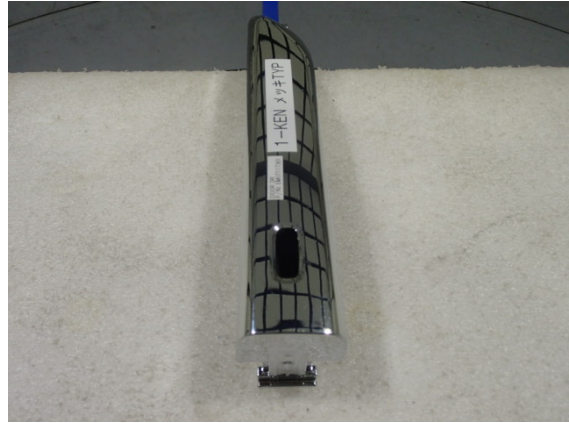
### DOOR DR

Below 30 MHz: Z-axis

Above 30 MHz

Horizontal: X-axis / Vertical: X-axis  
X-axis

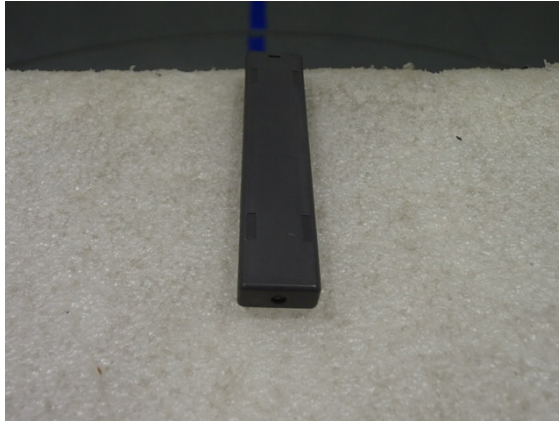
**CENTER / REAR DR / DOOR AS**

**Below 30 MHz: X-axis**

**Above 30 MHz**

**Horizontal: X-axis / Vertical: X-axis  
X-axis**

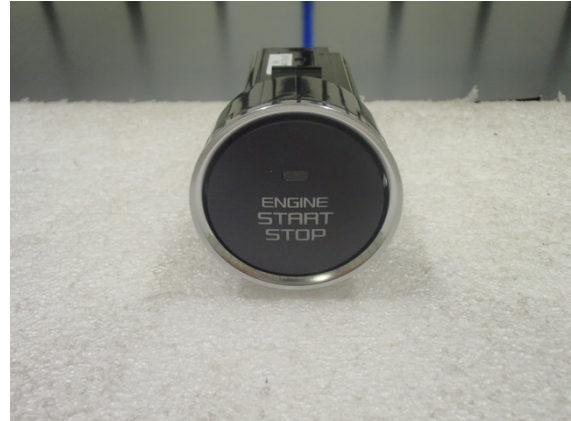
**START SW**

**Below 30 MHz: Z-axis**

**Above 30 MHz**

**Horizontal: X-axis / Vertical: X-axis  
X-axis**
