### **APPENDIX 3: Photographs of test setup**

#### **Radiated Spurious Emission**

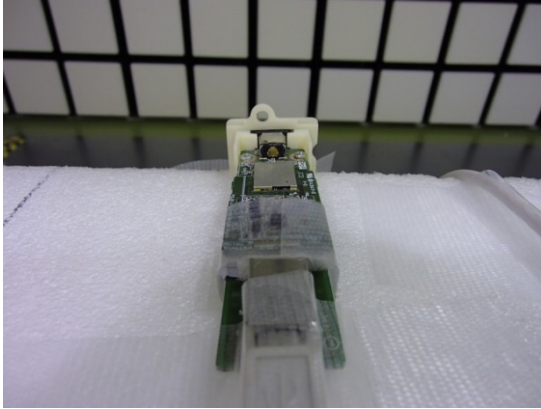
**Module X-axis**

**Worst Case Position**

**Module (Horizontal: X-axis / Vertical:X-axis)**

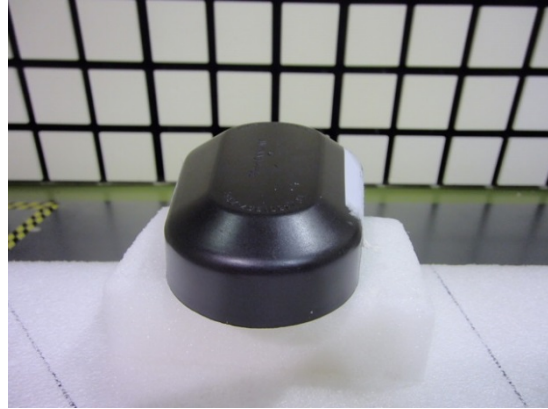
**Antenna X-axis**

**Antenna (Horizontal: Y-axis / Vertical:X-axis)**
