### **APPENDIX 3: Photographs of test setup**

#### **Conducted Emission**

### Radiated Spurious Emission

#### Description of EUT and Support equipment

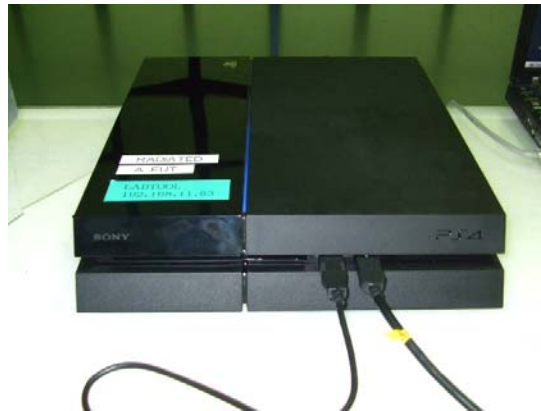
**X-axis**

**Worst Case Position (Horizontal: X-axis/ Vertical:Y-axis)**

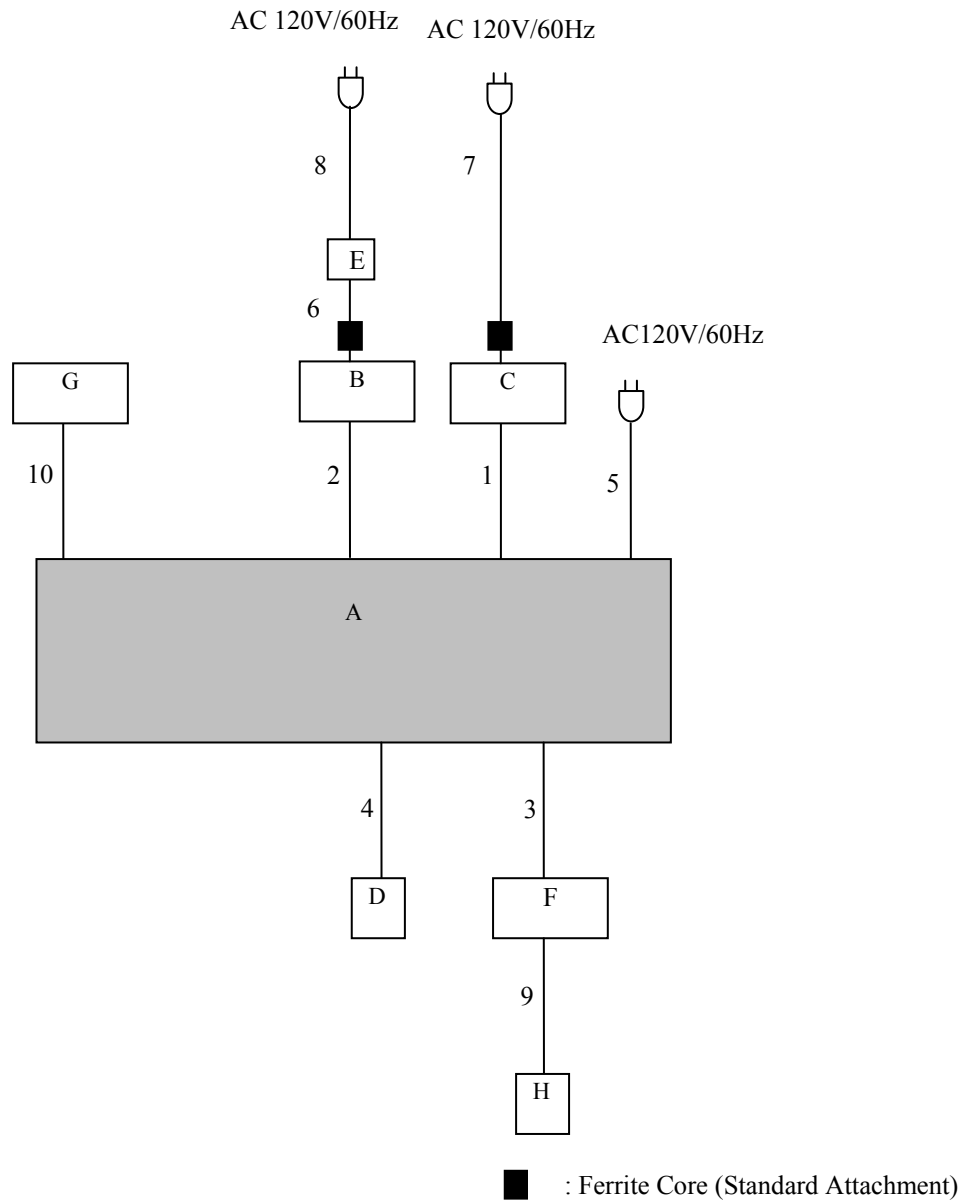
### Test Configuration and peripherals

\*Cabling and setup were taken into consideration and test data was taken under worse case conditions.

| No | Item | Model number | Serial number | Manufacturer | Remarks |
| A | Computer Entertainment System | CUH-1115A | 9CD21EEA1209 for AT*<br>1300099 for CE* and RE* | Sony Computer Entertainment | EUT |

| No | Name | Length (m) | Shield | | Remarks |
| 1 | HDMI Cable | 2.0 | Shielded | Shielded | - |
