# 1.Back Surface A of PEG-TG50/U

## 2.Back Surface B of PEG-TG50/U

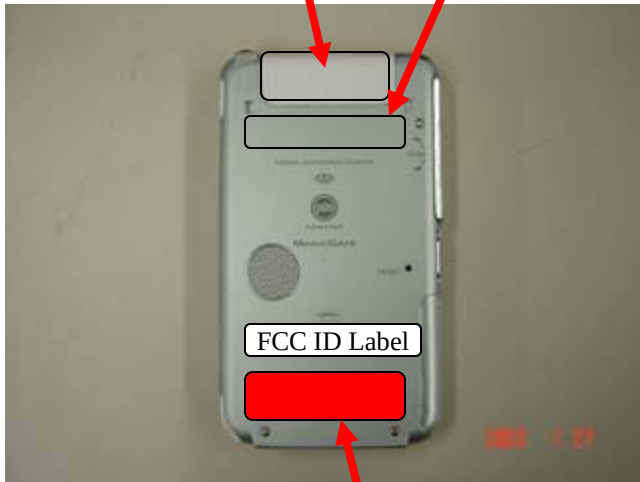
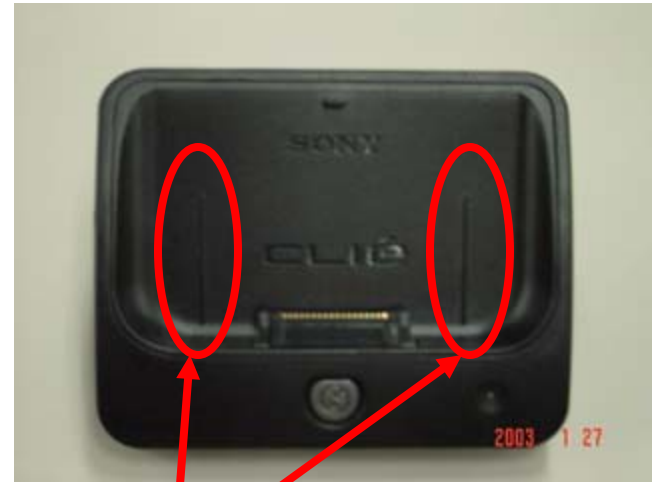
If Label Statement is attached or printed to Back Surface A, it will touch the Cradle and came off.

Every time, user set the product on the cradle, red circular part of cradle will touch the Back Surface A. Therefore, Label or Print of Back Surface A will come off and not last for a long time.

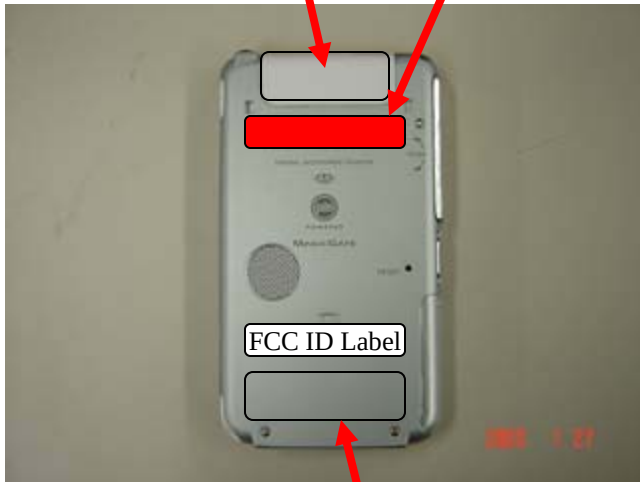
Logo mark of the product “CLIE” will be on this place, so that label statement cannot be attached or printed in this area.

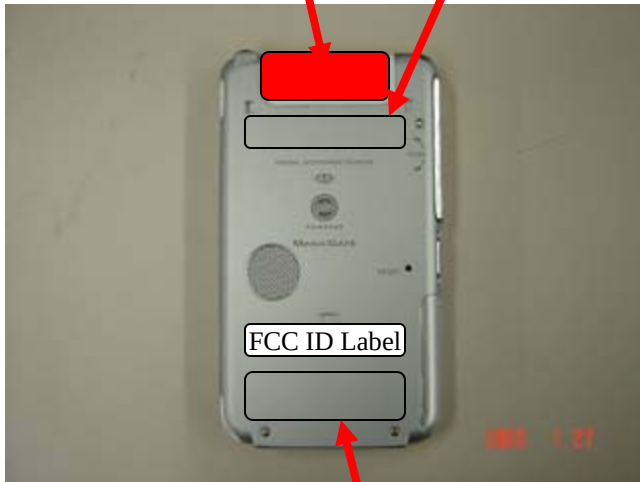
### 3. Bluetooth Window on the back surface of PEG-TG50/U

- Characteristic of Bluetooth can be ruined by label.
- Label statement cannot be printed directly to component. Because figure of the component is not suitable for printing the statement.

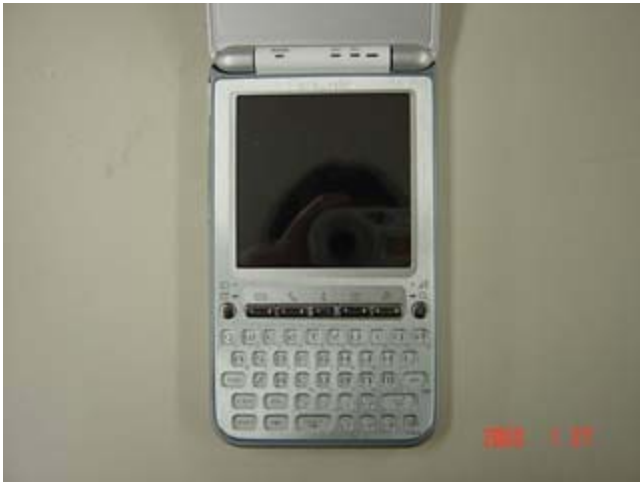
## 4.Foreface of PEG-TG50/U

There is no place for attaching or printing label statement foreface of this product.

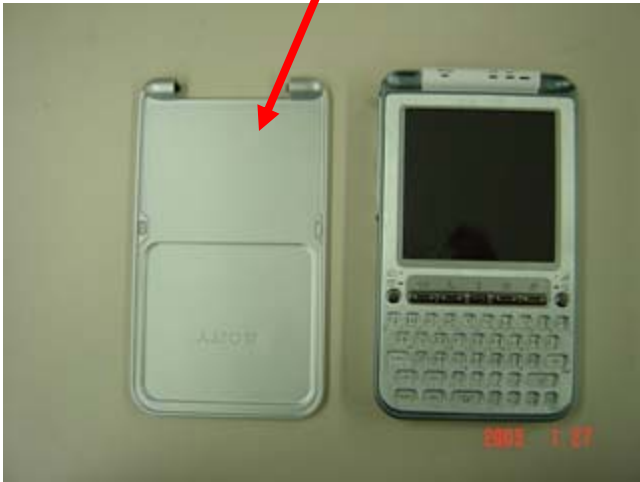
## 5. Front Cover of PEG-TG50/U

Front cover can be removed easily and user do not always carry the product with the front cover.
