## USCG Approved Lab Test Report to RTCM Specification 76-2002/SC110-STD

**FCC ID: B66-ACR-PLB100**

**RTCM  
Test Report  
PLB-100**

## **ENVIRONMENTAL AND OPERATIONAL PERFORMANCE TEST PLAN FOR PLB-100**

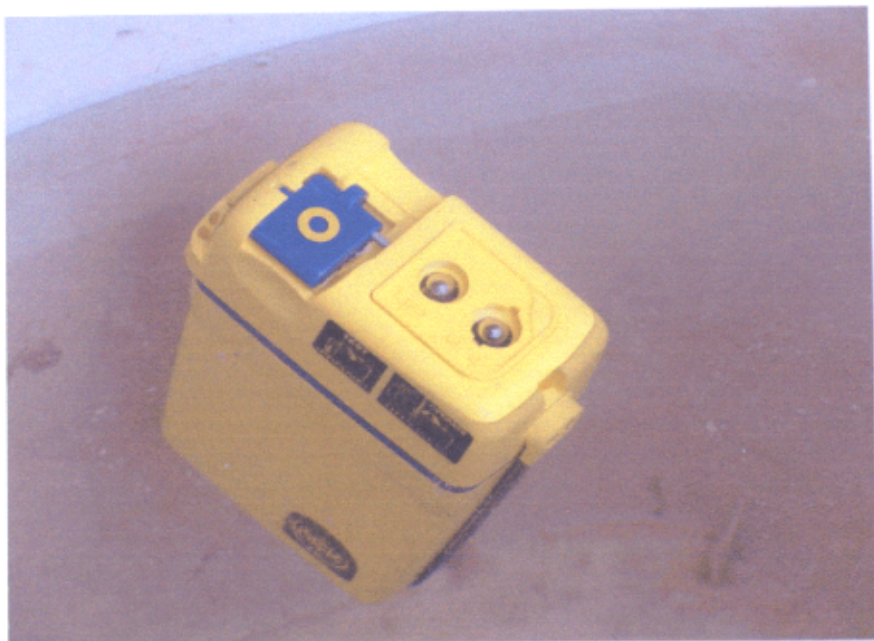
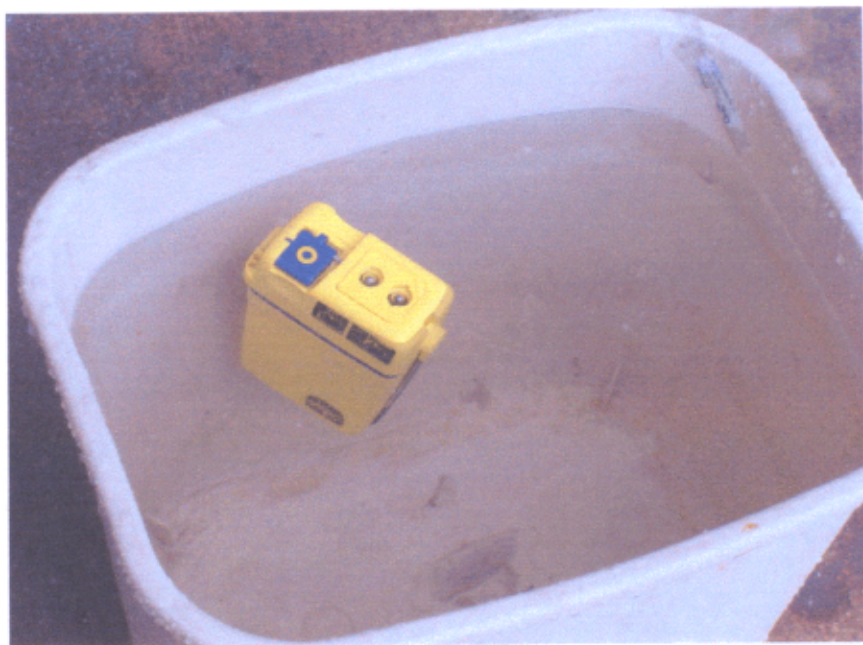
The satellite PLB was allowed to float in calm fresh water. The satellite PLB was removed from pouch before conducting test.

Please submit picture of unit floating with test report.

| | | | T <sub>min.</sub><br>(____°C) | T <sub>amb.</sub><br>(____°C) | T <sub>max.</sub><br>(____°C) | |
| - | | | | | | |
| <b>A 11.0 Buoyancy Test (Cat 1 only)</b> | | | | | | |
| - FLOATS | | | | | | |
