### **APPENDIX 3: Photographs of test setup**

#### **Radiated Spurious Emission**

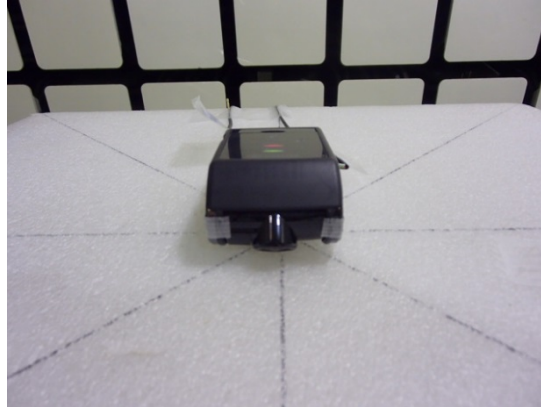
**X-axis**

**Worst Case Position**

**Above 1GHz : (Horizontal: X-axis/ Vertical:Z-axis)**

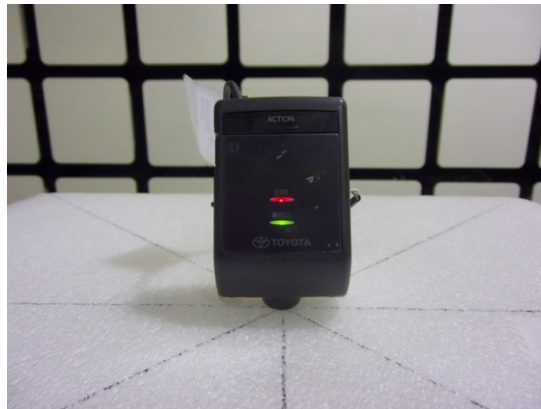
**Y-axis**

**Below 1GHz : (Horizontal: Y-axis/ Vertical:Y-axis)**
