## APPENDIX A: PHOTOGRAPHS OF TEST SETUP

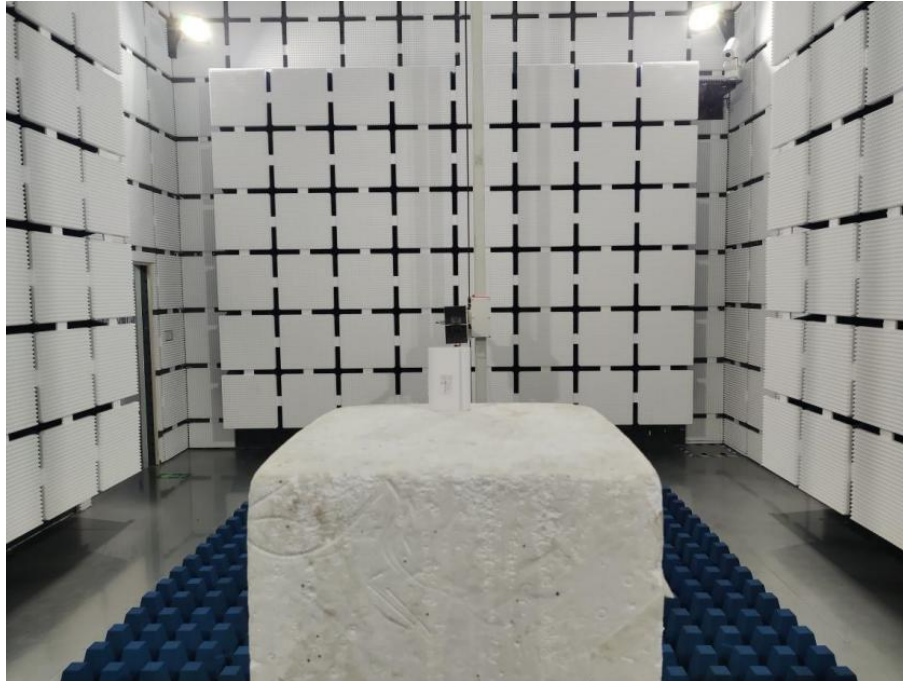
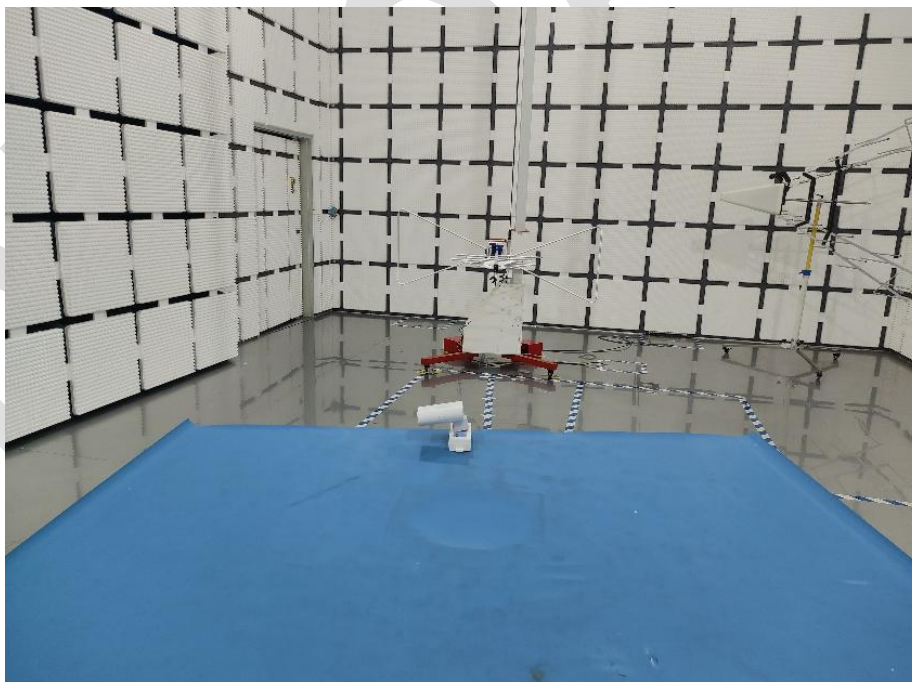
### Radiated Spurious Emissions

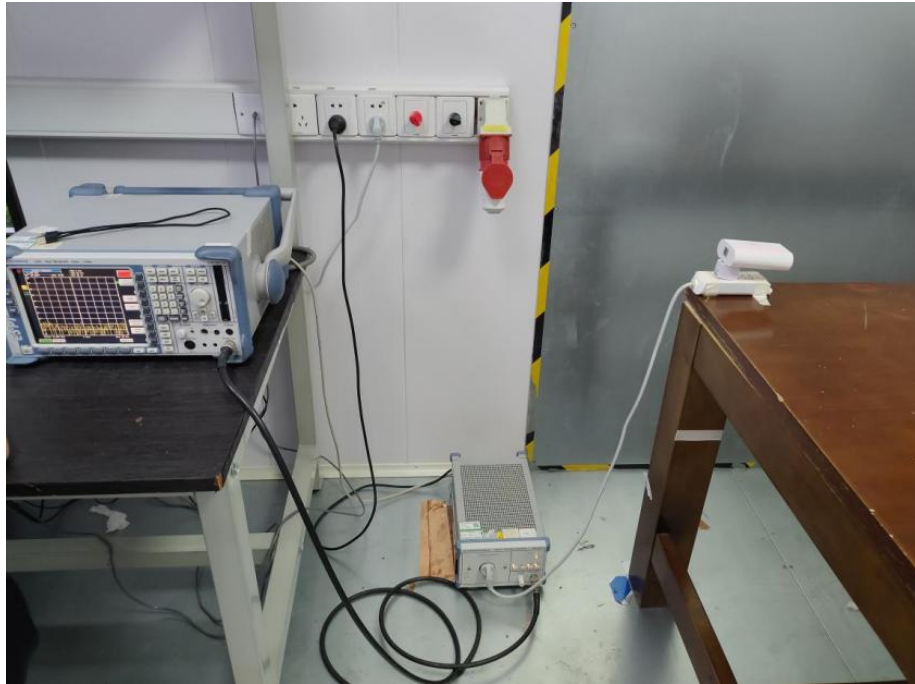
**Conducted Emissions at AC Power Line (150kHz-30MHz)**
