## A.4 DWELL TIME

## A.5 NUMBER OF HOPPING CHANNEL

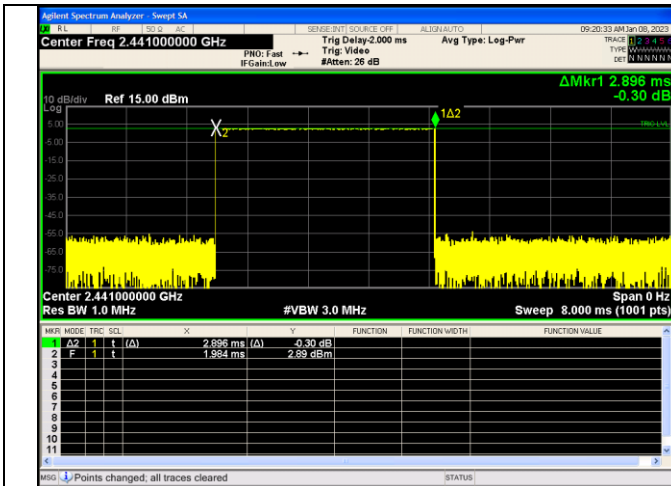
Pulse Width  
GFSK\_DH5

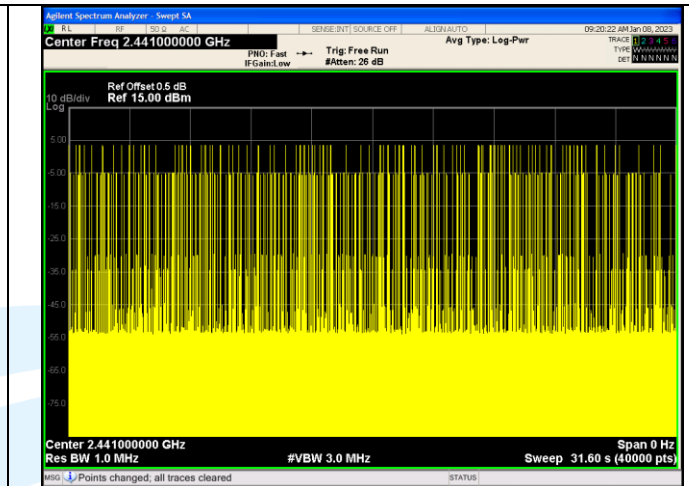
Number of Pulses in 31.6 seconds  
GFSK\_DH5

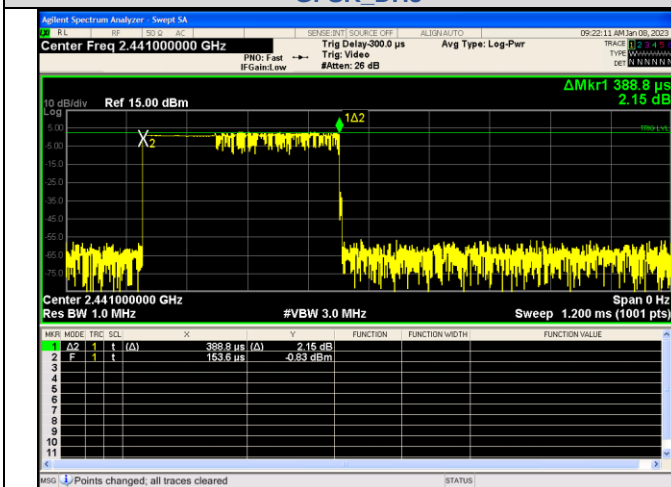
Pulse Width  
 $\pi/4$ DQPSK\_2-DH1

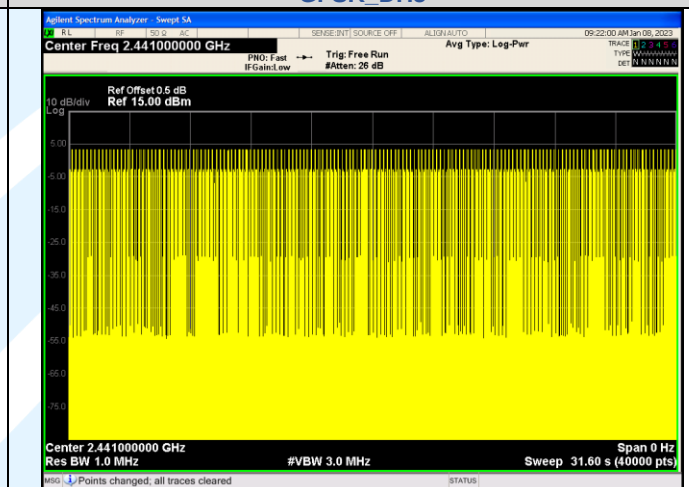
Number of Pulses in 31.6 seconds  
 $\pi/4$ DQPSK\_2-DH1

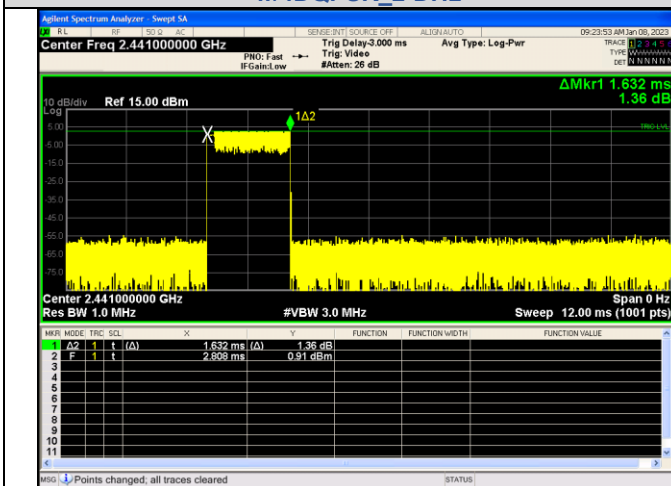
Pulse Width  
 $\pi/4$ DQPSK\_2-DH3

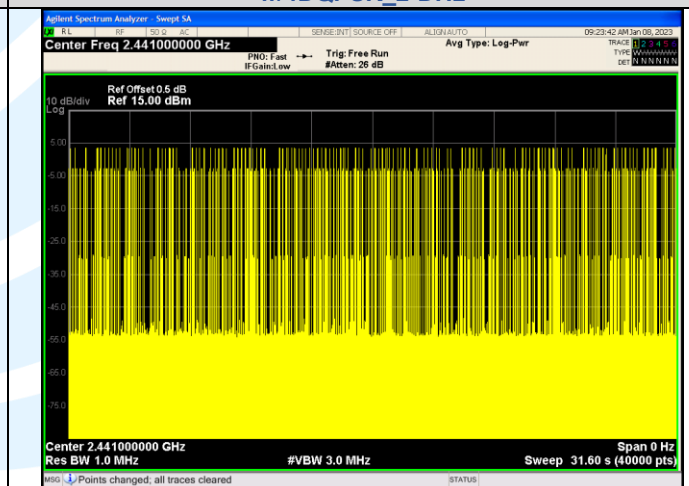
Number of Pulses in 31.6 seconds  
 $\pi/4$ DQPSK\_2-DH3

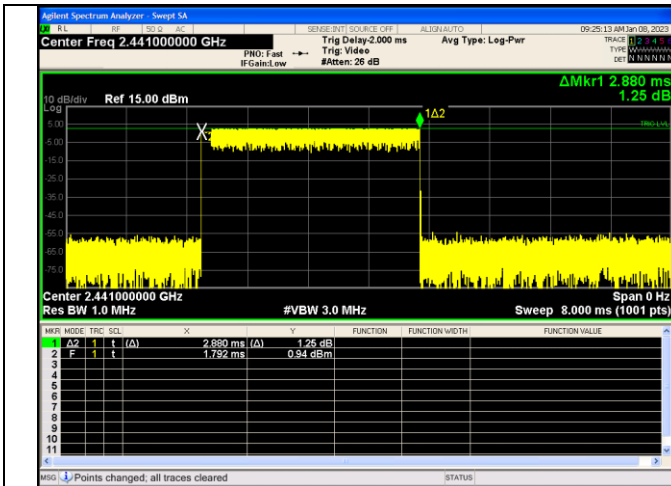
Pulse Width  
 $\pi/4$ DQPSK 2-DH5

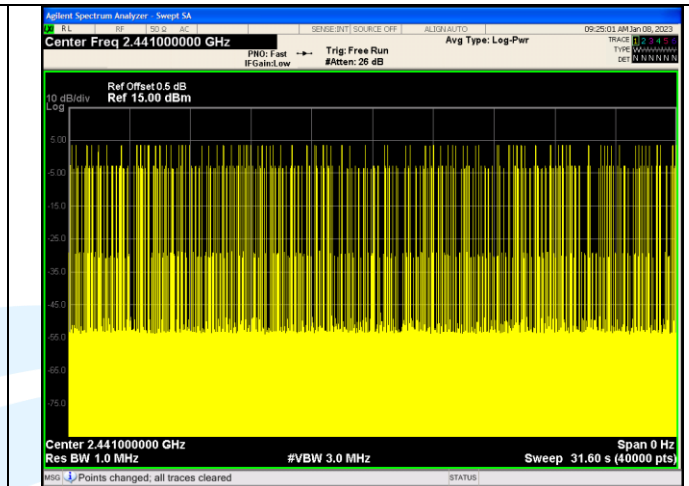
Number of Pulses in 31.6 seconds  
 $\pi/4$ DQPSK 2-DH5

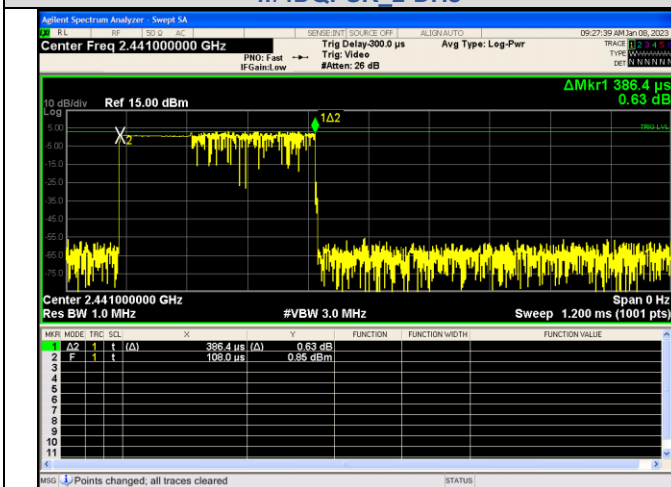
Pulse Width  
8DPSK 3-DH1

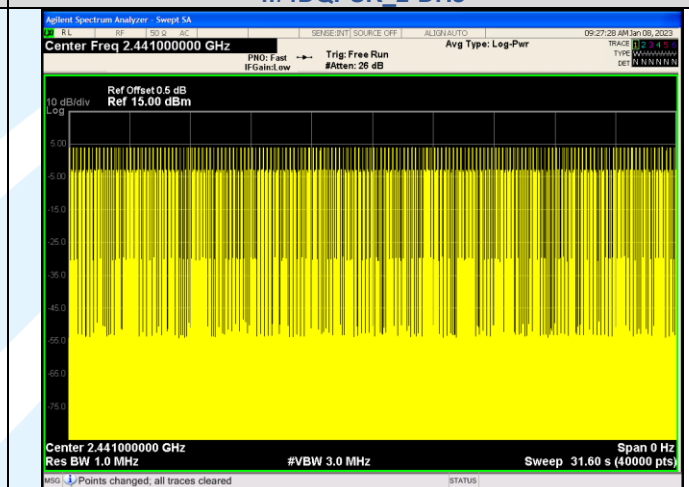
Number of Pulses in 31.6 seconds  
8DPSK 3-DH1

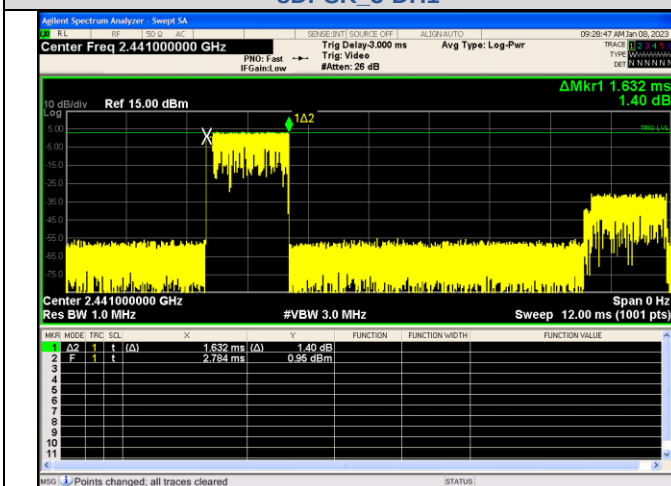
Pulse Width  
8DPSK 3-DH3

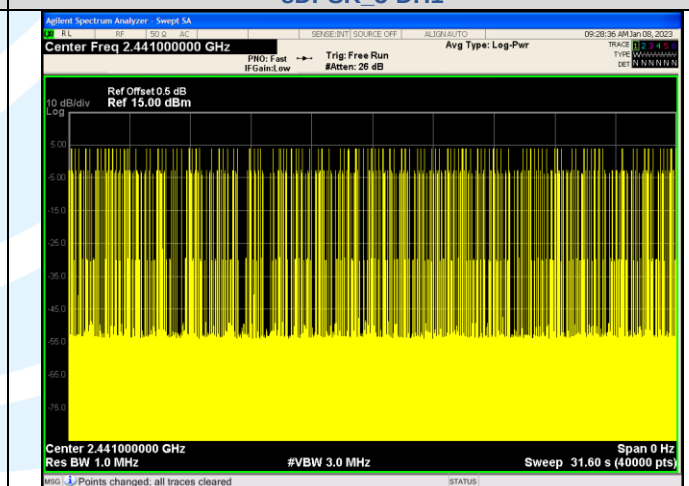
Number of Pulses in 31.6 seconds  
8DPSK 3-DH3

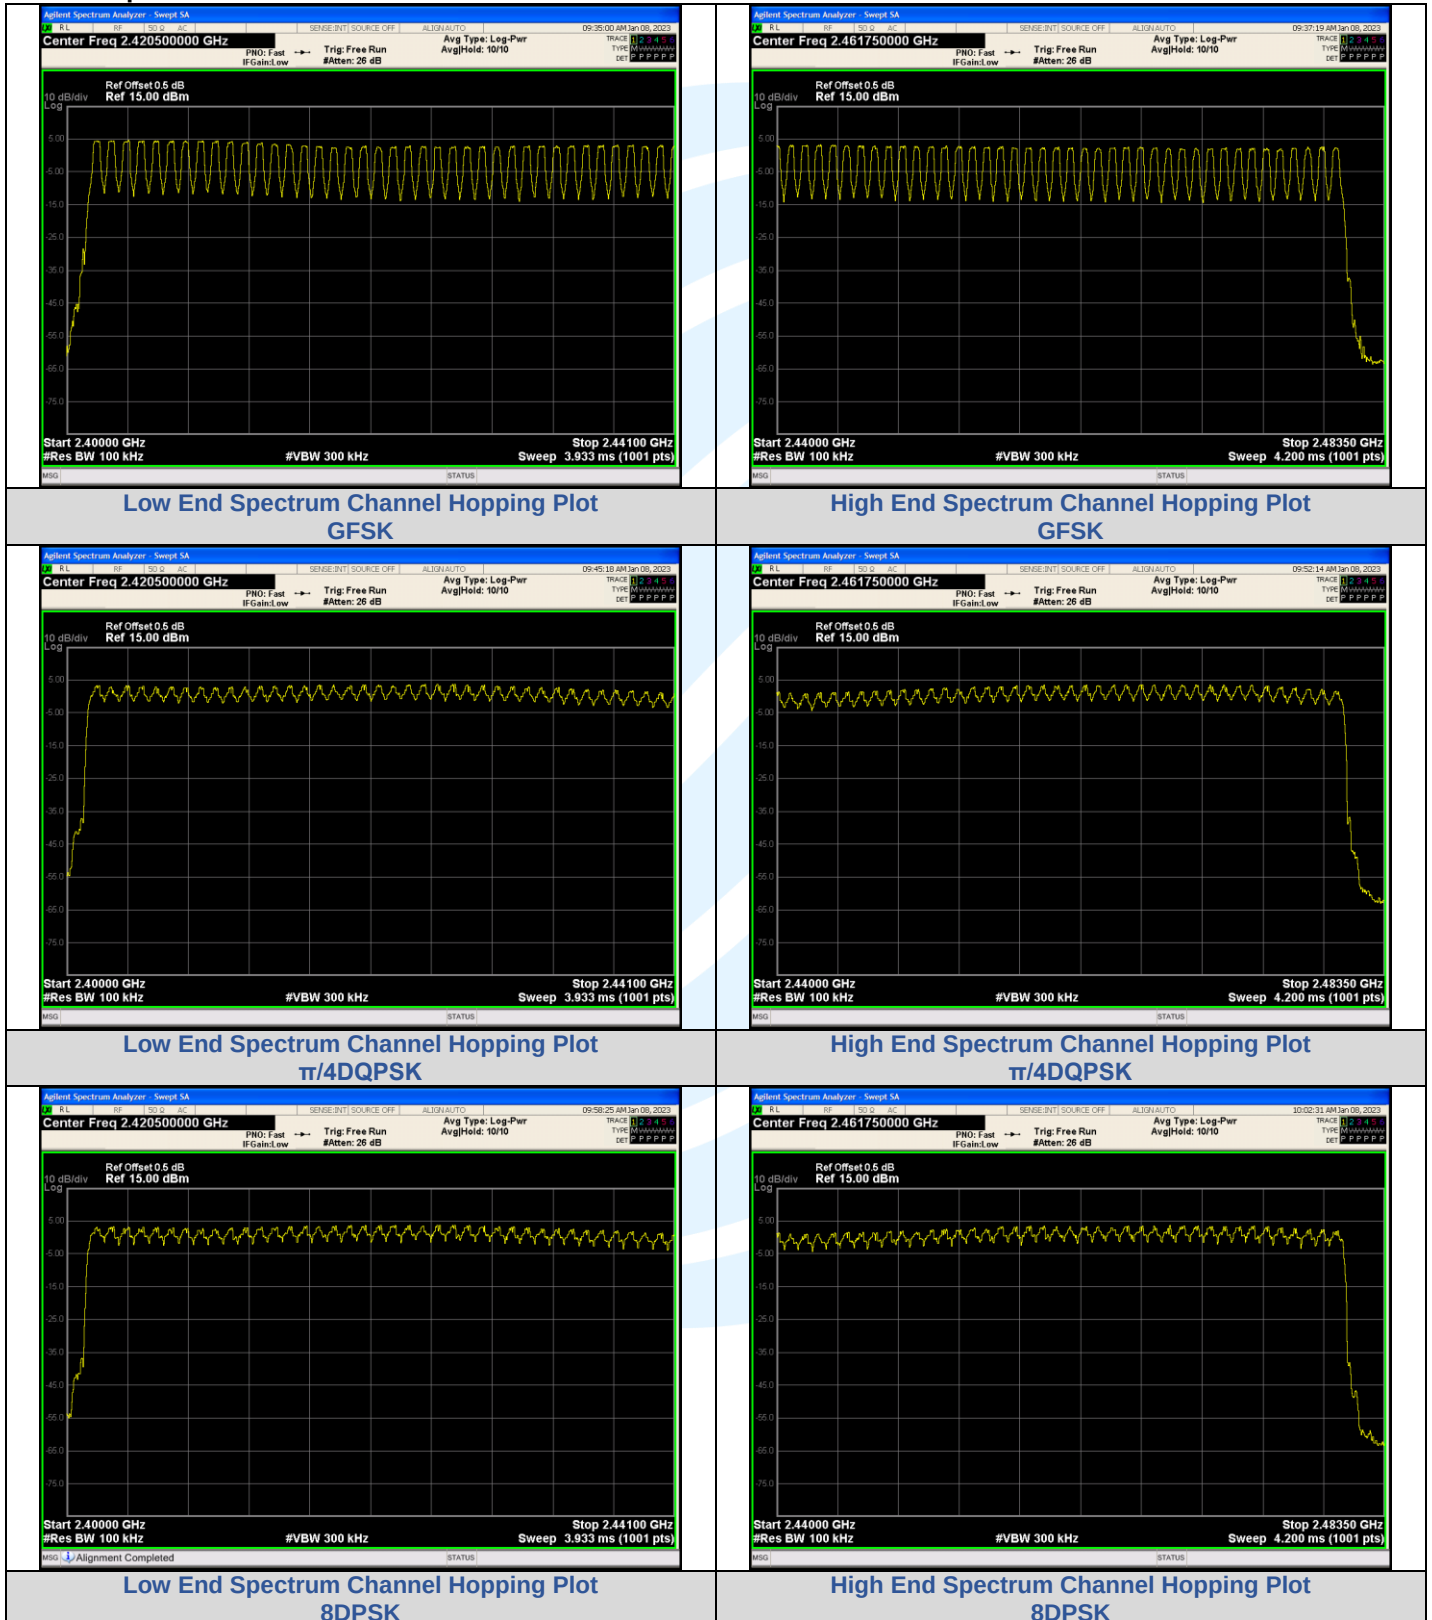
### Test Graphs

| Modulation | Packet | Number of Hopping Channel | Result |
| GFSK | DH5 | 79 | PASS |
| $\pi/4$ DQPSK | 2-DH5 | 79 | PASS |
| 8DPSK | 3-DH5 | 79 | PASS |
