**Emission tests to FCC and IC requirements of HA03**

**Performed for Intermatic Inc.**

DELTA Test Report E501839-1  
DANAK-197369  
5 March 2004

containing only the photos of the test set-ups

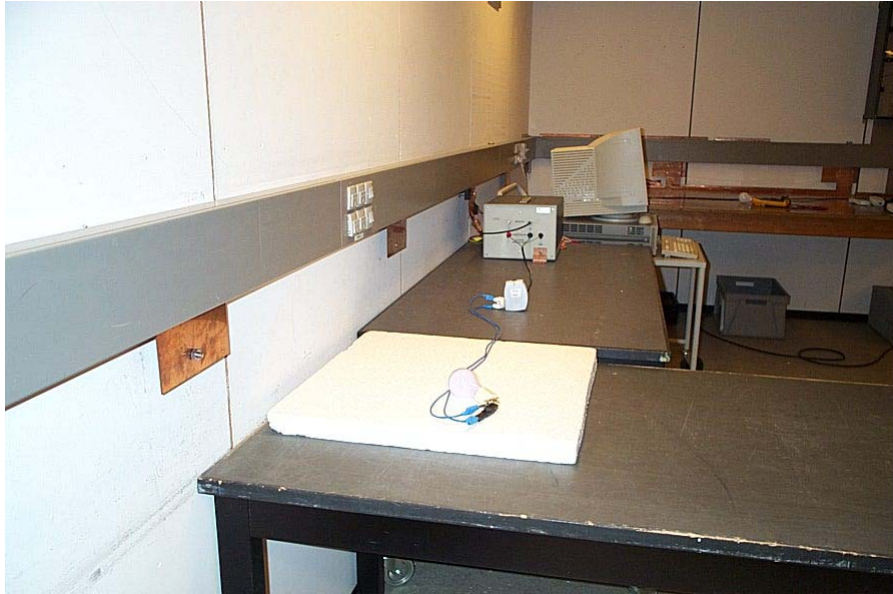
Photo 1 Set-up for conducted emission measurements.  
The LISN is bonded to the vertical ground plane (wall) of the screened room.

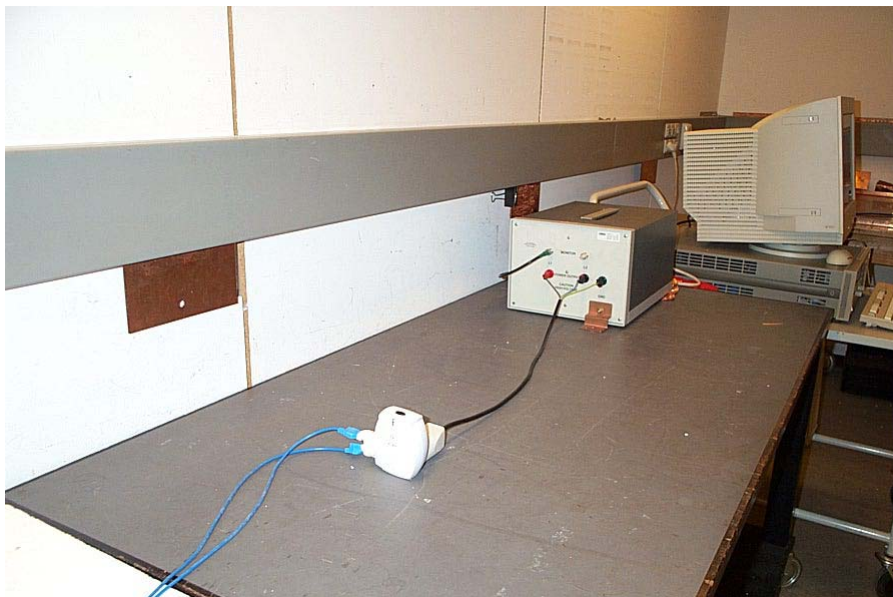
Photo 2 Set-up for conducted emission measurements.  
The LISN is bonded to the vertical ground plane (wall) of the screened room.

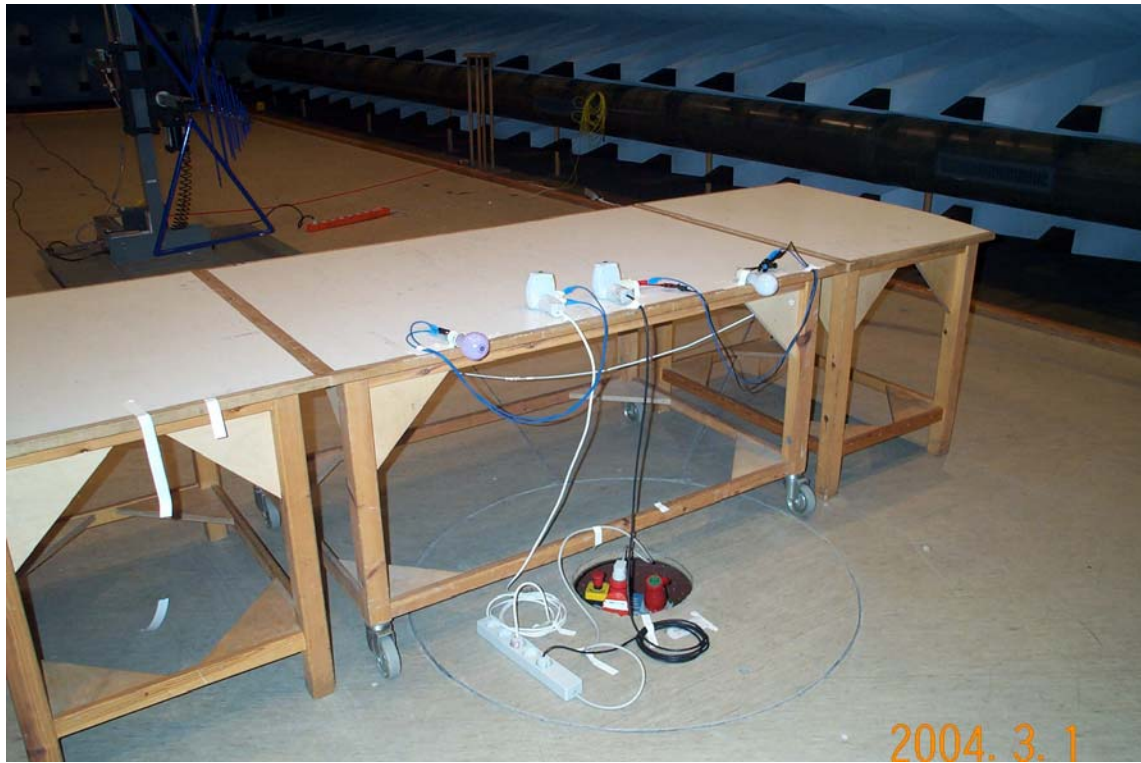
Photo 3 Set-up for measurements 30 – 1000 MHz. Date is 2004-02-12. Camera time is faulty.

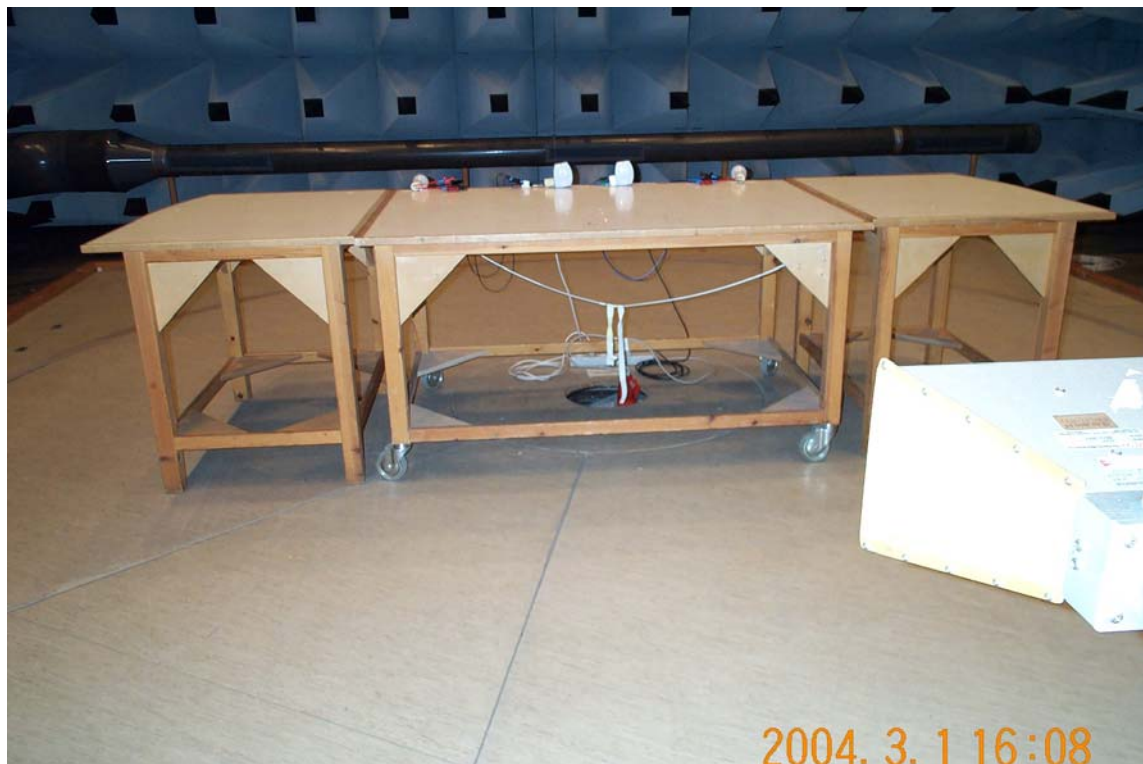
Photo 4 Measurement set-up > 1 GHz.
