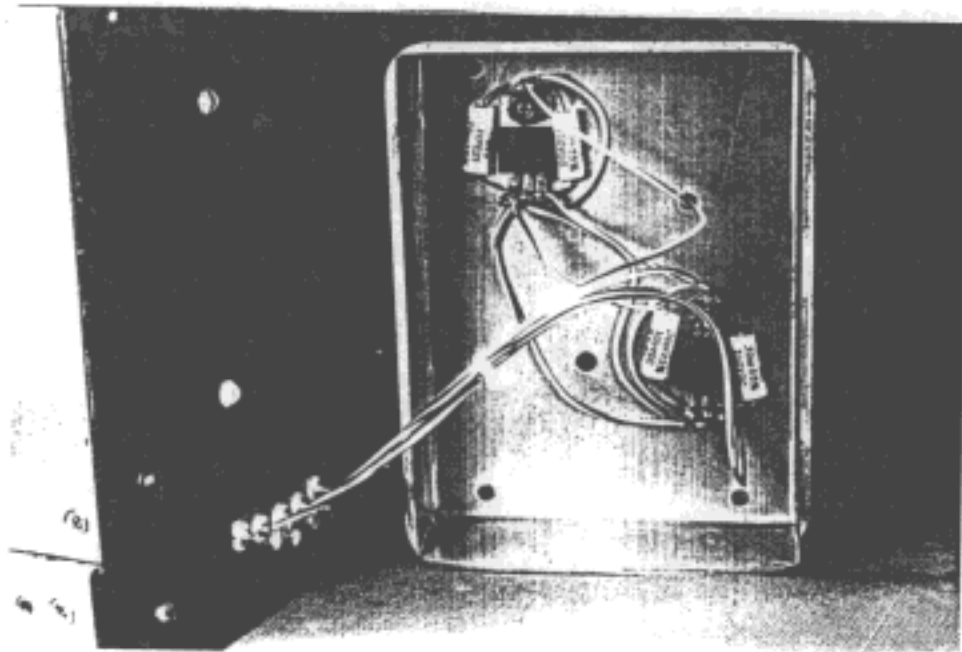
6. Inside View of Rear "Cover" Assembly.

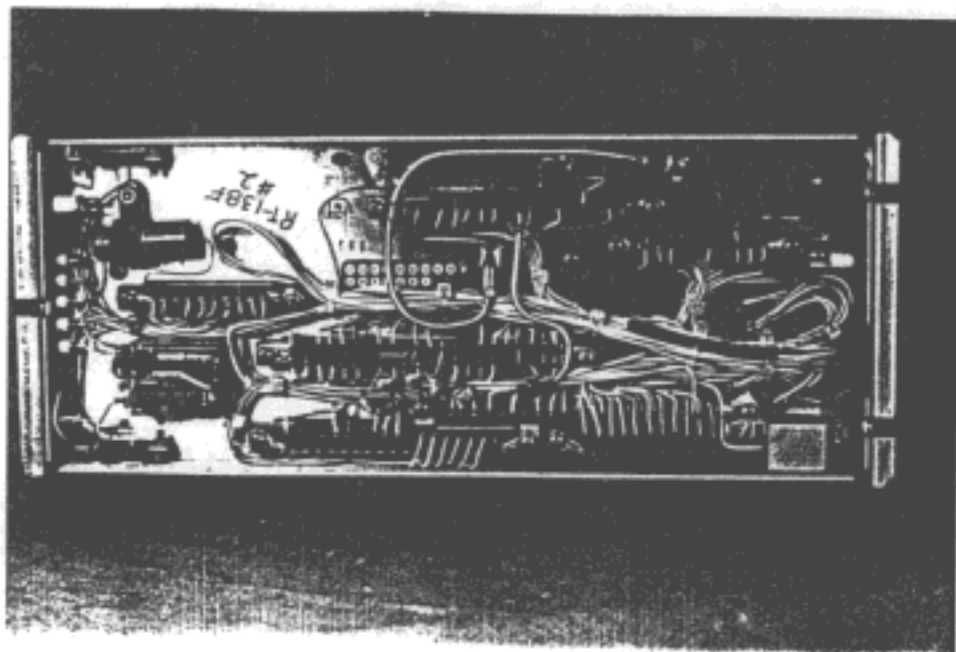
7. Bottom View of RT-138F With Bottom Cover Removed.

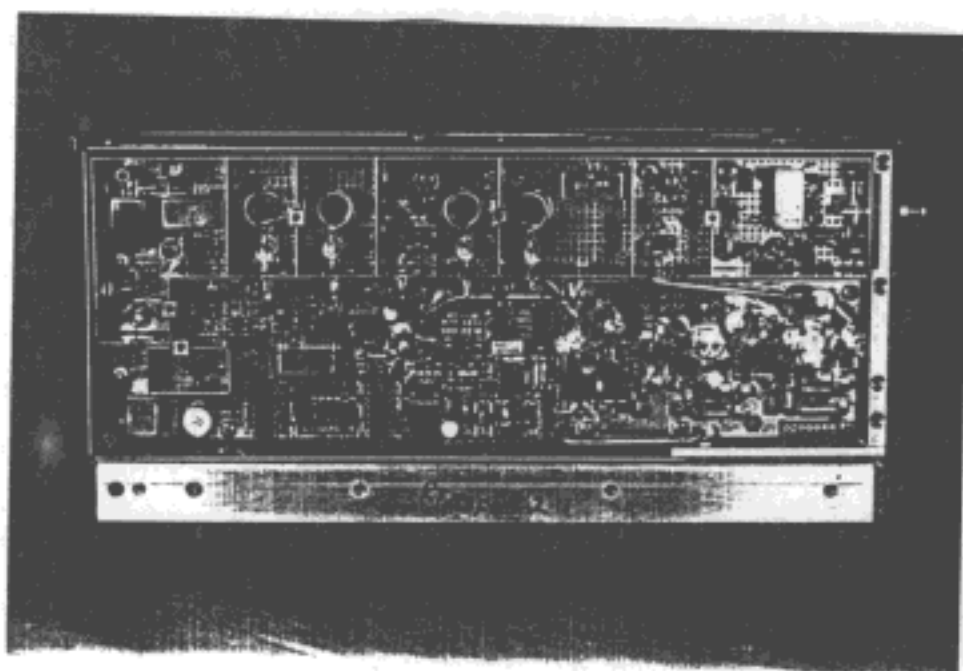
8. Left Side View of RT-138F, Showing Transmitter/Receiver Sub-Assembly, With Shield Cover Removed.

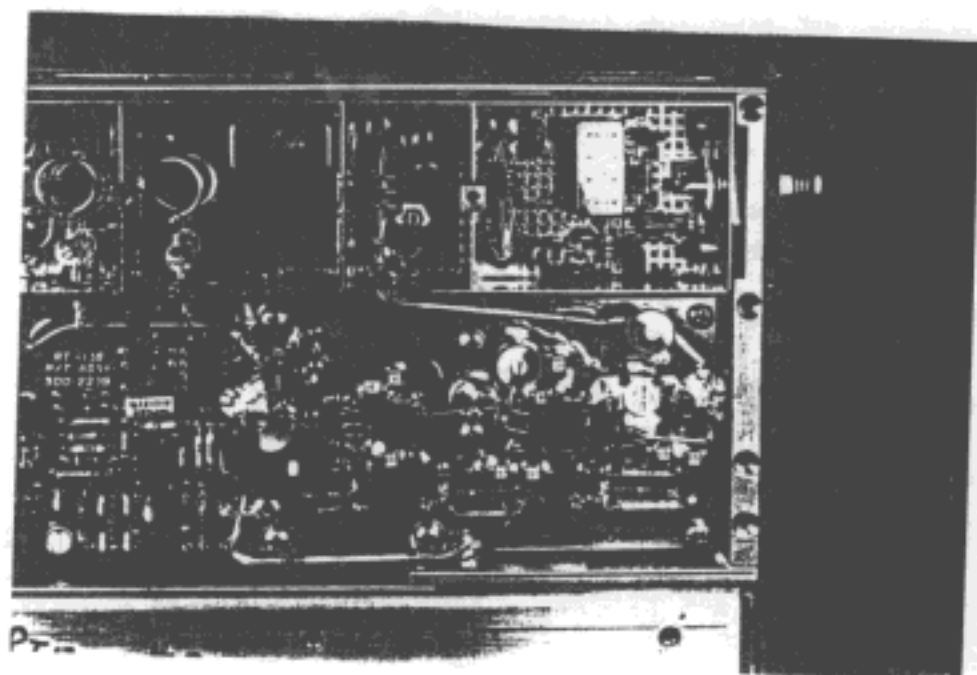
9. Close-up View of Front Portion of  
Transmitter/Receiver Sub-Assembly.

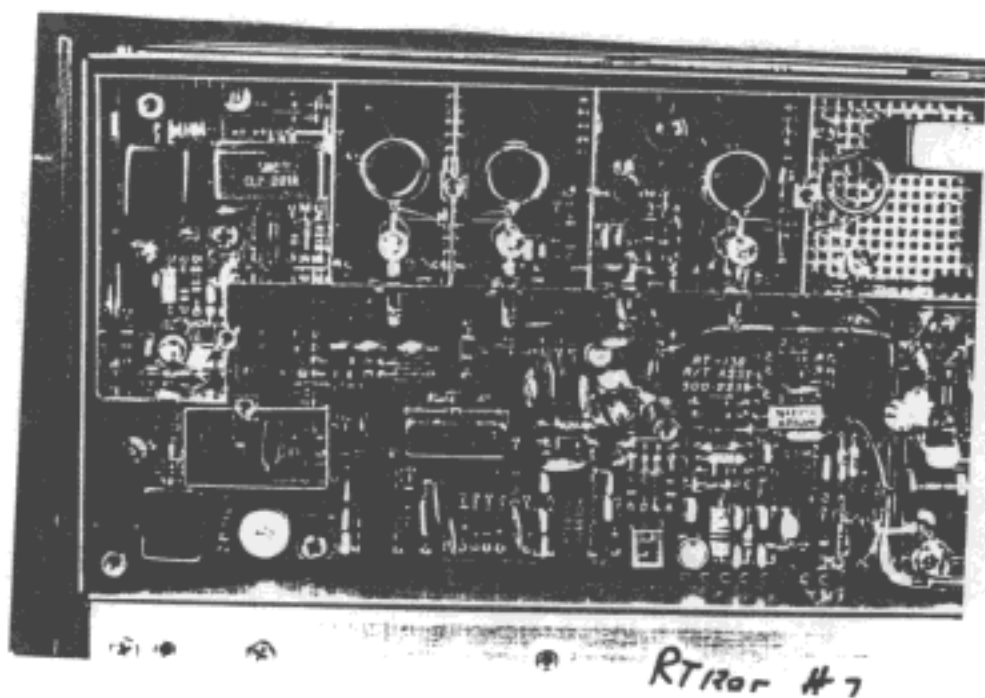
10. Close-up View of Rear Portion of T/R Sub-Assembly.

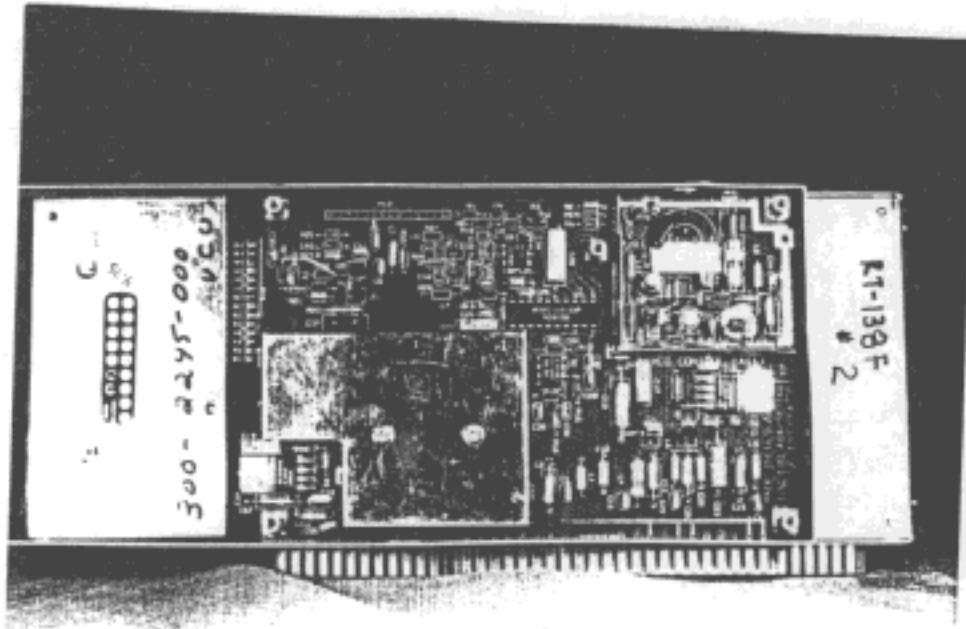
11. Modulator/VCO Sub-Assembly (Removed From Right Side of Chassis) With Shield Cover Removed.

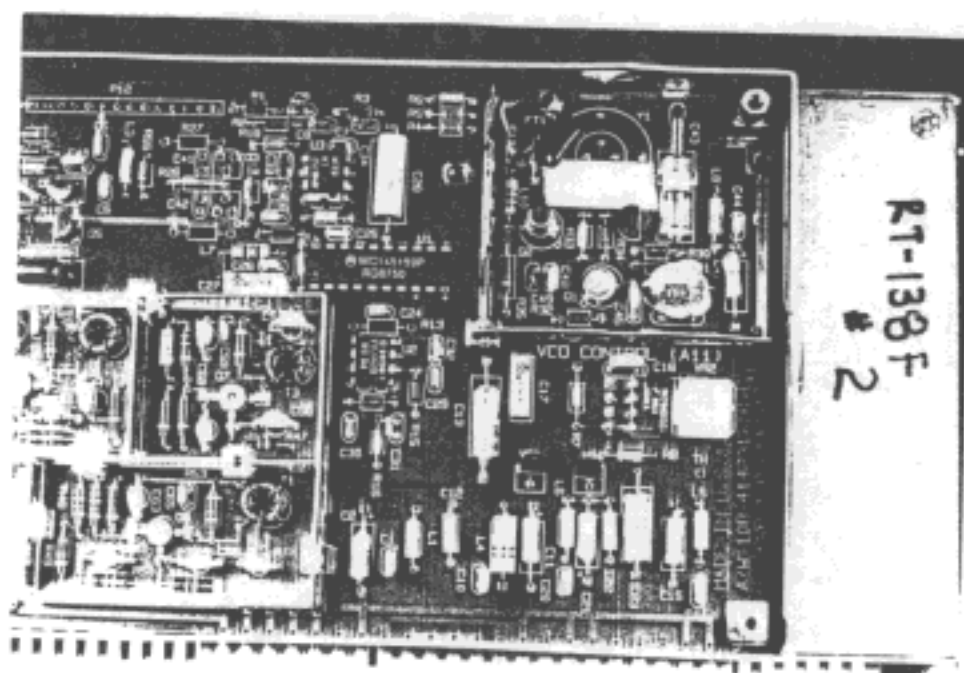
12. Close-up View of Front Portion of VCO/Modulator Sub-Assembly (Small Shield Cover Removed).

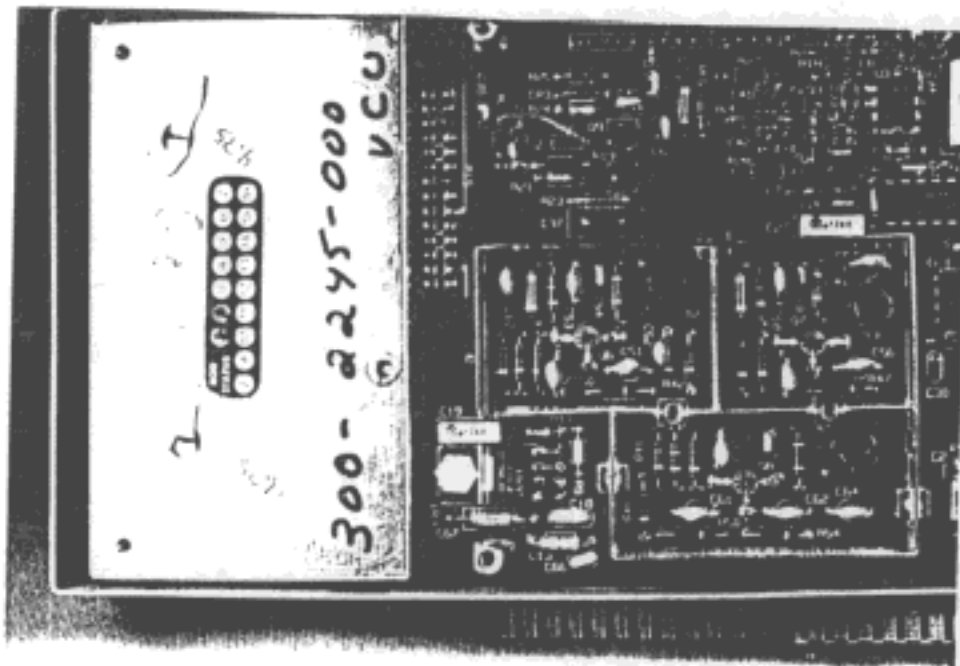
13. Close-up View of Rear Portion of VCO/Modulator Sub-Assembly.

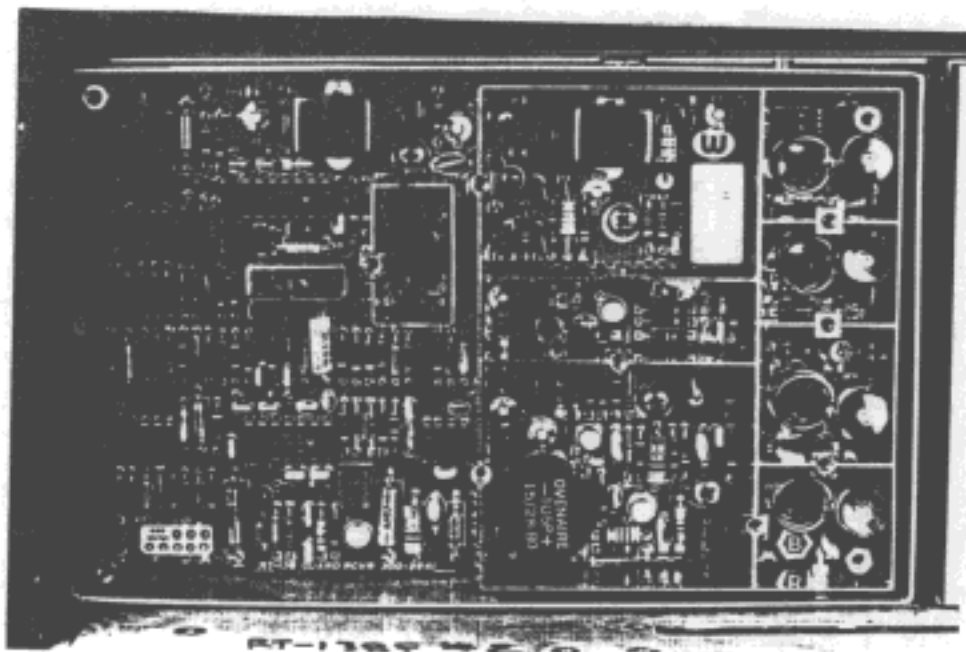
14. View of Guard Receiver Sub-Assembly.

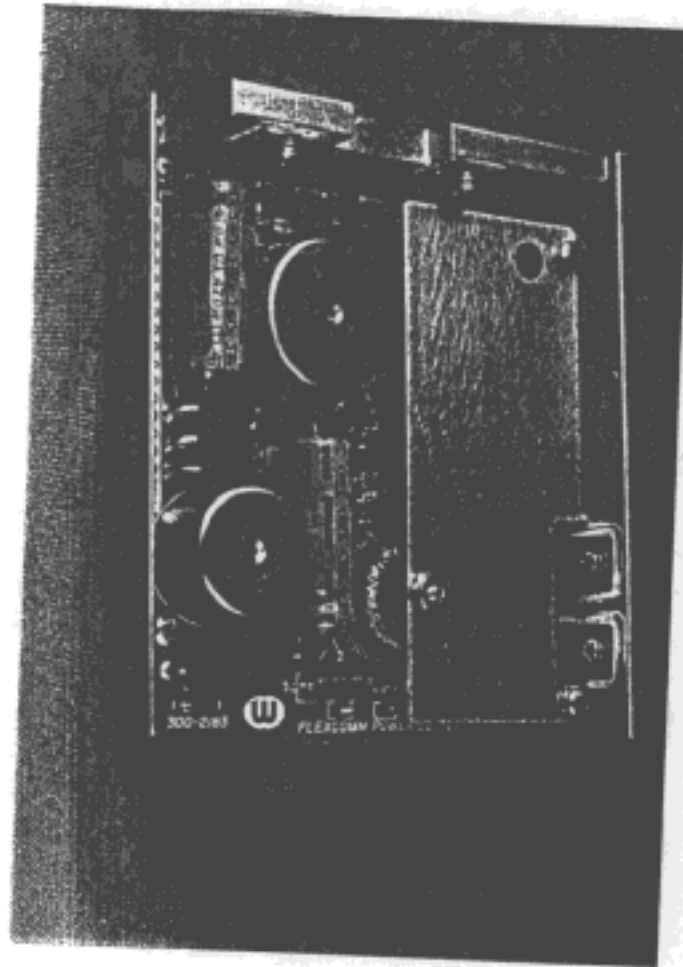
15. Rear, Side View of Power Supply Sub-Assembly.

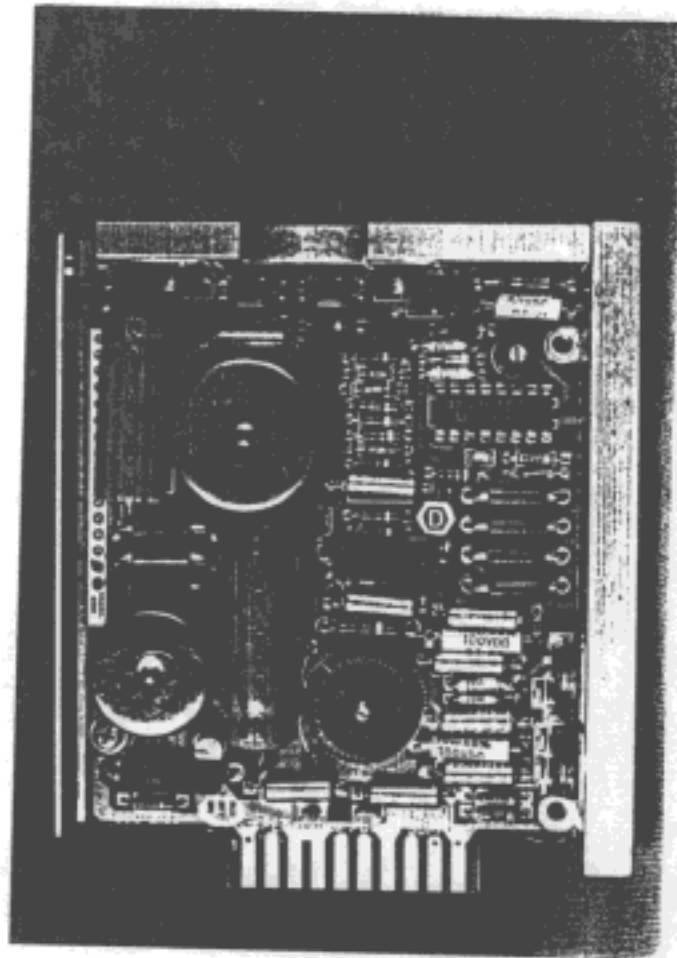
16. Side View of Power Supply Sub-Assembly, With Shield Cover Removed.

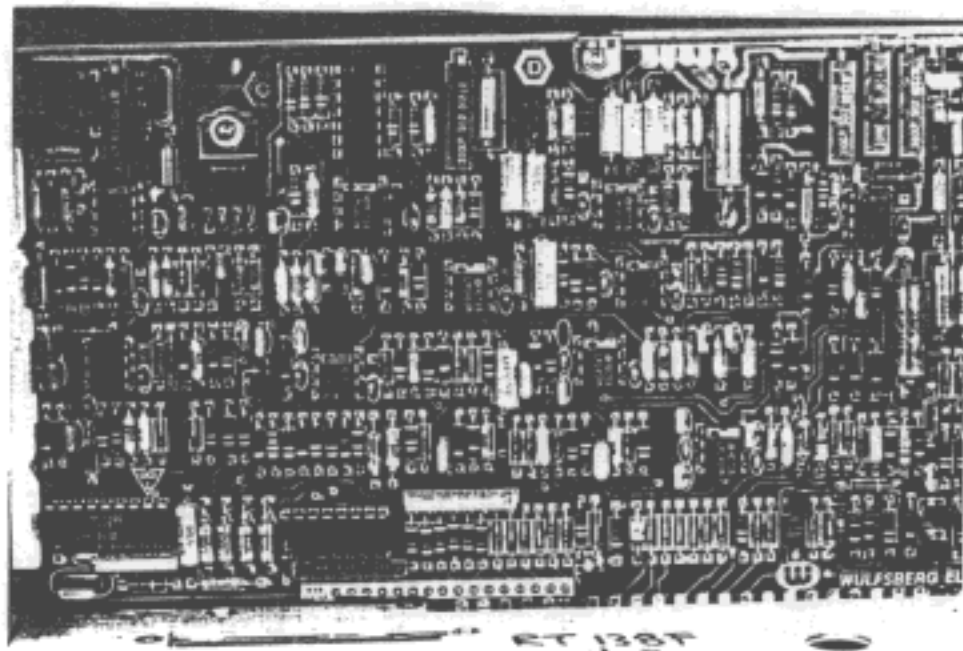
17. Rear Portion of Audio P.C. Board Sub-Assembly.

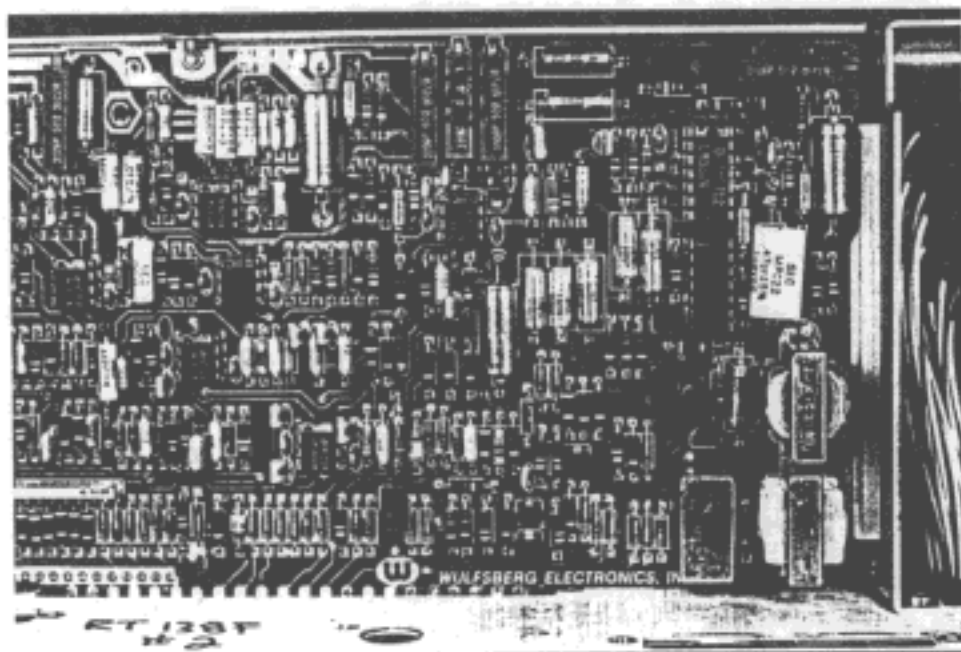
18. Front Portion of Audio P.C. Board Sub-Assembly.

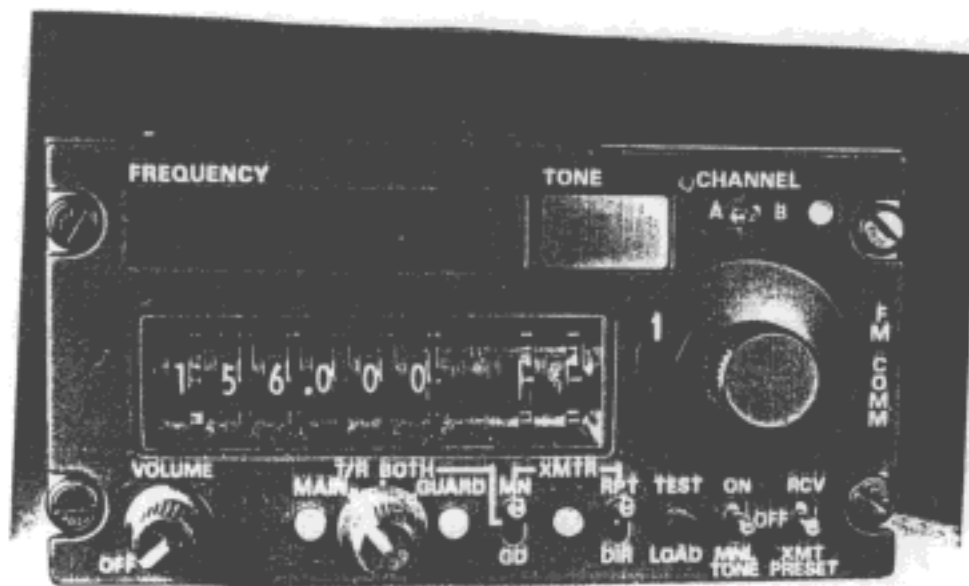
19. Front View of C-1000 Control Unit (Used With RT-130F Transceiver).
