**Title:** 5.2dBi Omni Antenna Test Setup

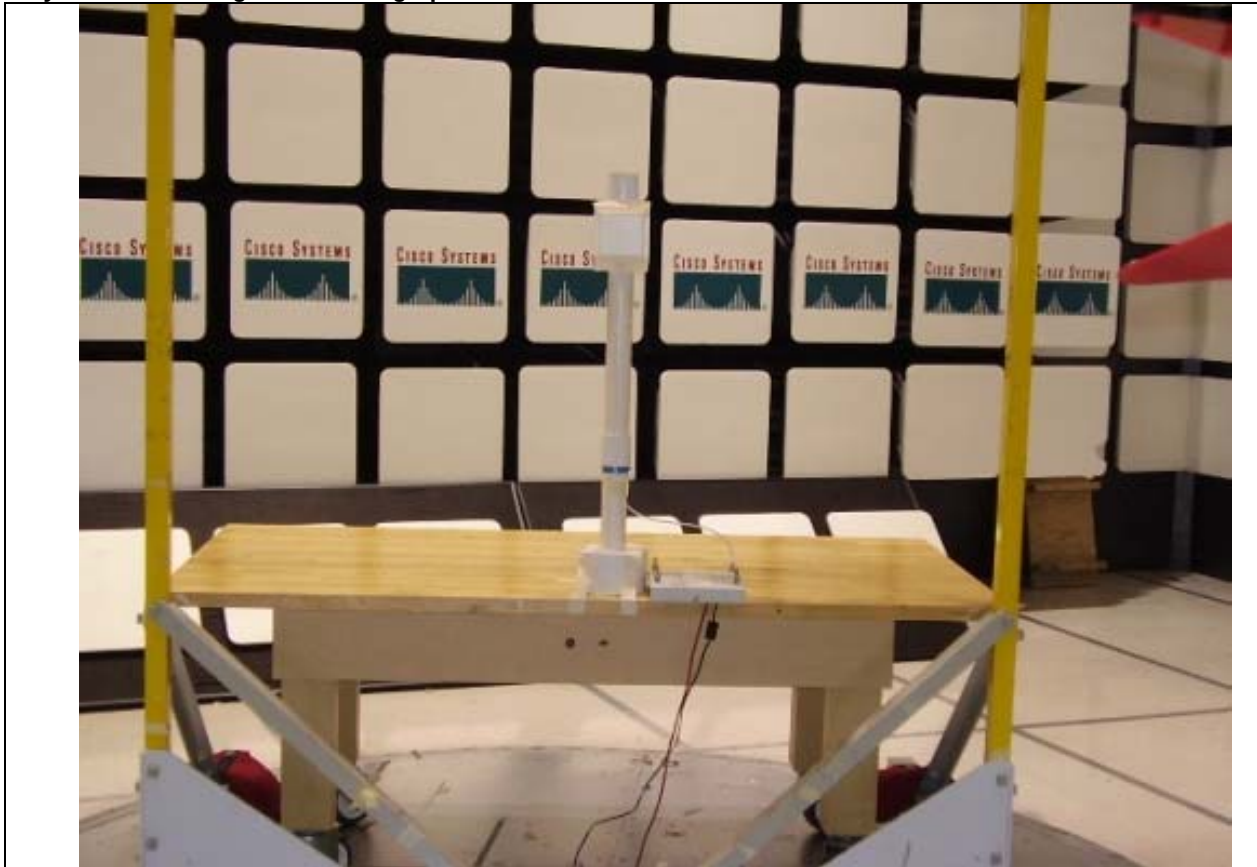
**Title:** 9.5dBi Patch Antenna Bandedge Setup

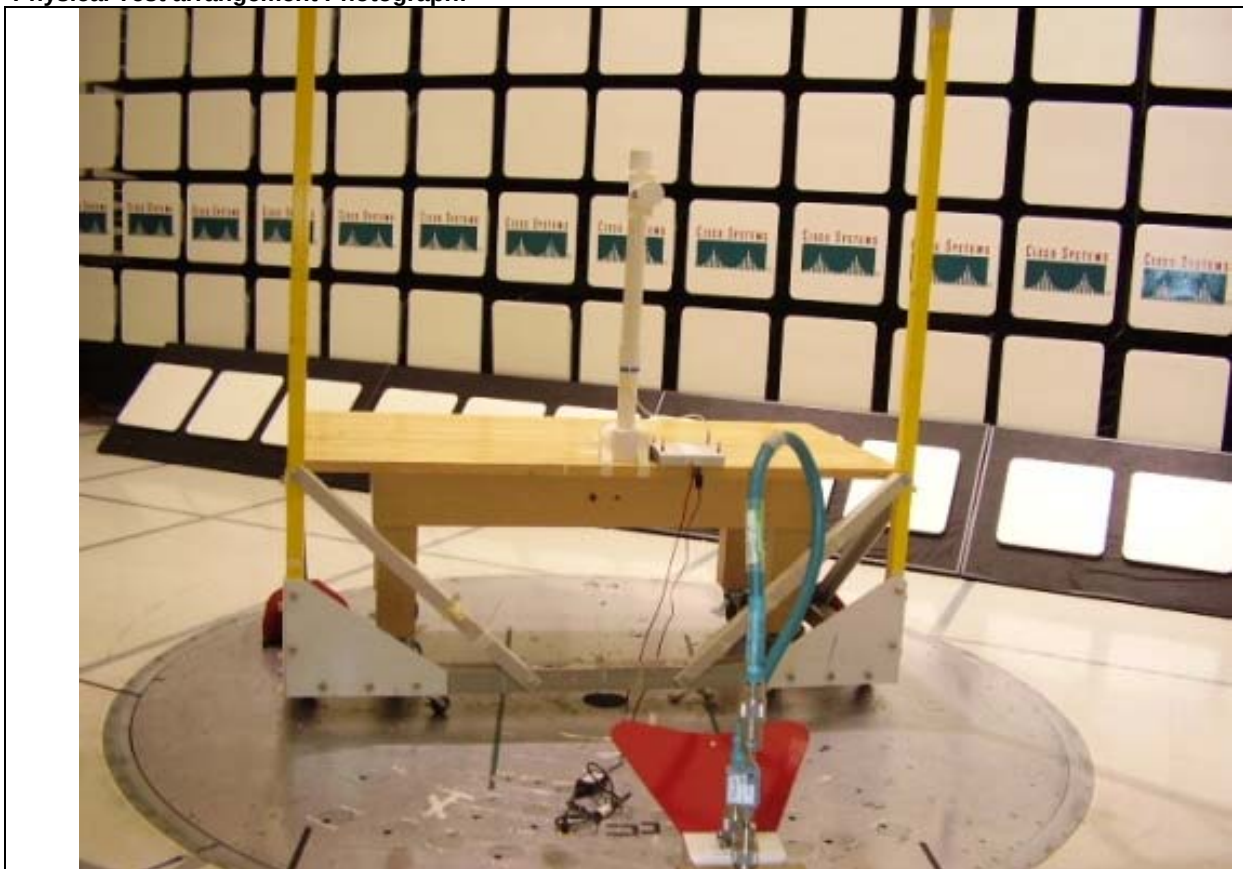
**Title:** 10dBi Band Edge Test Setup

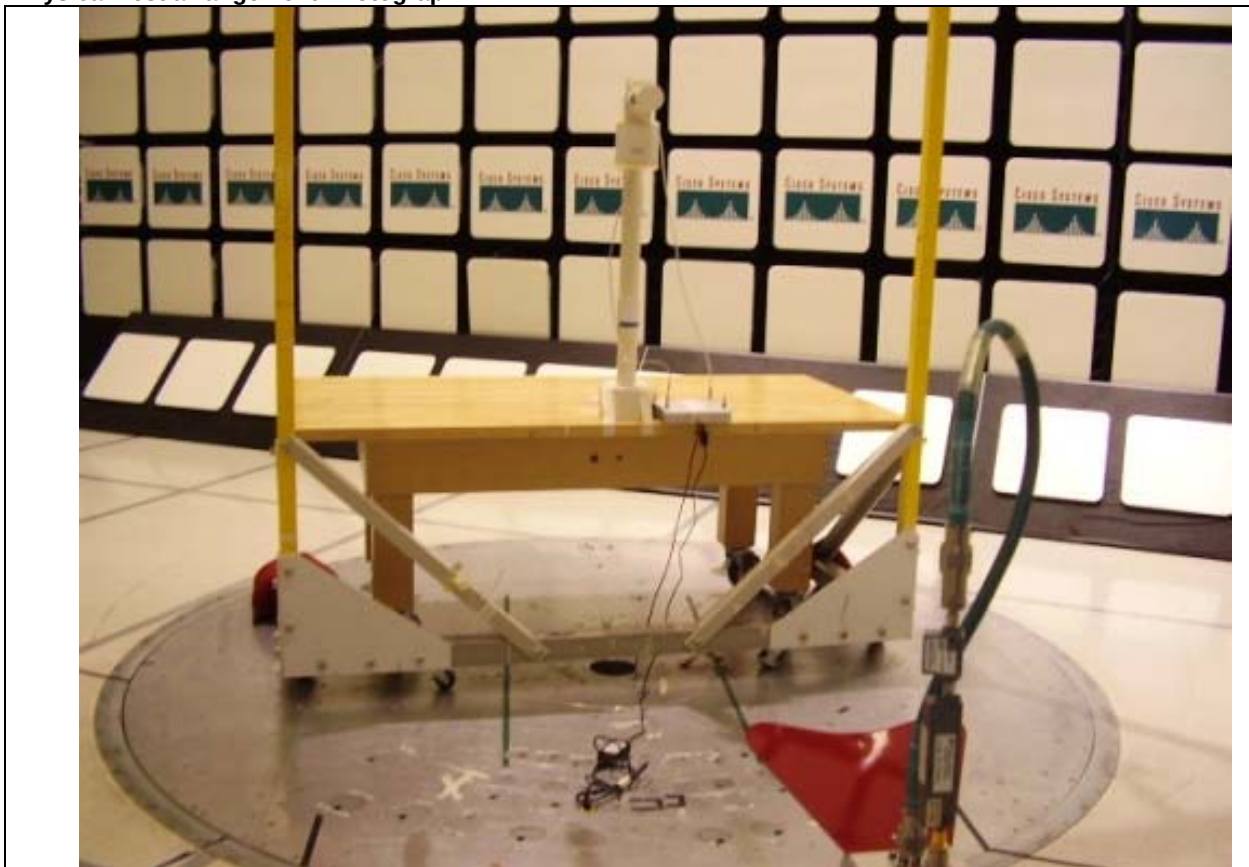
**Title:** Colocation Test Configuration

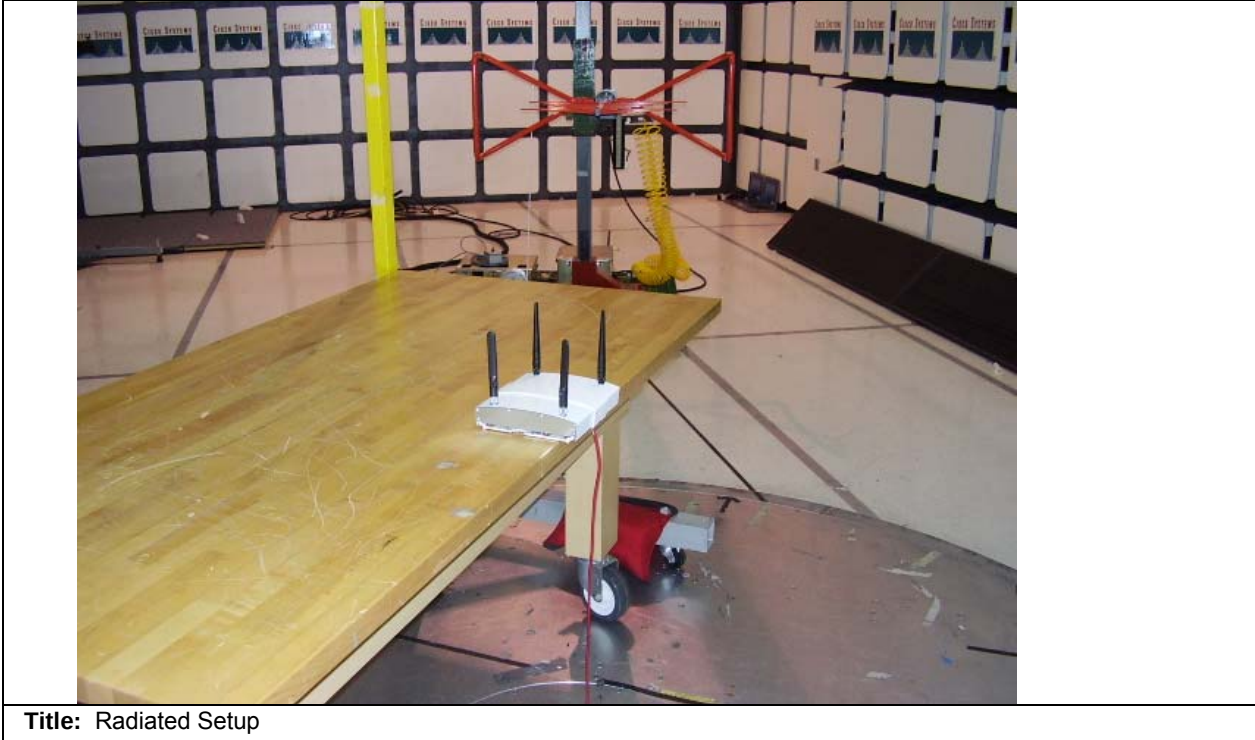
**Title:** Radiated Setup

Bilog antenna in background used to measure 30Mhz to 1Ghz range.

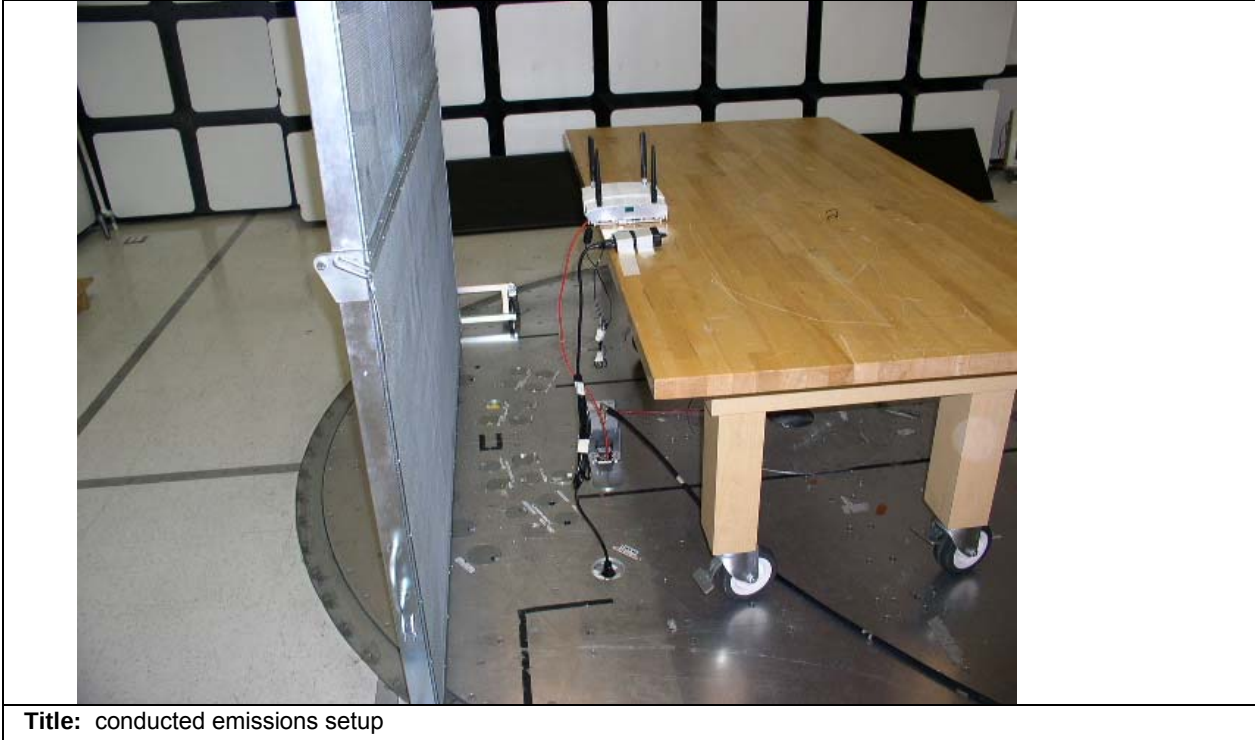
Power supply plugged into LISN mounted under Turntable.
