## INTERTEK TESTING SERVICES

### 3.7 Line Conducted Configuration Photograph (cont.) - Base Unit

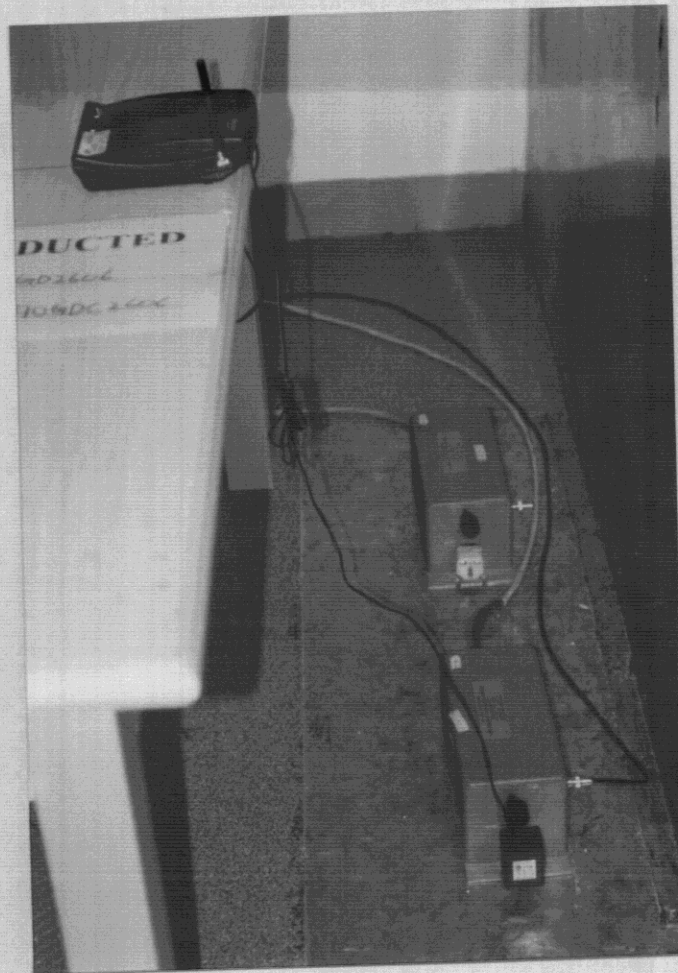
#### Worst Case Line-Conducted Configuration

Side View

at 16.515 MHz

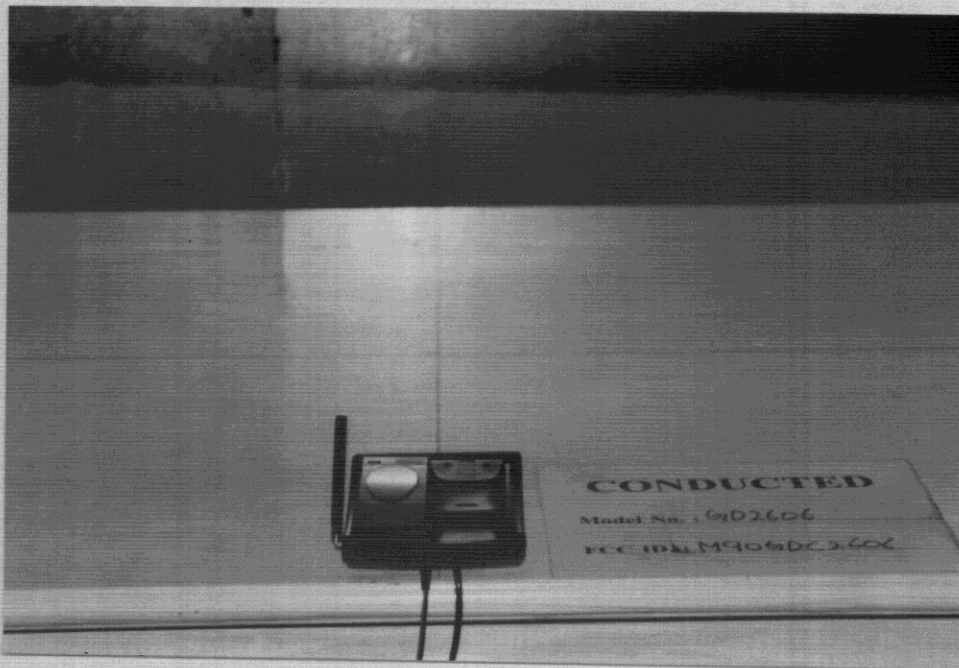
### 3.7 Line Conducted Configuration Photograph (cont.) - Base Unit

Worst Case Line-Conducted Configuration

Rear View

at 16.515 MHz

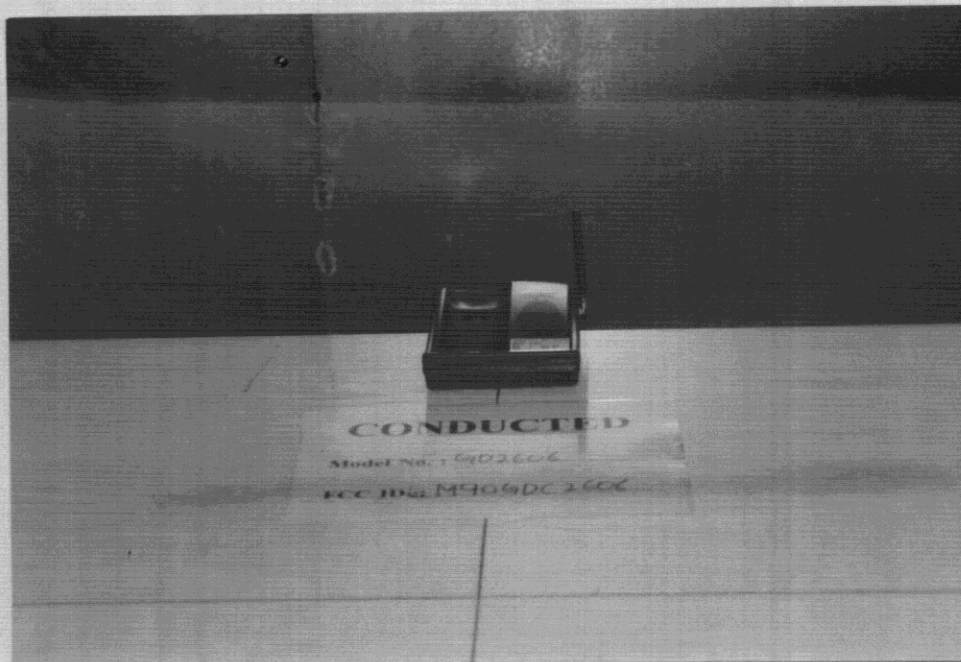
### 3.7 Line Conducted Configuration Photograph - Base Unit

Worst Case Line-Conducted Configuration

Front View

at 16.515 MHz

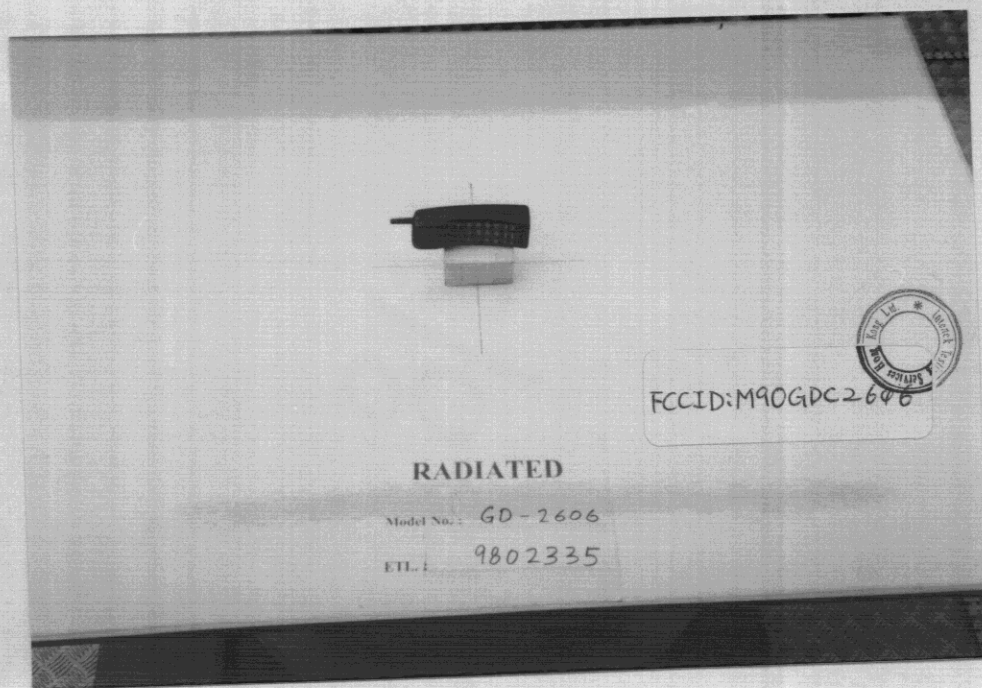
### 3.4 Radiated Emission Configuration Photograph - Handset

Worst Case Radiated Emission

Front View

at 3707.300 MHz

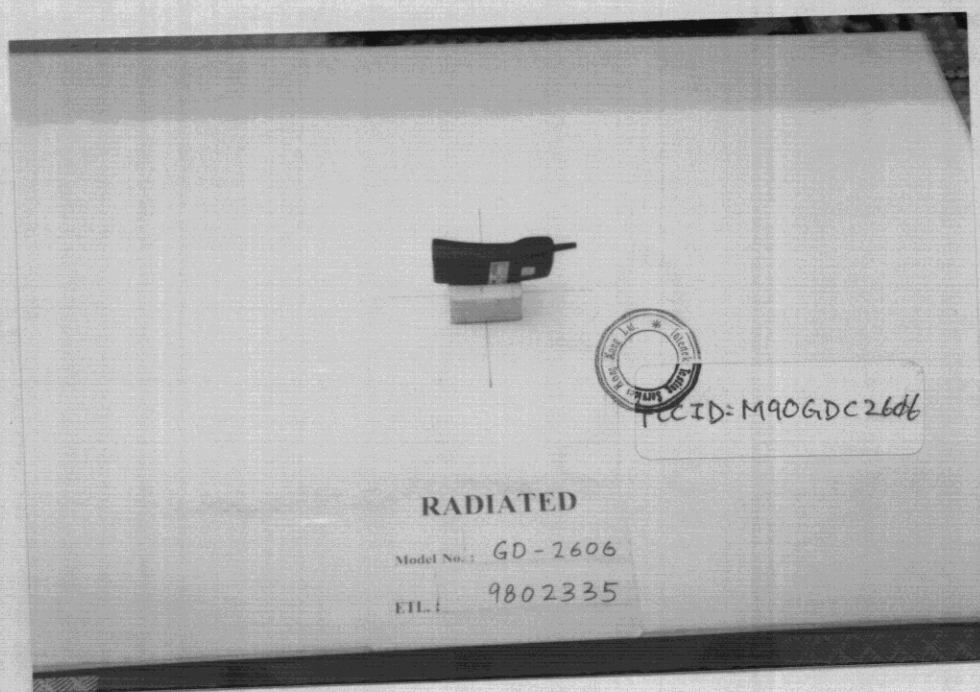
### 3.4 Radiated Emission Configuration Photograph (cont.) - Handset

Worst Case Radiated Emission

Rear View

at 3707.300 MHz

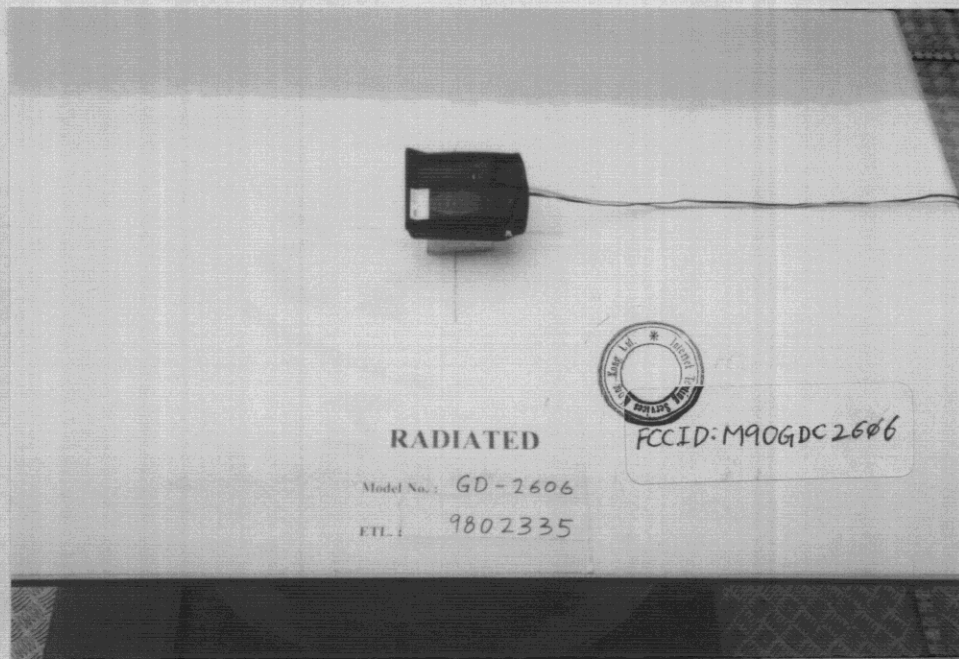
### 3.2 Radiated Emission Configuration Photograph - Base Unit

Worst Case Radiated Emission

Front View

at 3614.482 MHz

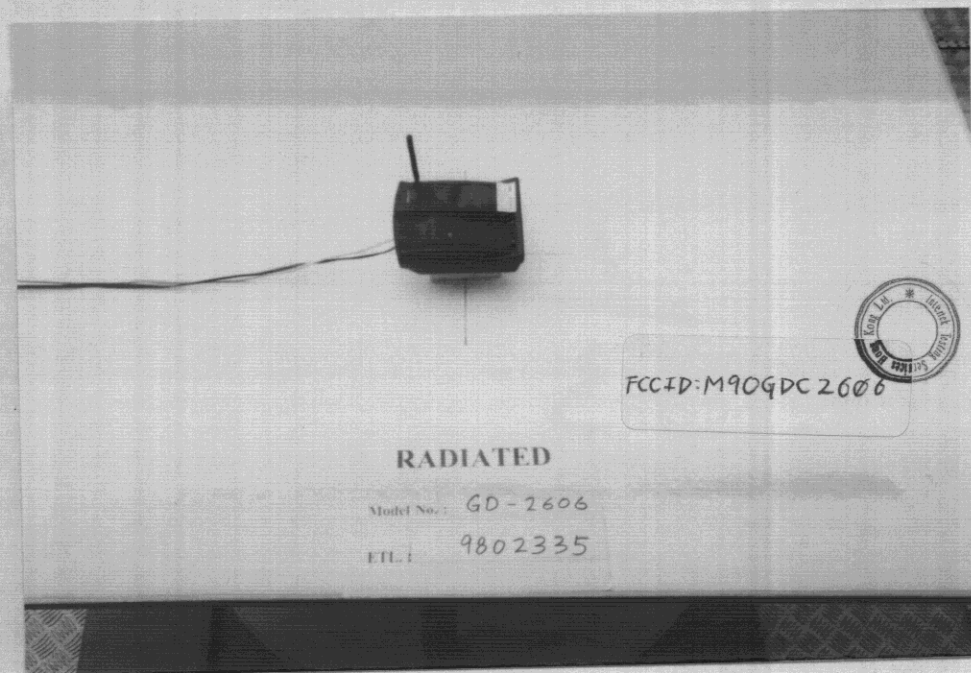
### 3.2 Radiated Emission Configuration Photograph (cont.) - Base Unit

Worst Case Radiated Emission

Rear View

at 3614.482 MHz
