Report No.: 9808666

Scan Settings (1 Range)

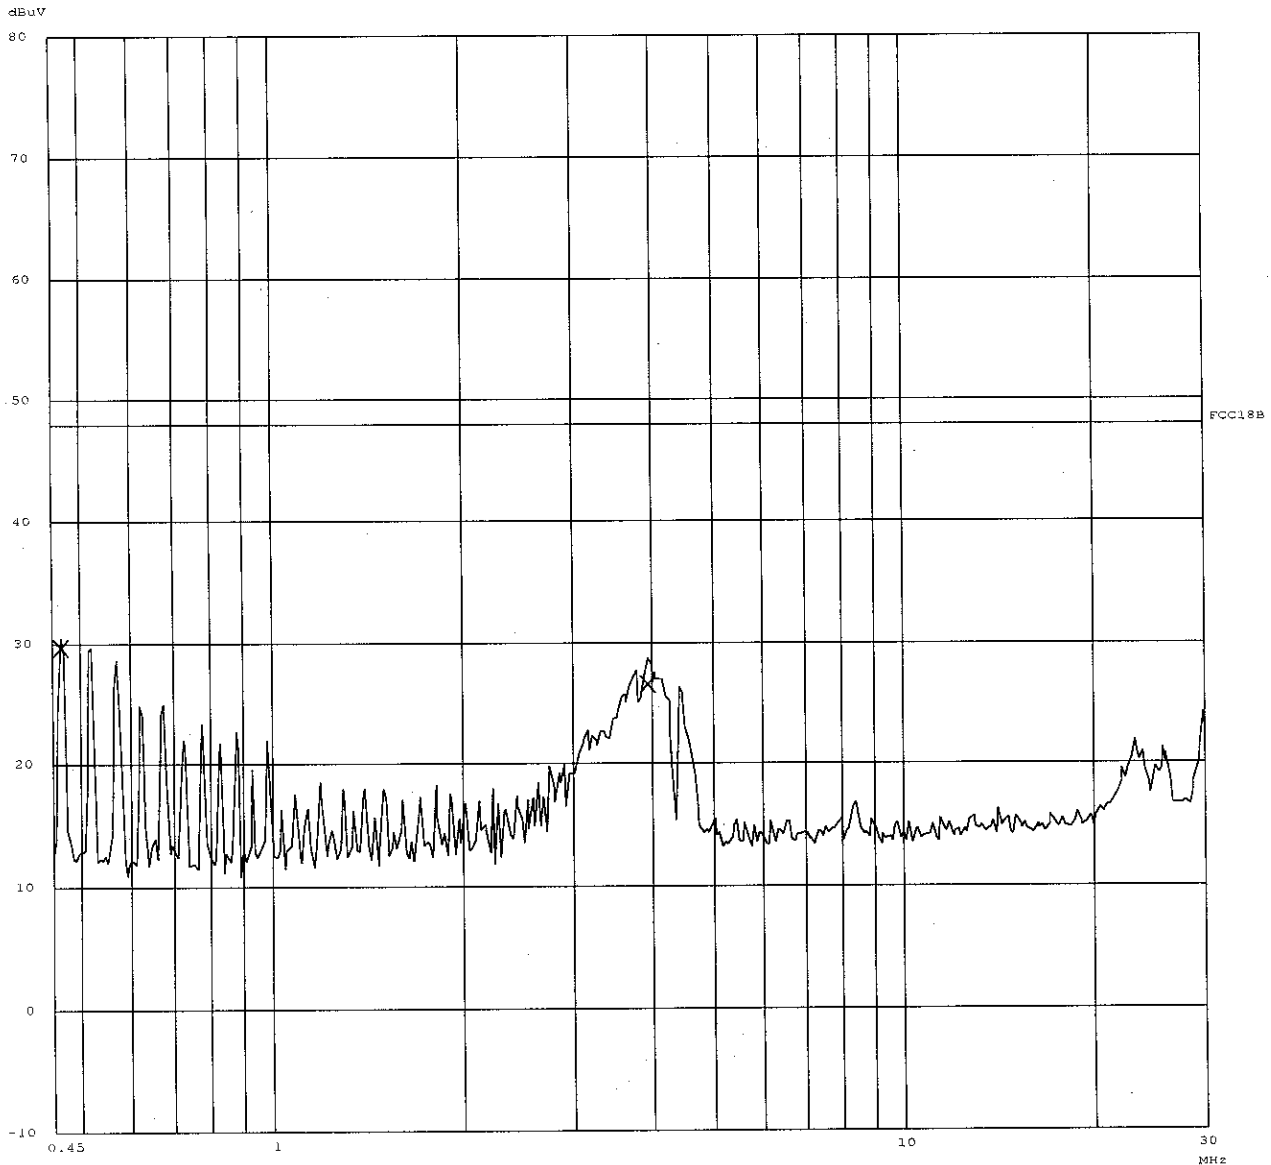
| Frequencies | | | Receiver Settings | | | | |
|---|---|---|---|---|---|---|---|
| 450k | 30M | 5k | 10k | PK | 20ms | AUTO | LN OFF 60dB |

Final Measurement: X QP

Meas Time: 1 s  
Subranges: 16  
Acc Margin: 20dB

Final Measurement Results:

| Frequency<br>MHz | QP Level<br>dBuV | QP Limit<br>dBuV |
|---|---|---|
| 0.46500 | 29.6 | 48.0 |
| 3.94000 | 26.5 | 48.0 |
