## TEST REPORT

REPORT NO: **SATEL-TR-0021-HMM**

DEVICE UNDER TEST: **SATELLINE-3AS**

- Transient Frequency Behaviour of the transmitter  
#1: at 12.5 kHz channel spacing  
(pages 2 to 10, figures 1-18)  
on various temperatures  
(-30, -20, -10,  $\pm 0$ , +10, +20, +30, +40, +50 °C)

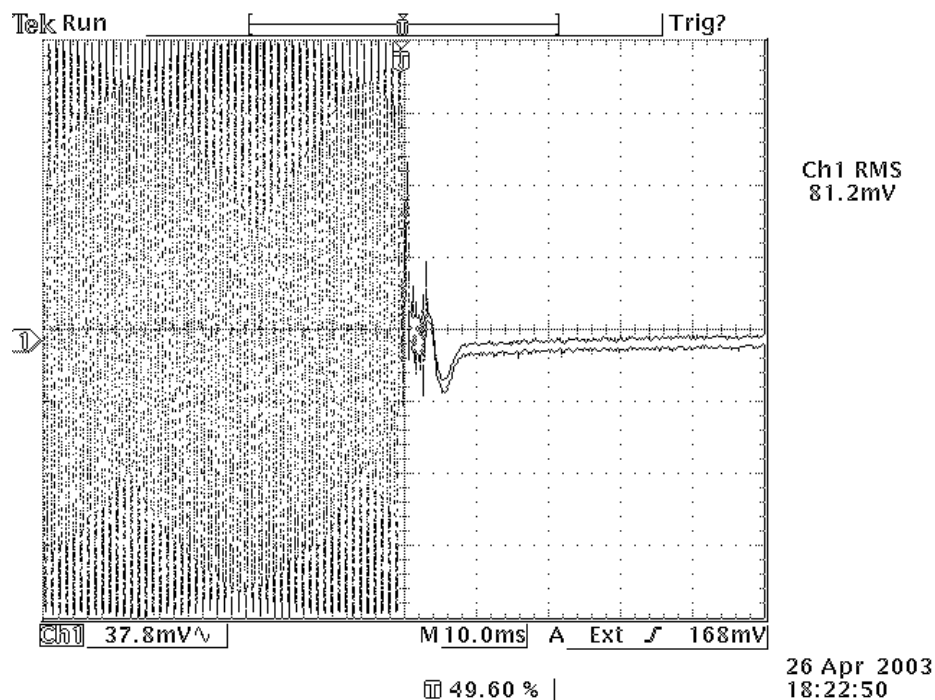
Fig. 5. Transmitter switched ON at  $-10^{\circ}\text{C}$ . (12.5 kHz ch. sp.)

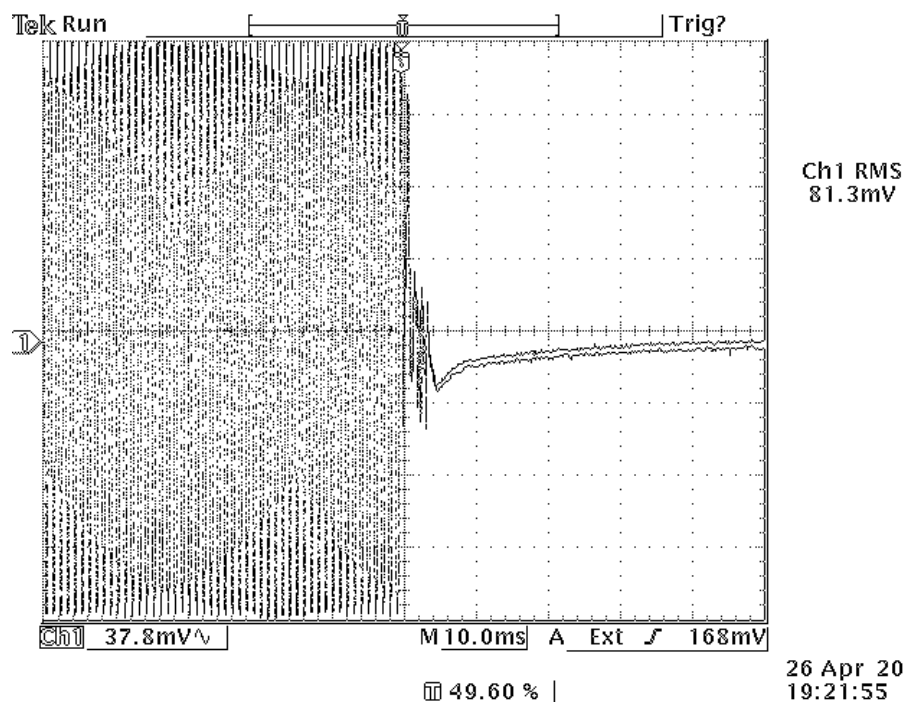
Fig. 13. Transmitter switched ON at +30 °C. (12.5 kHz ch. sp.)

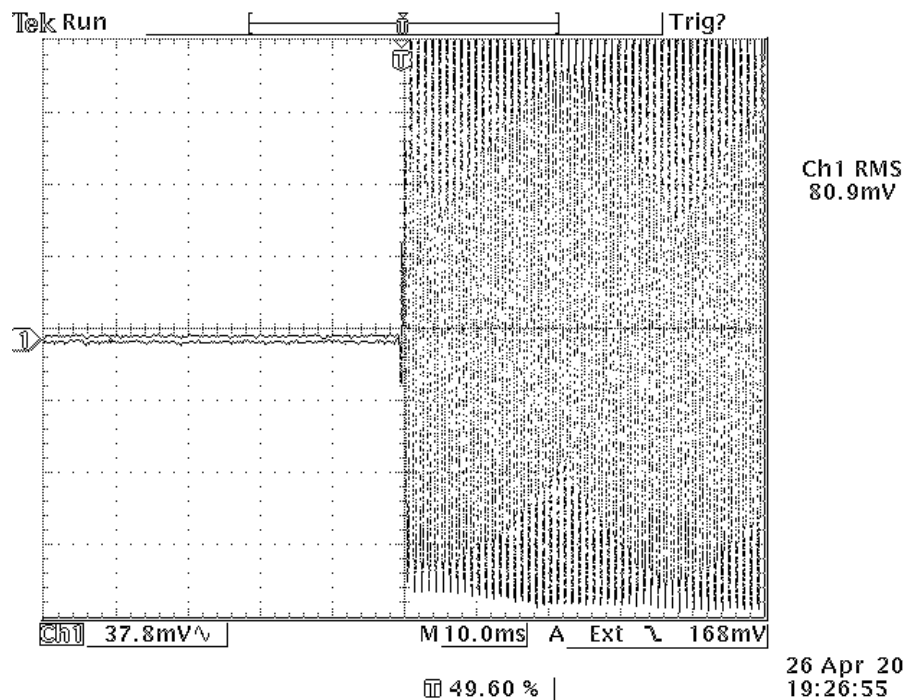
Fig. 14. Transmitter switched OFF at +30 °C. (12.5 kHz ch. sp.)
