## INTERTEK TESTING SERVICES

### 3.7 Line Conducted Configuration Photograph - Base Unit

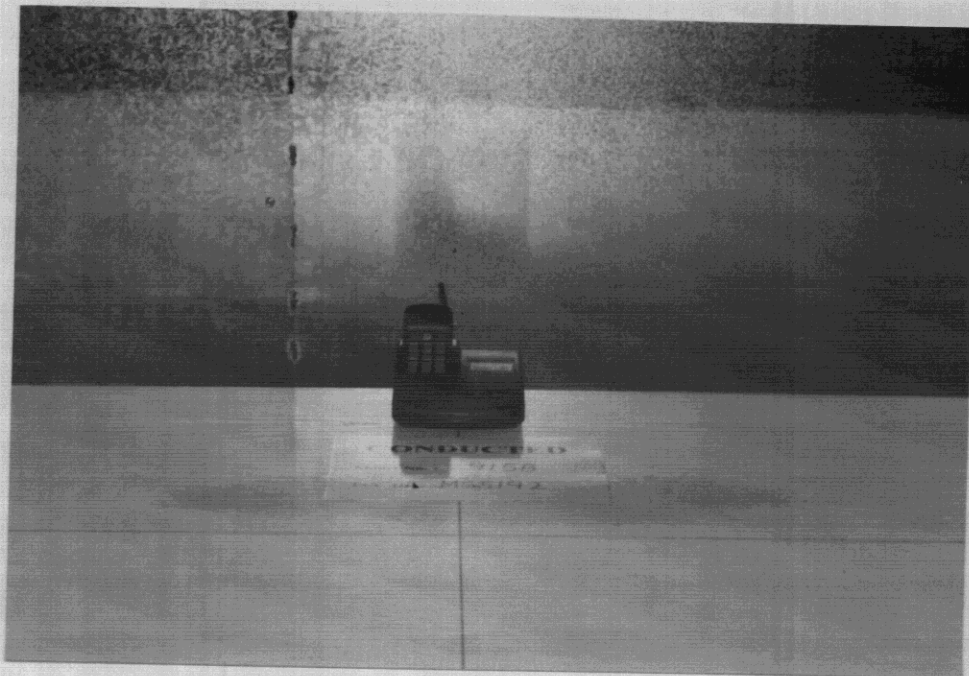
Worst Case Line-Conducted Configuration

Front View

at 0.450 MHz

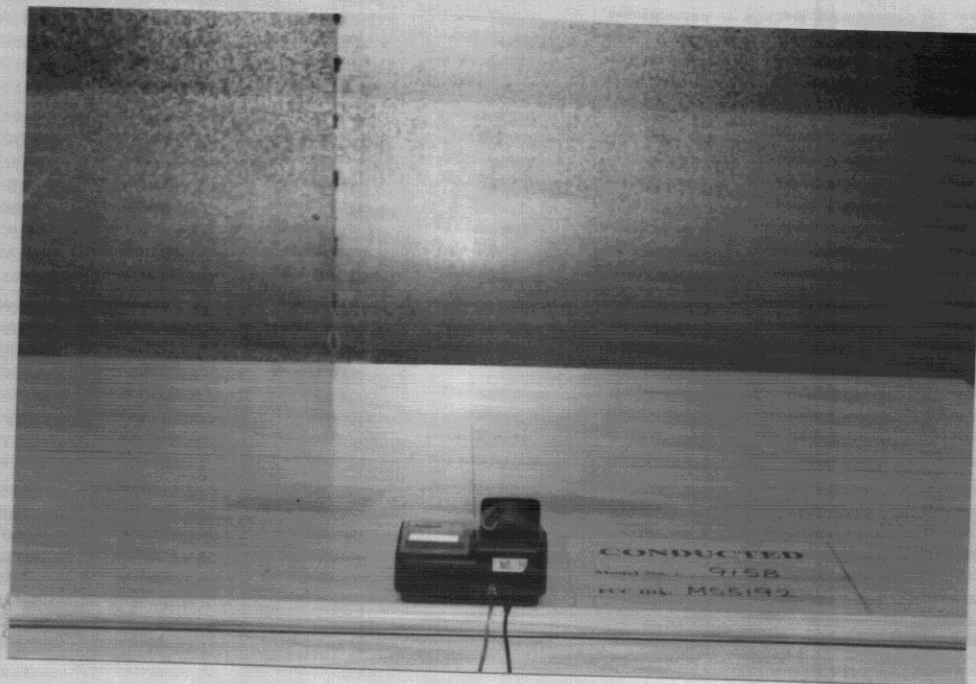
### 3.7 Line Conducted Configuration Photograph (cont.) - Base Unit

#### Worst Case Line-Conducted Configuration

Rear View

at 0.450 MHz

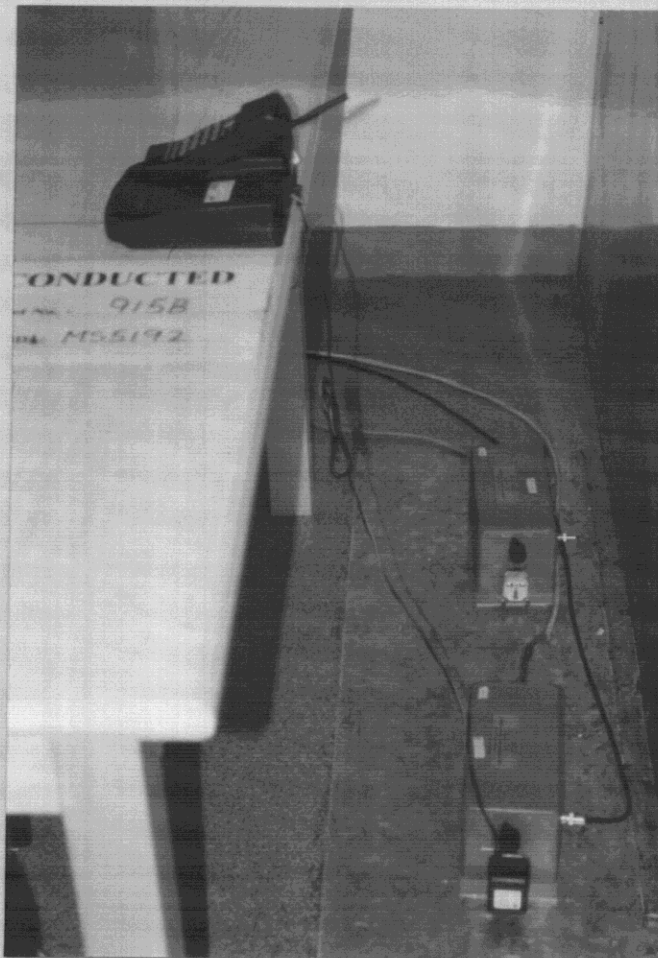
### 3.7 Line Conducted Configuration Photograph (cont.) - Base Unit

#### Worst Case Line-Conducted Configuration

Side View

at 0.450 MHz

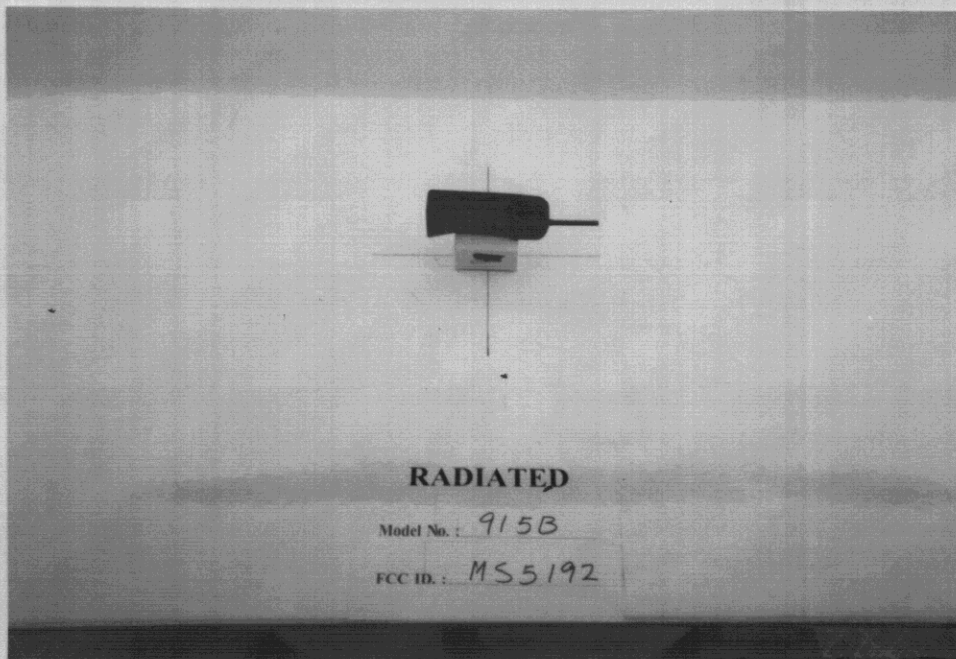
### 3.4 Radiated Emission Configuration Photograph - Handset

Worst Case Radiated Emission

Front View

at 3703.210 MHz

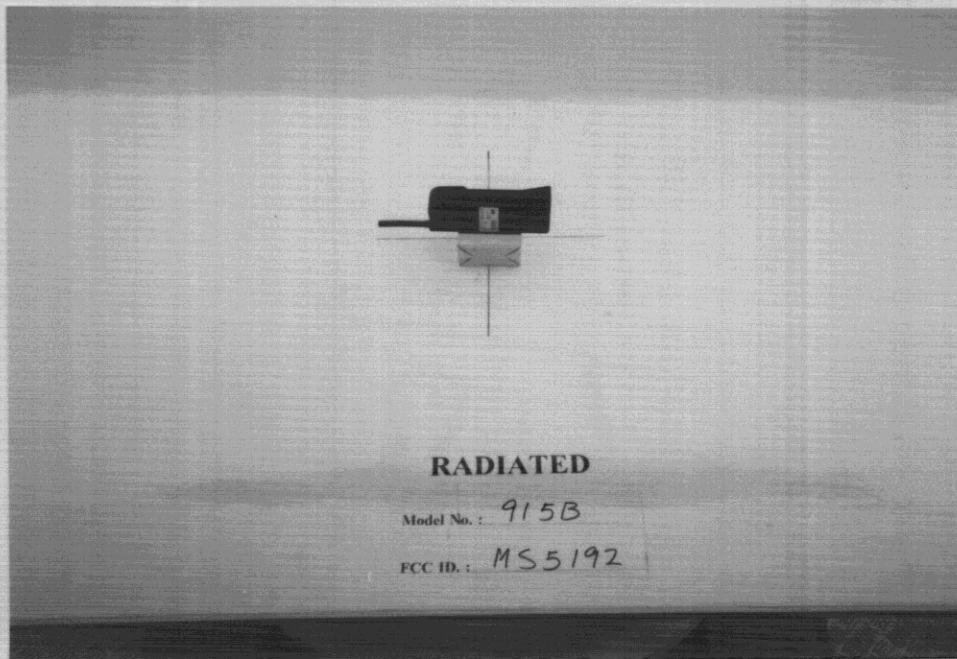
### 3.4 Radiated Emission Configuration Photograph (cont.) - Handset

#### Worst Case Radiated Emission

Rear View

at 3703.210 MHz

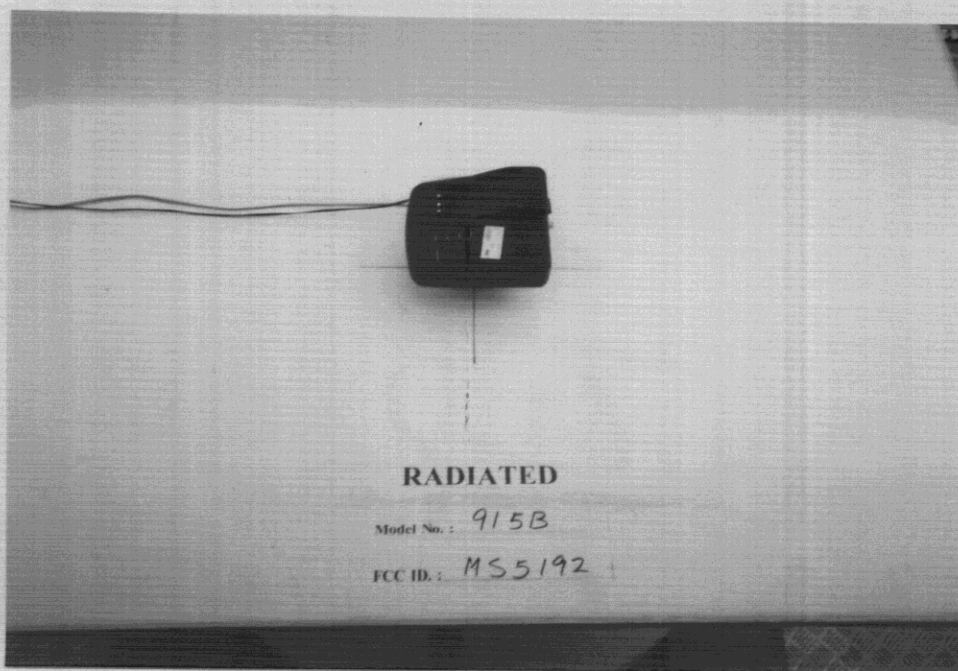
### 3.2 Radiated Emission Configuration Photograph - Base Unit

Worst Case Radiated Emission

Front View

at 2716.804 MHz

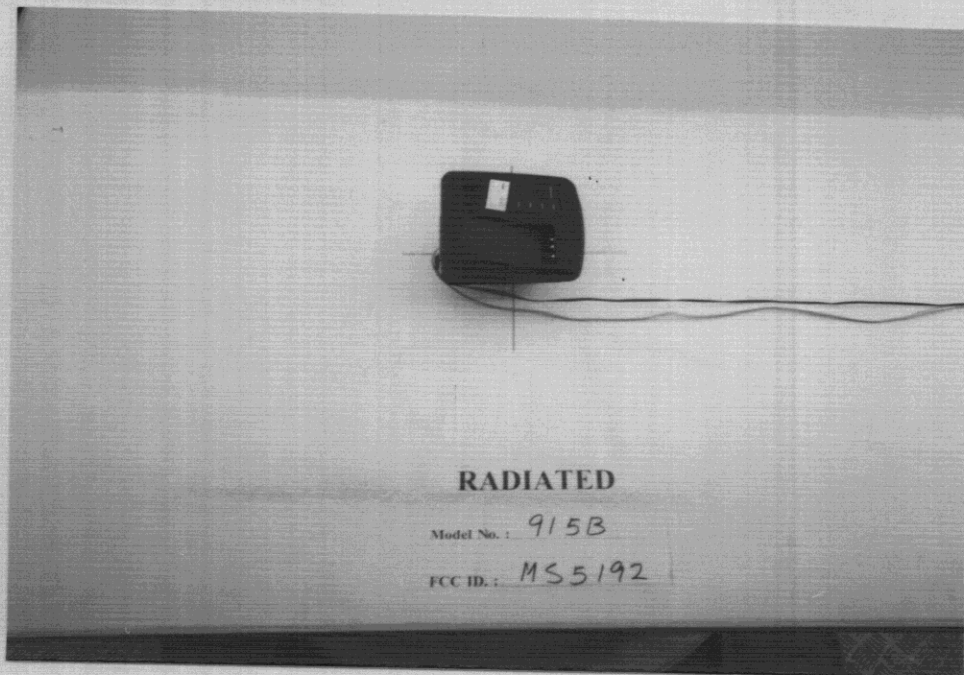
### 3.2 Radiated Emission Configuration Photograph (cont.) - Base Unit

Worst Case Radiated Emission

Rear View

at 2716.804 MHz
