**Prüfbericht - Nr.: 16004798 001**  
*Test Report No.:*

## 6 Photographs of the Test Set-Up

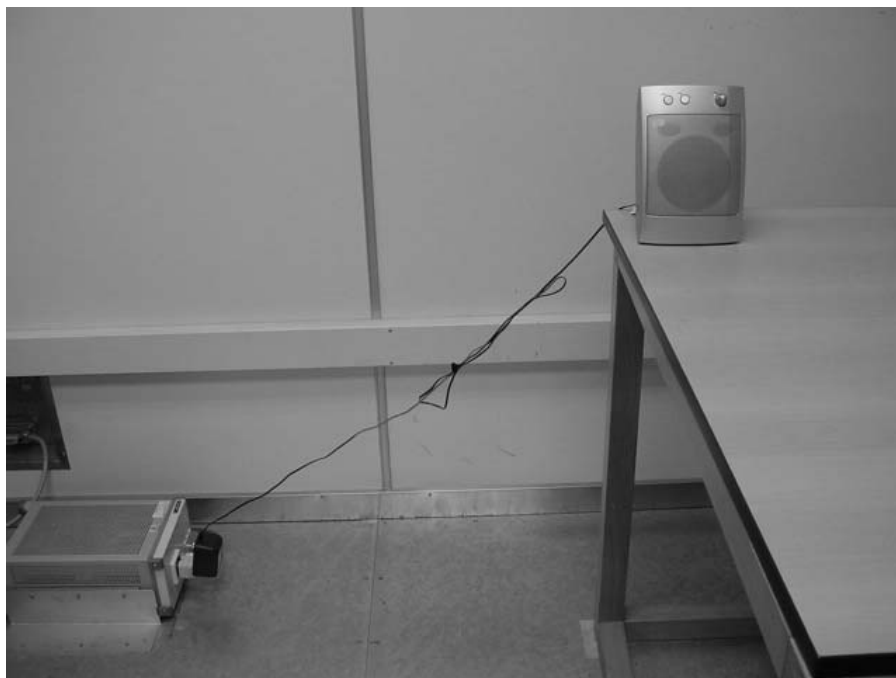
**Photograph 1: Set up for Conducted Emission on AC Mains**

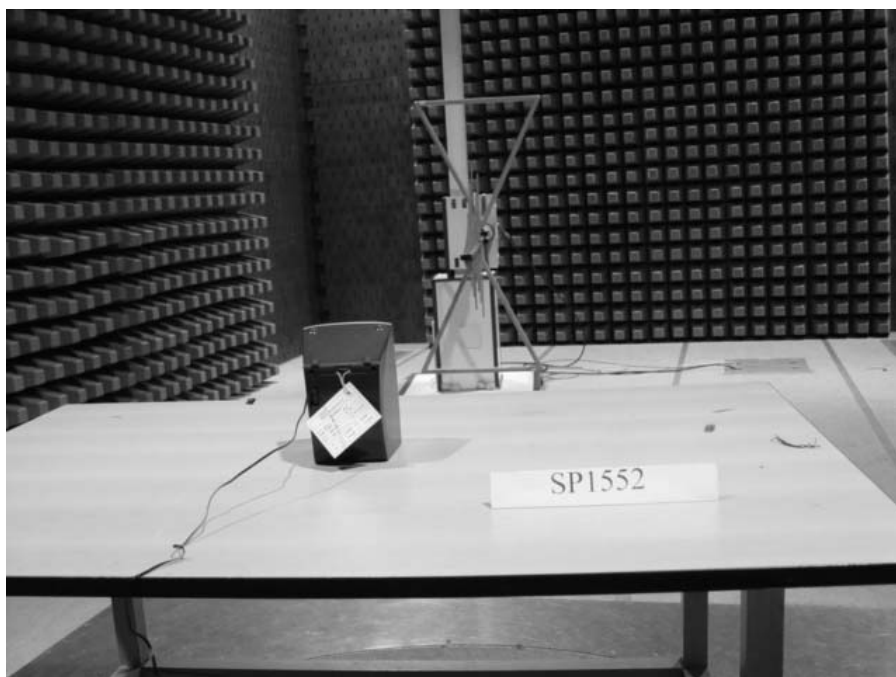
**Photograph 2: Set-up for Radiation Measurement Below 1GHz**

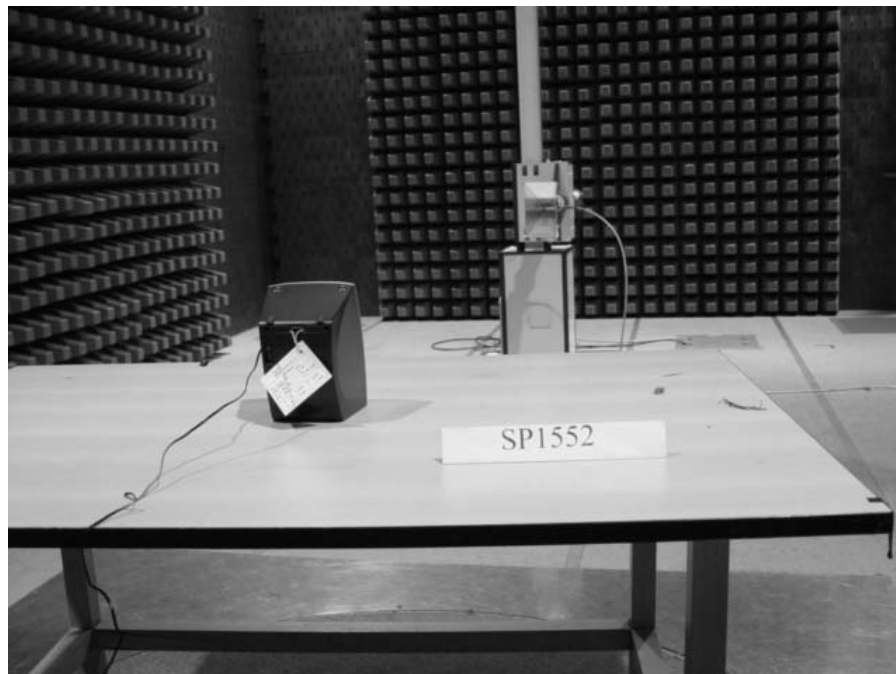
**Photograph 3: Set-up for Radiation Measurement Above 1GHz**
