# Intertek Testing Services

Report No.: 9906319

Mode: Charging

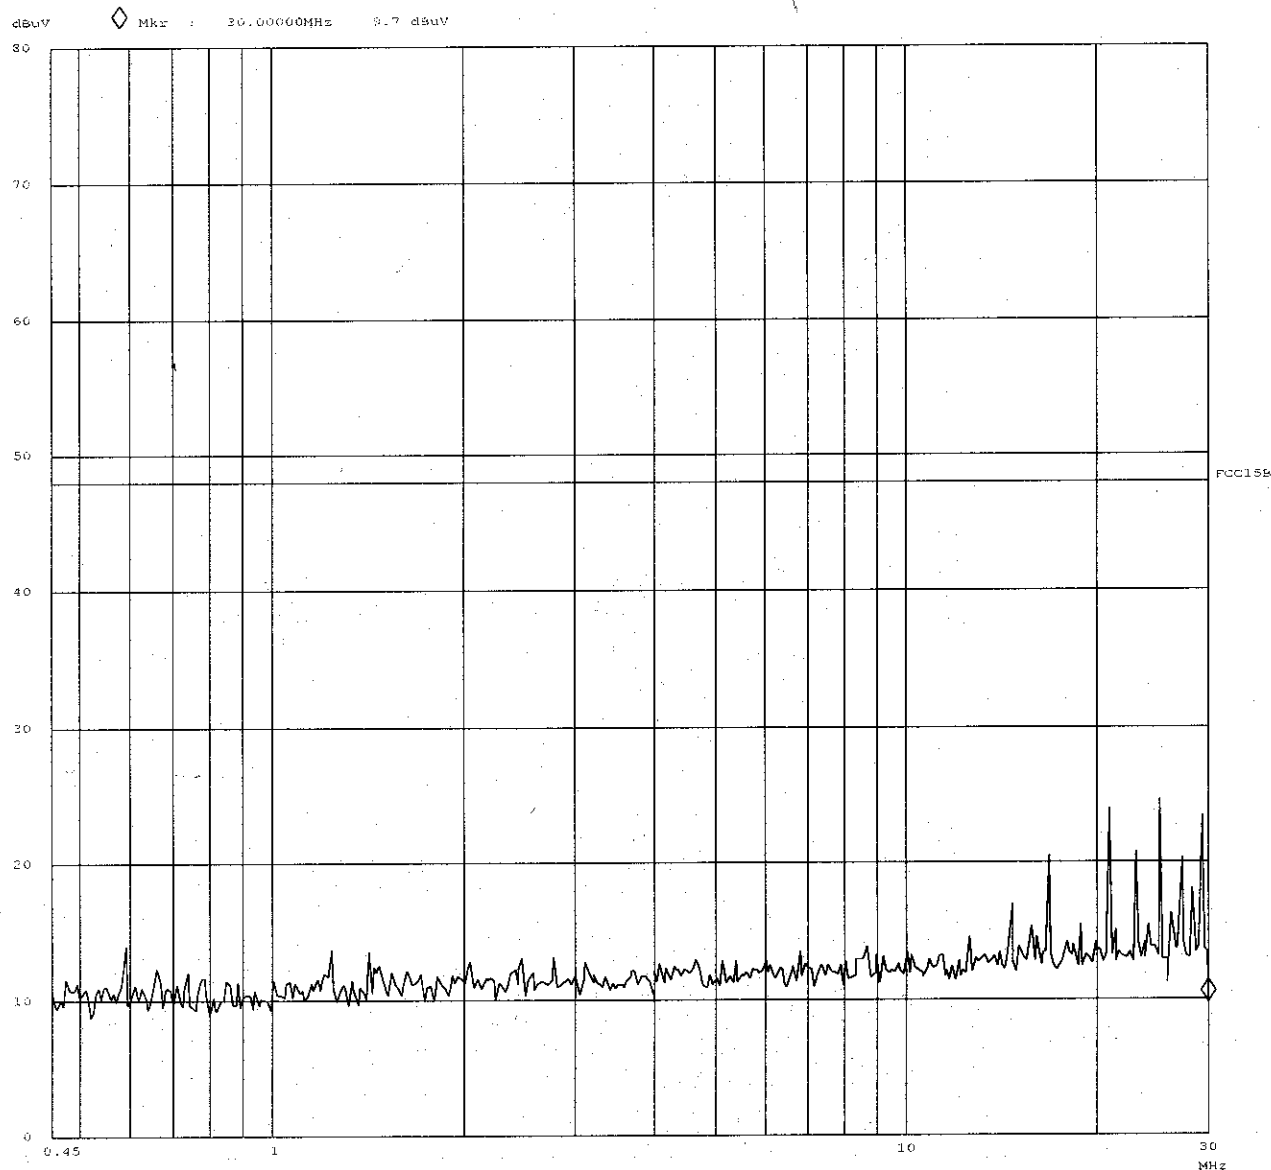
Scan Settings (1 Range)

| Start | Stop | Step | IF BW | Detector | M-Time | Atten | Preamp | OpRge |
| 450K | 30M | 5k | 10K | PK | 20ms | AMTO | LN OFF | 60dB |

| Final Measurement: 0 QP | Transducer No. | Start | Stop | Name |
| Meas Time: 1 s | 3 | 9k | 30M | EI078 |

Final Measurement Results:

no Results

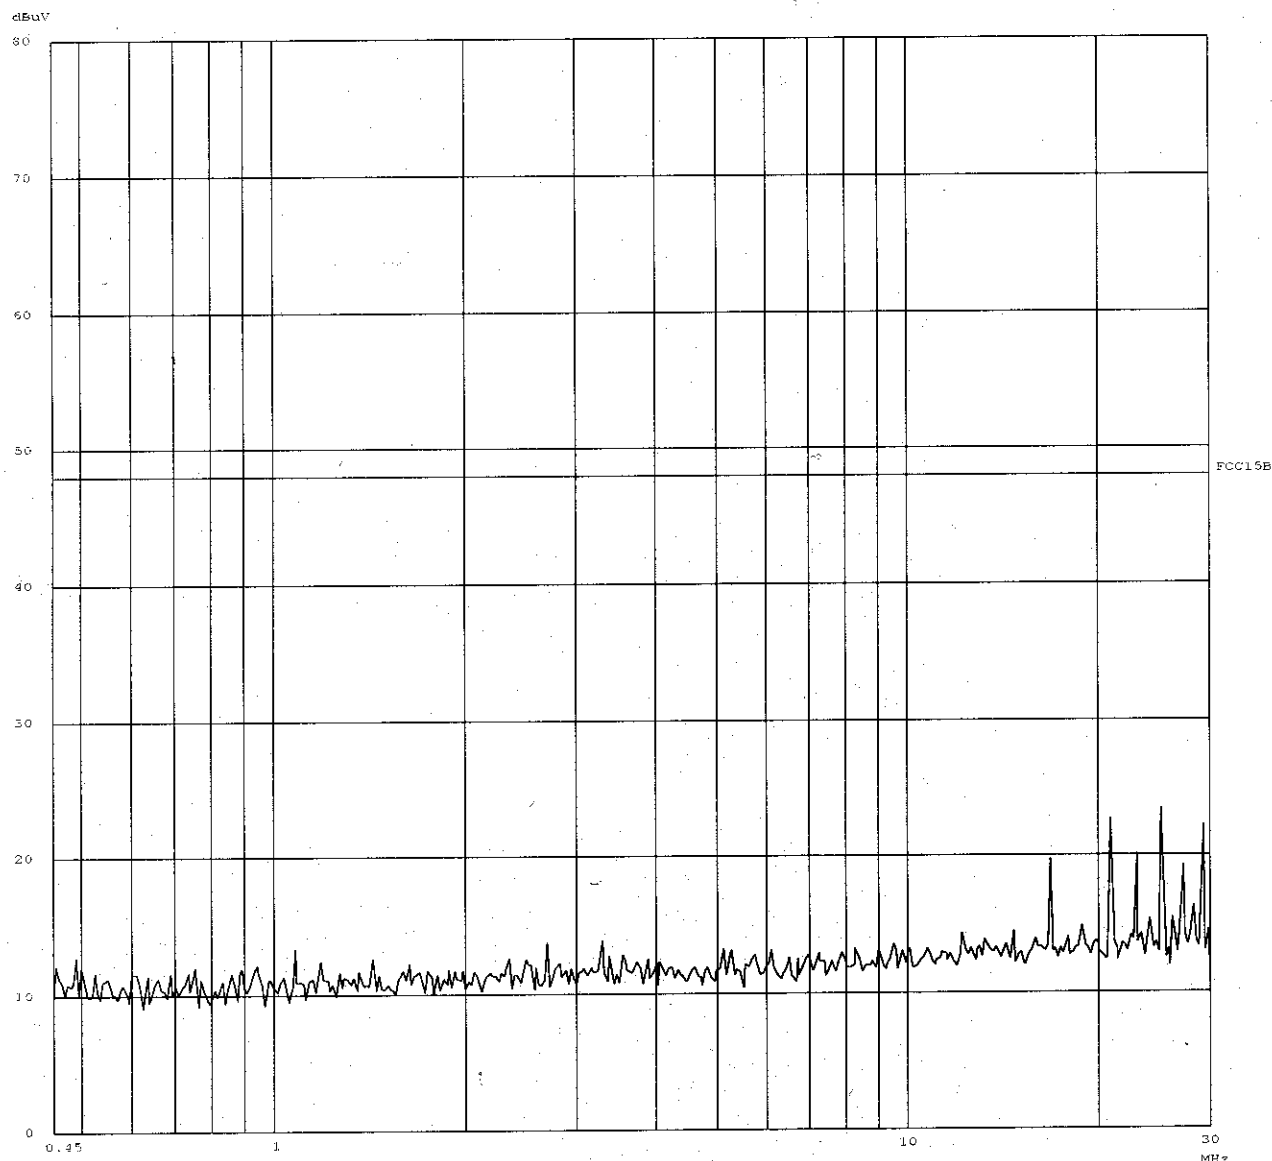
Mode: Standby

Tested By: Hong, Report No.: 9906319  
Scan Settings (1 Range)

| Frequencies | | Receiver Settings | | | | | | |
|---|---|---|---|---|---|---|---|---|
| Start | Stop | Step | IF BW | Detector | M-Time | Atten | Preamp | OpRge |
| 450k | 30M | 5k | 10k | PK | 10ms | AUTO | LN OFF | 60dB |

| Final Measurement: | x | QP | Transducer No. | Start | Stop | Name |

Final Measurement Results:

no Results

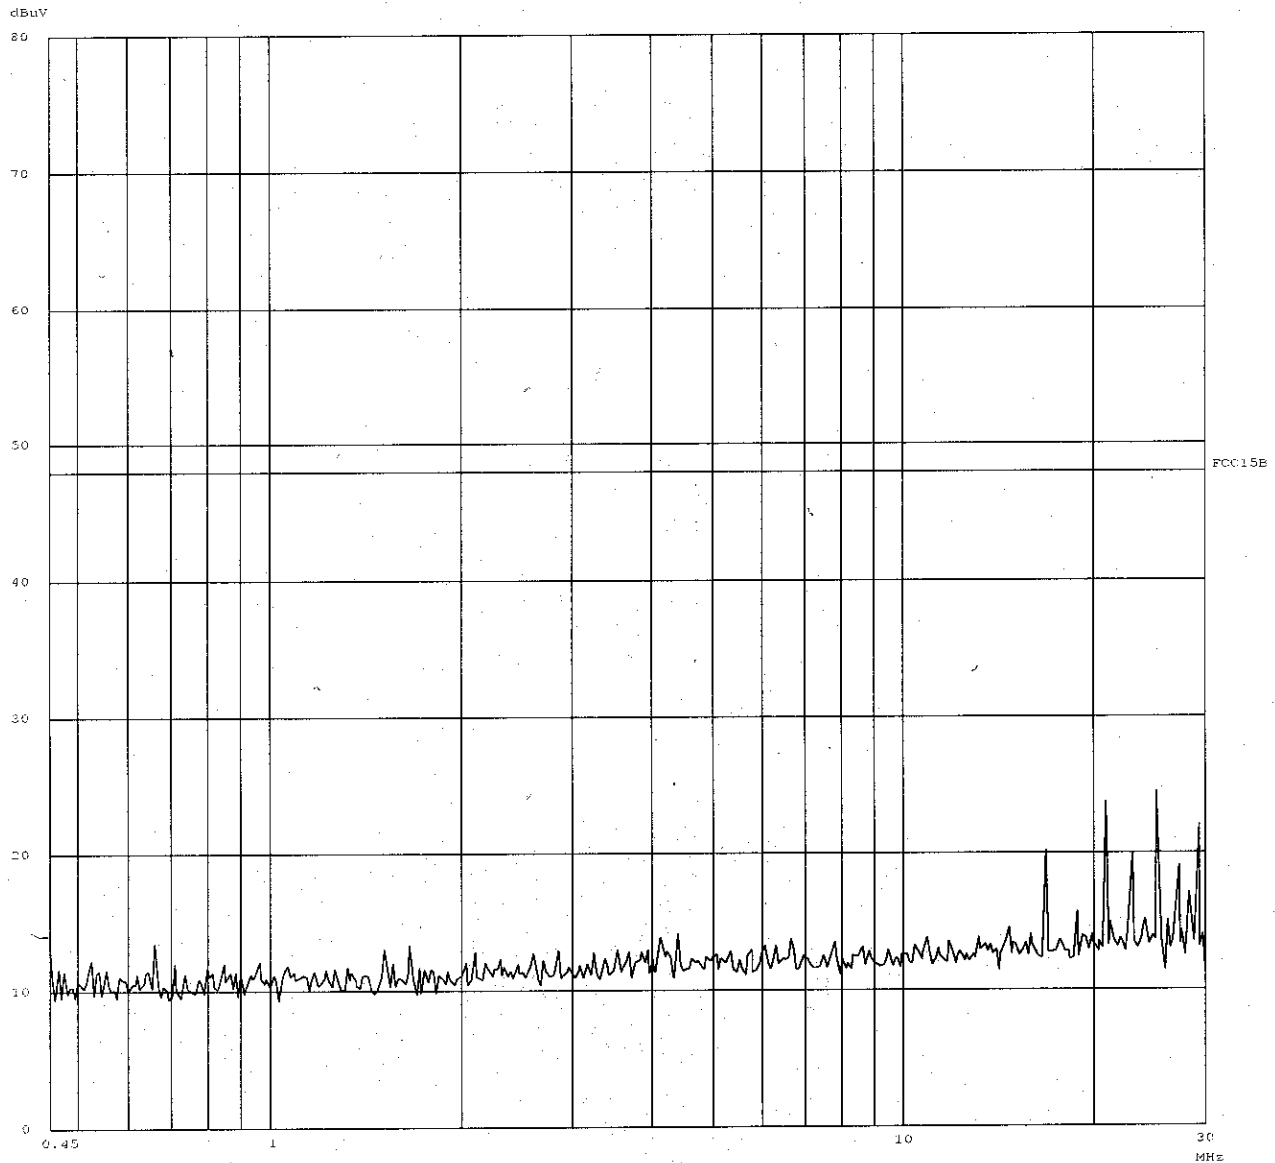
Mode: Transmission

Scan Settings (1 Range)

| Frequencies | | | Receiver Settings | | | | | |
|---|---|---|---|---|---|---|---|---|
| Start | Stop | Step | IF BW | Detector | M-Time | Atten | Preamp | OpRge |
| 450k | 30M | 5k | 10k | PK | 20ms | AUTO | LN OFF | 60dB |

| Final Measurement: | Transducer No. | Start | Stop | Name |
| 0 QF | 3 | 9k | 30M | EI078 |

Final Measurement Results:

no Results
