### **APPENDIX 3: Photographs of test setup**

#### **Radiated Emission**

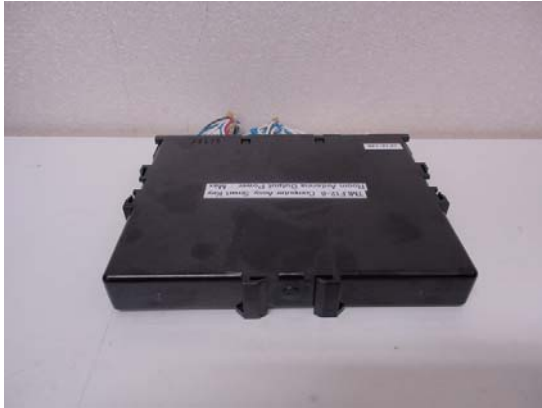
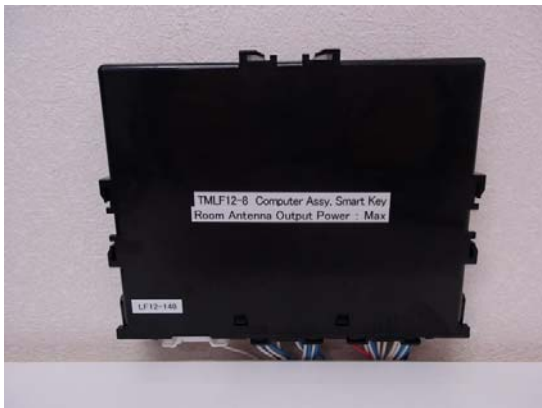
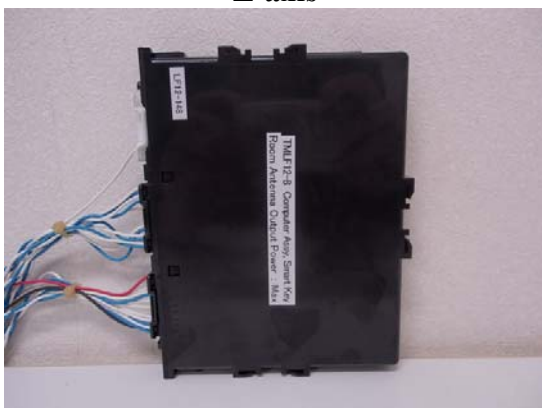
**ECU**  
Below 30 MHz  
X-axis  
Above 30 MHz  
Horizontal: X-axis / Vertical: X-axis  
X-axis

Y-axis

Z-axis

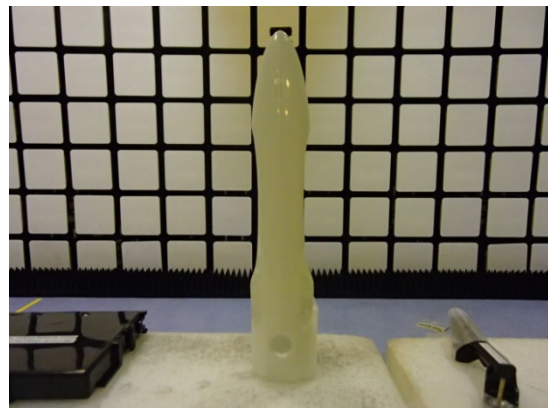
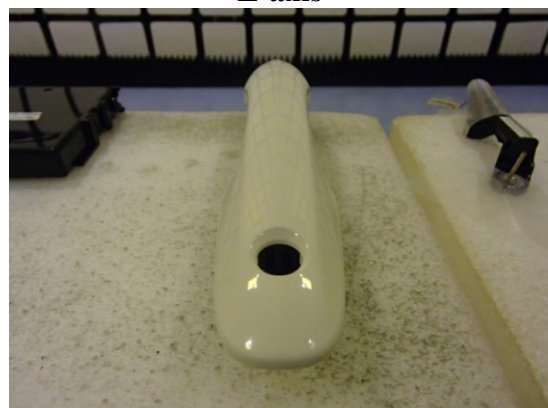
**Outside ANT**  
Below 30 MHz  
Z-axis  
Above 30 MHz  
Horizontal: X-axis / Vertical: X-axis  
X-axis

Y-axis

Z-axis

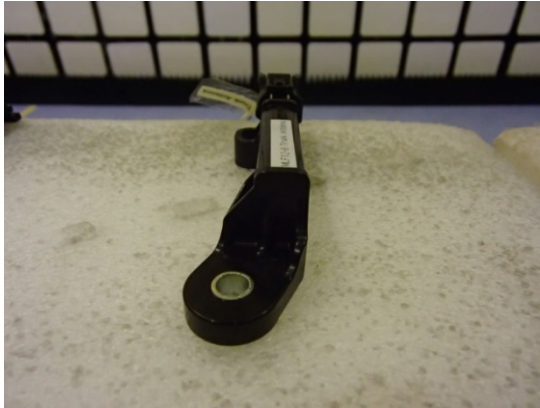
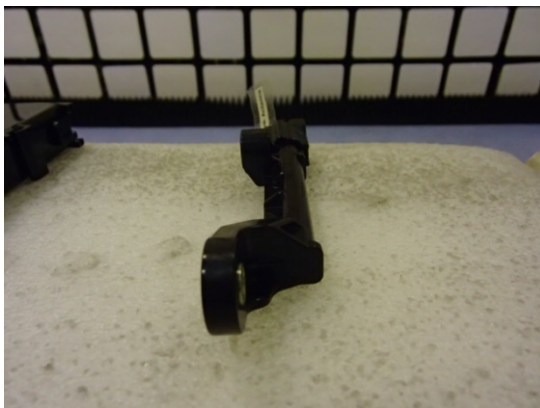
**Trunk ANT**  
Below 30 MHz  
X-axis  
Above 30 MHz  
Horizontal: X-axis / Vertical: X-axis  
X-axis

Y-axis

Z-axis
