### **APPENDIX 3: Photographs of test setup**

#### **Radiated Spurious Emission**

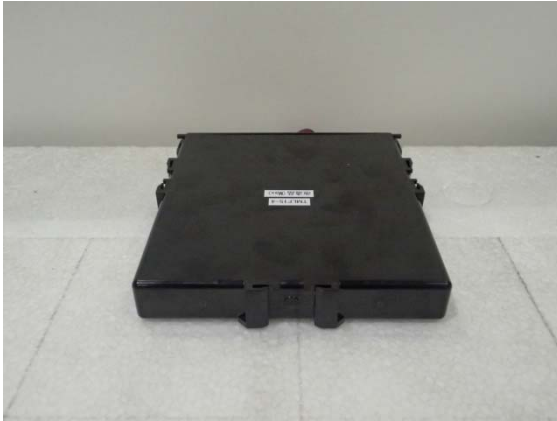
**X-axis**

#### ECU

Below 30 MHz:

X-axis

Above 30 MHz:

Horizontal: X-axis / Vertical: X-axis

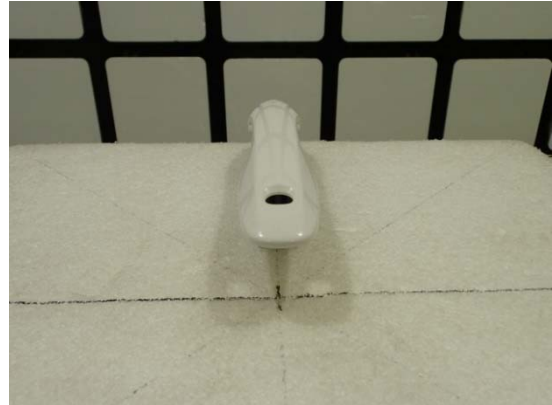
**X-axis**

#### Door Antenna

Below 30 MHz:

X-axis

Above 30 MHz:

Horizontal: X-axis / Vertical: X-axis

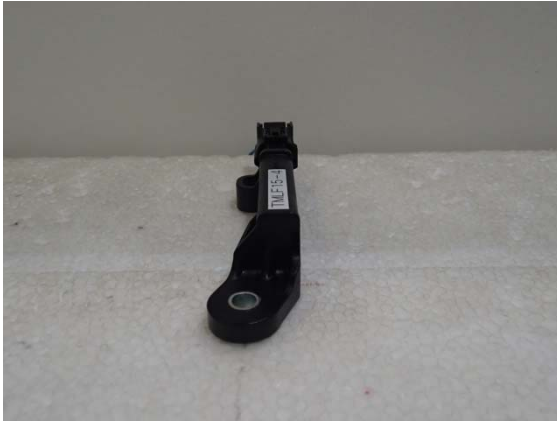
**X-axis**

#### Trunk Antenna

Below 30 MHz:

X-axis

Above 30 MHz:

Horizontal: X-axis / Vertical: X-axis

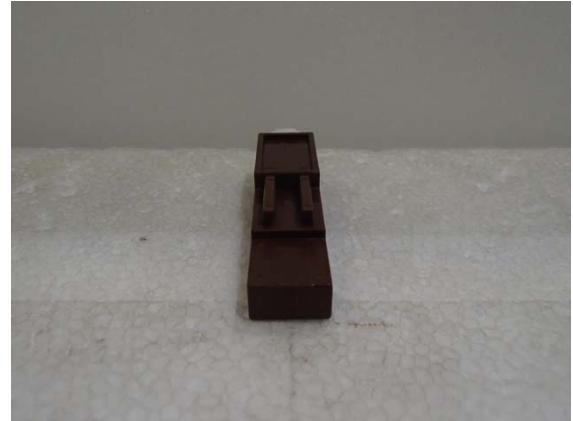
**X-axis**

#### Room Antenna / Luggage Antenna

Below 30 MHz:

X-axis

Above 30 MHz:

Horizontal: X-axis / Vertical: X-axis
