### **APPENDIX 3: Photographs of test setup**

#### **Radiated Emission**

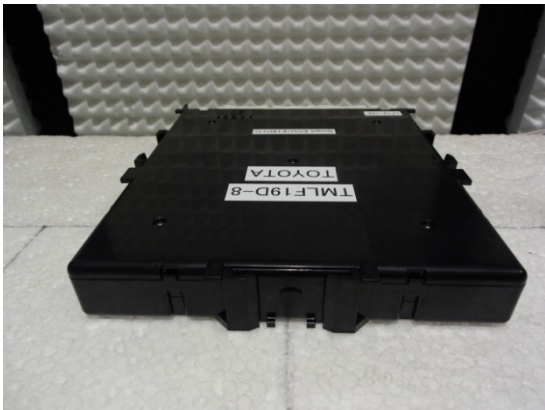
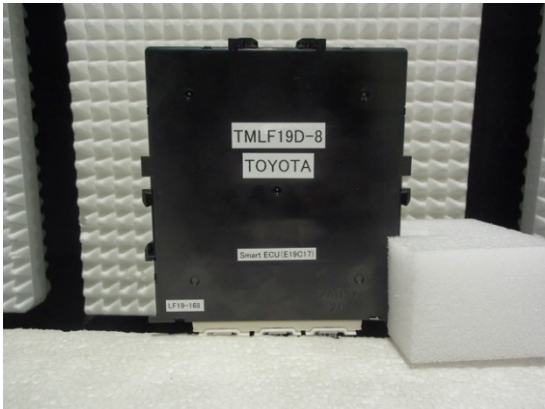
**ECU**  
Below 30 MHz  
X-axis  
Above 30 MHz  
Horizontal: X-axis / Vertical: X-axis

**X-axis**

**Y-axis**

**Z-axis**

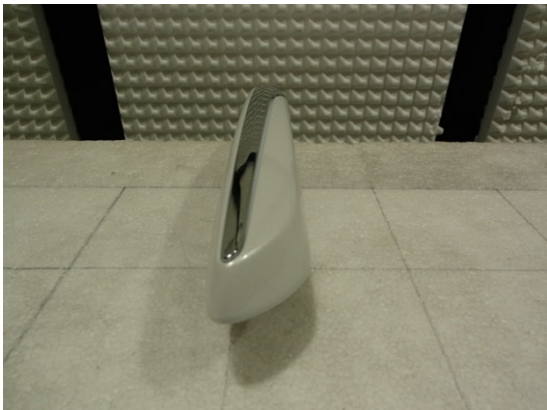
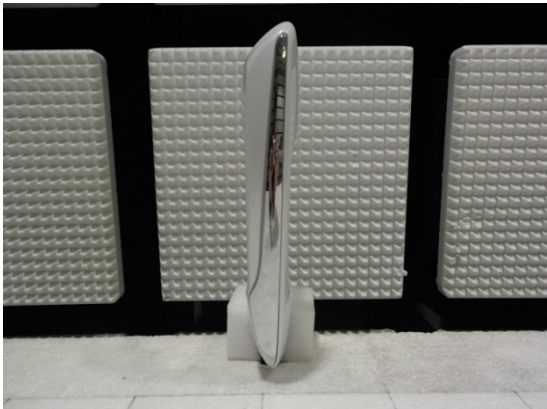
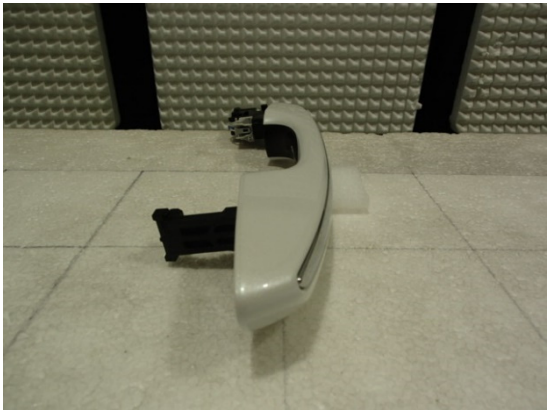
**Outside Antenna**  
Below 30 MHz  
X-axis  
Above 30 MHz  
Horizontal: X-axis / Vertical: X-axis

**X-axis**

**Y-axis**

**Z-axis**

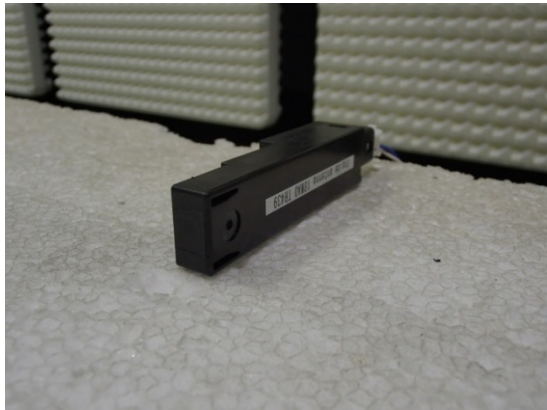
**Inside Antenna**  
Below 30 MHz  
X-axis  
Above 30 MHz  
Horizontal: X-axis / Vertical: X-axis

**X-axis**

**Y-axis**

**Z-axis**

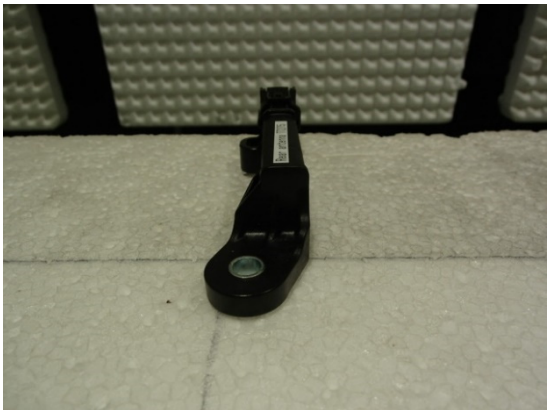
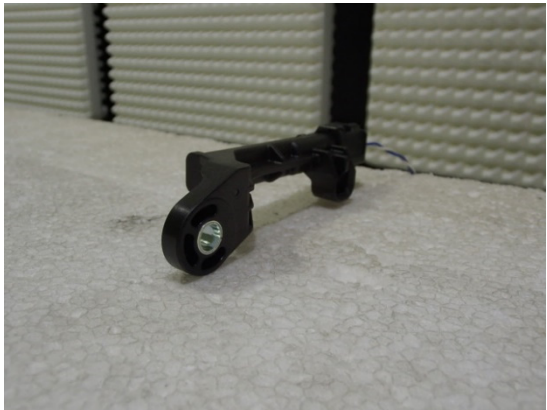
**Rear Antenna**  
Below 30 MHz  
X-axis  
Above 30 MHz  
Horizontal: X-axis / Vertical: X-axis

**X-axis**

**Y-axis**

**Z-axis**

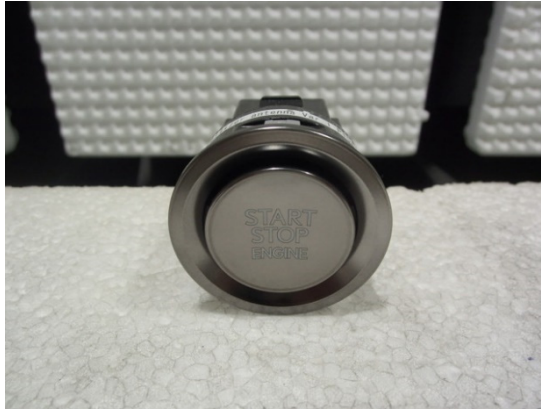
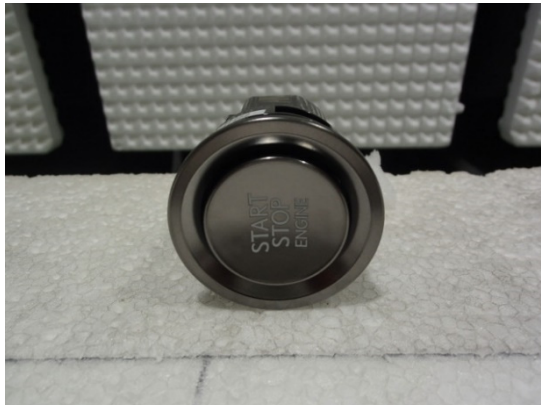
### **Immobilizer Antenna**

Below 30 MHz

X-axis

Above 30 MHz

Horizontal: X-axis / Vertical: X-axis

#### **X-axis**

#### **Y-axis**

#### **Z-axis**

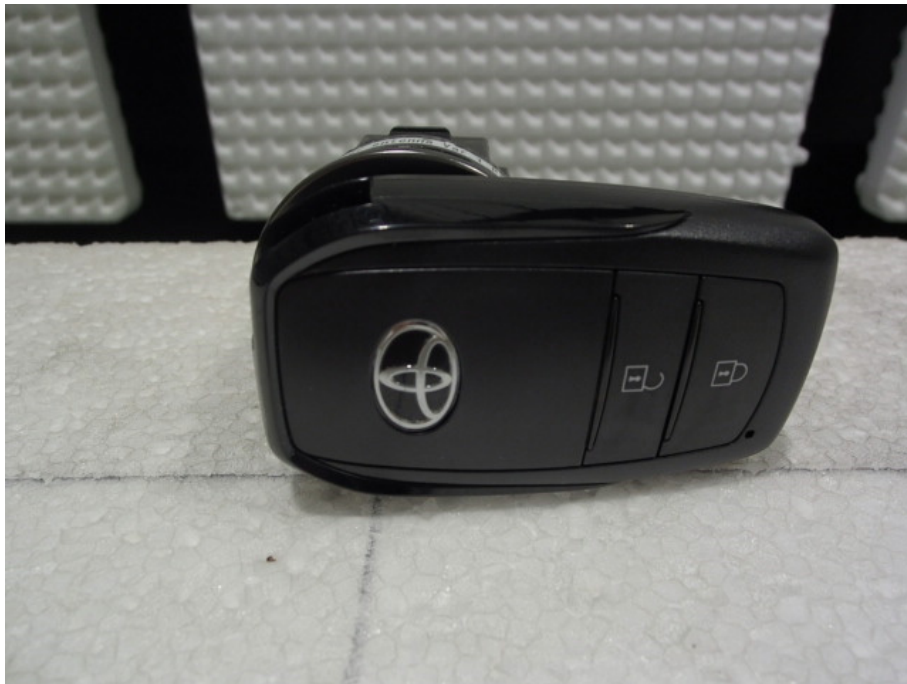
**With transponder key attached**

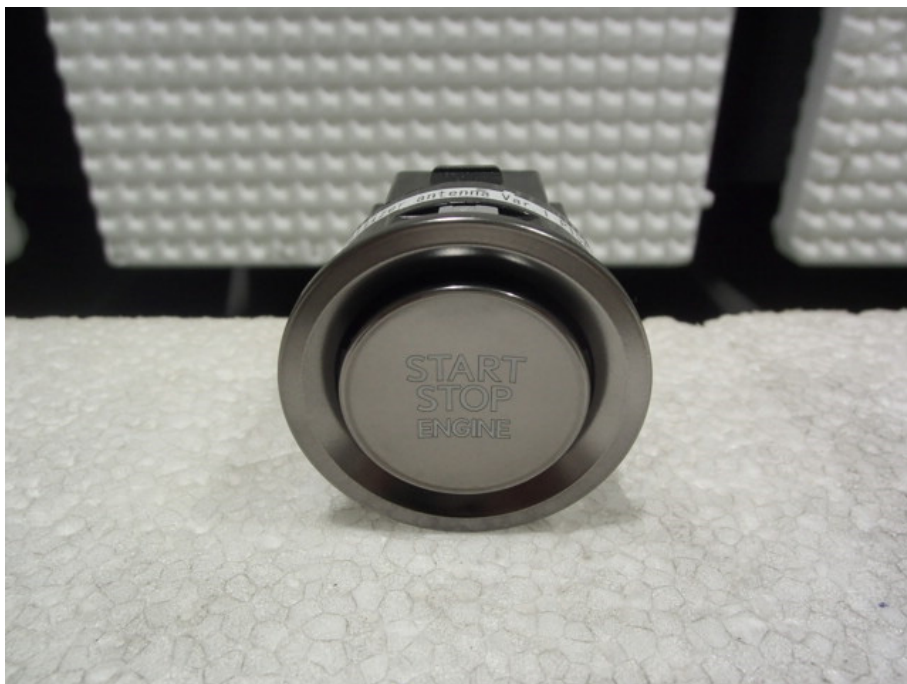
**Without transponder key attached (Worst)**
