**ANNEX 2 - PHOTOGRAPHS OF RADIATED EMISSIONS MEASUREMENTS**  
**Siemens Milltronics SITRANS LR**

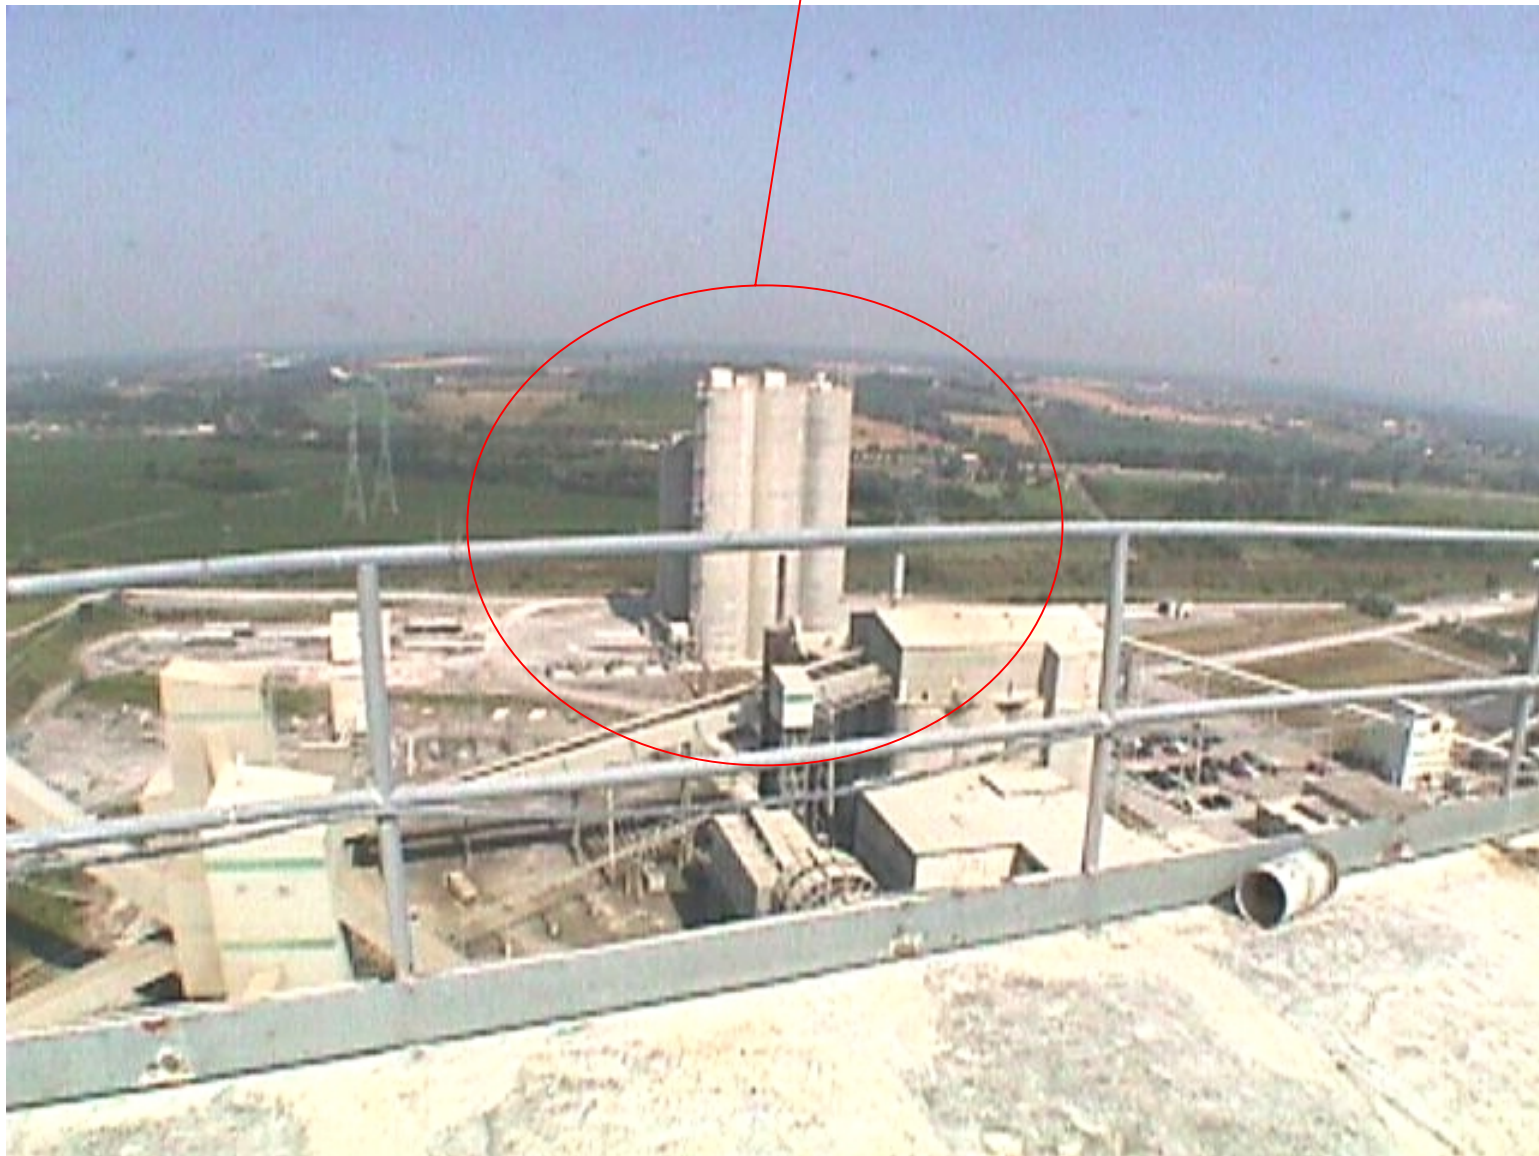
**PHOTO # 4**

Concrete cement tank contains cement

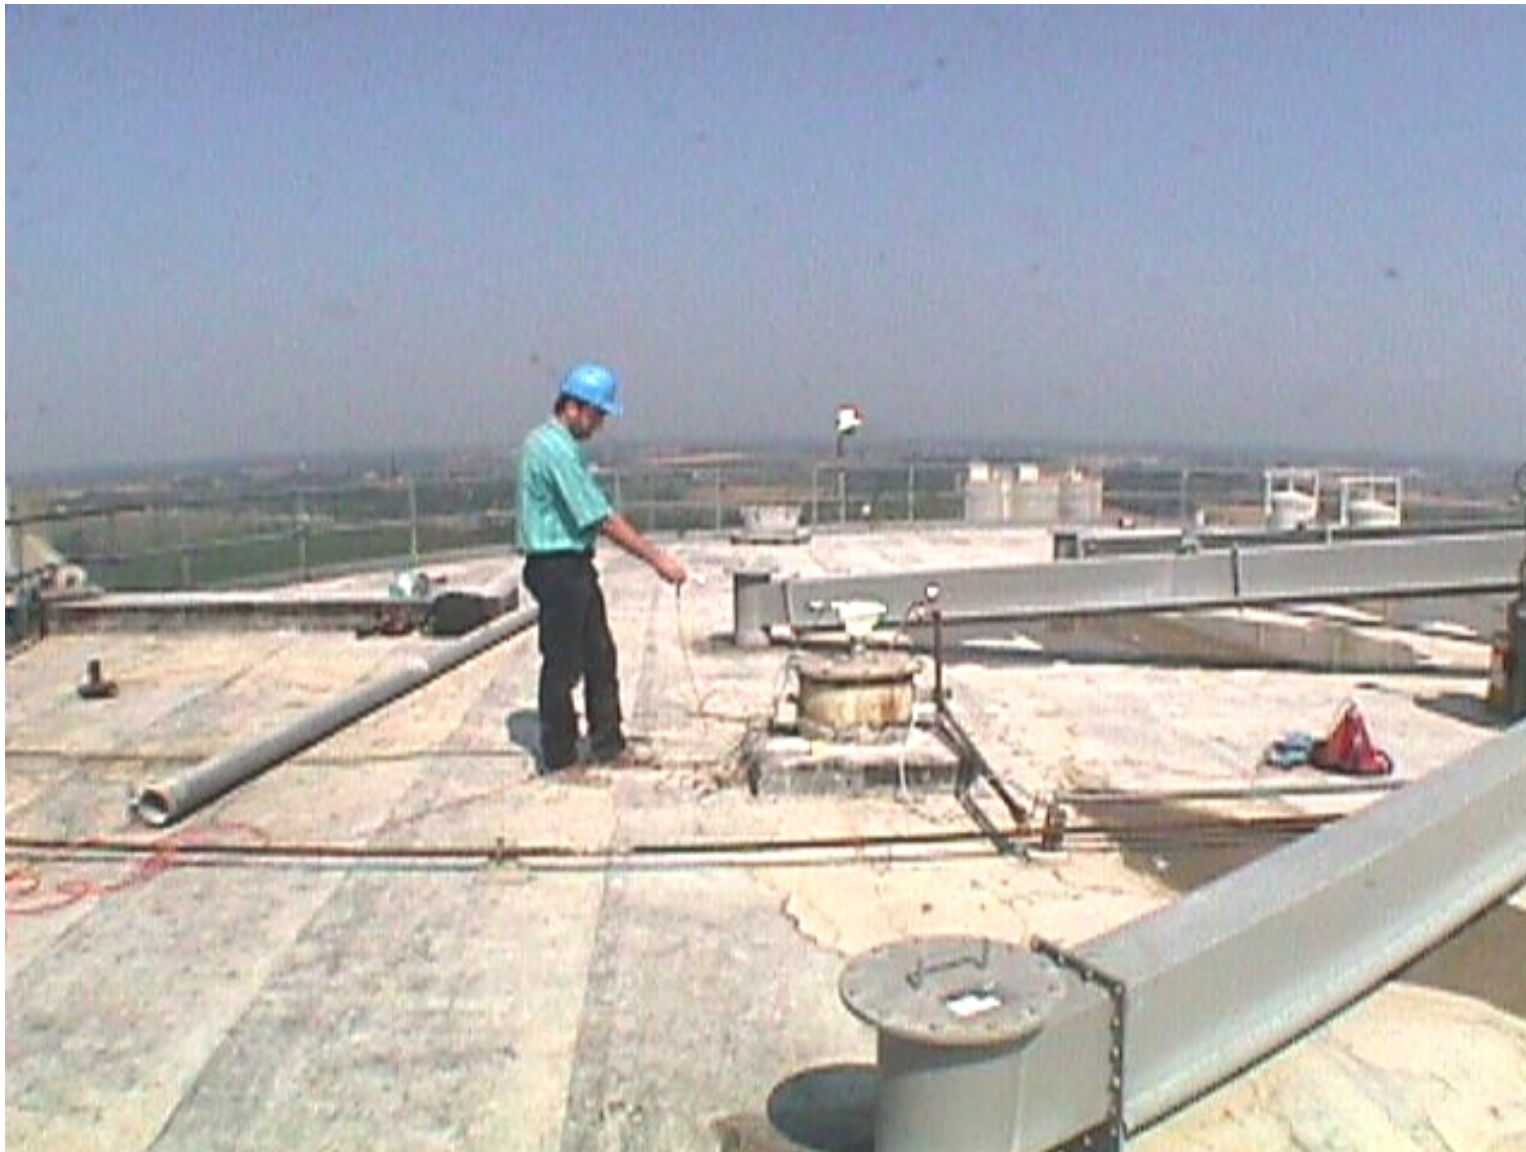
PHOTO # 6

Carrier and spurious/harmonic emissions from the Siemens Milltronics SITRANS LR , which was mounted on top of the concrete tank, were scanned using a horn antenna at 0.5, 1.0 and 3 meters distances.
