## INTERTEK TESTING SERVICES

### 3.7 Line Conducted Configuration Photograph (cont.) - Base Unit

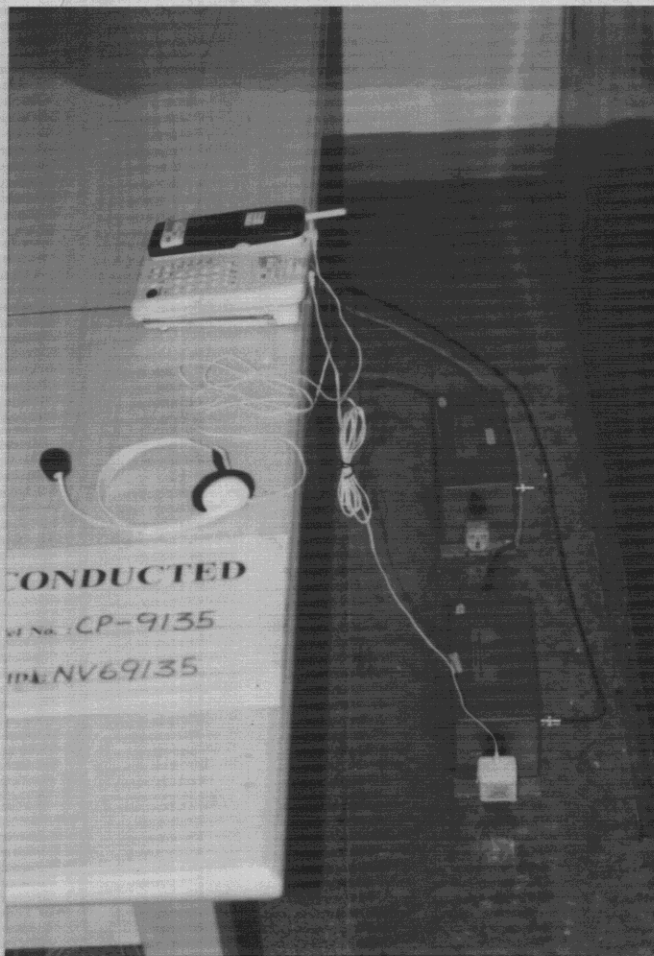
Side View

#### Worst Case Line-Conducted Configuration

at 28.005 MHz

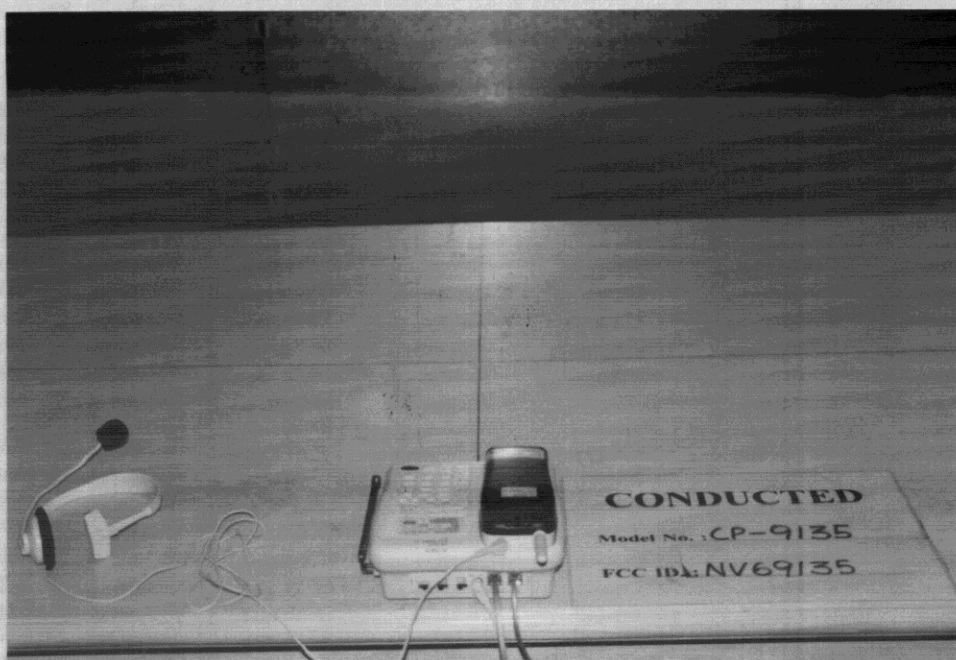
Rear View

#### Worst Case Line-Conducted Configuration

at 28.005 MHz

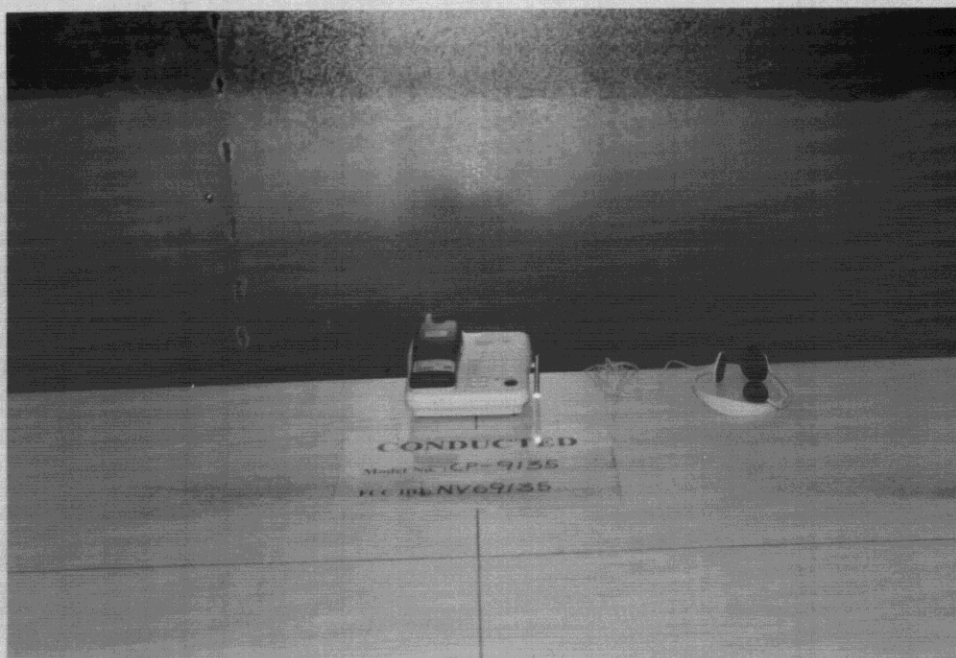
Front View

Worst Case Line-Conducted Configuration

at 28.005 MHz

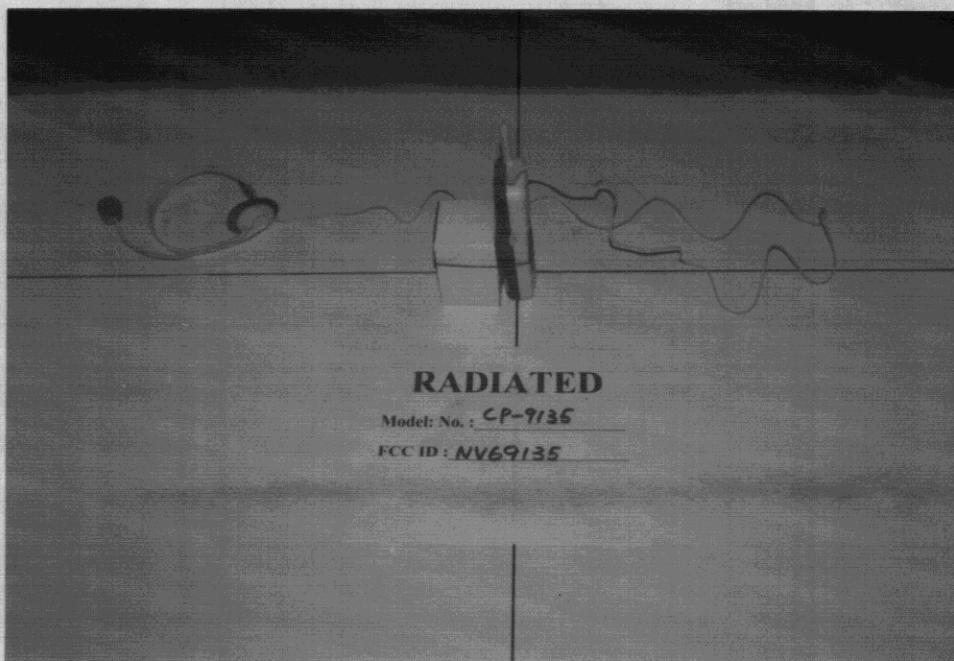
Rear View

Worst Case Radiated Emission

at 925.900 MHz

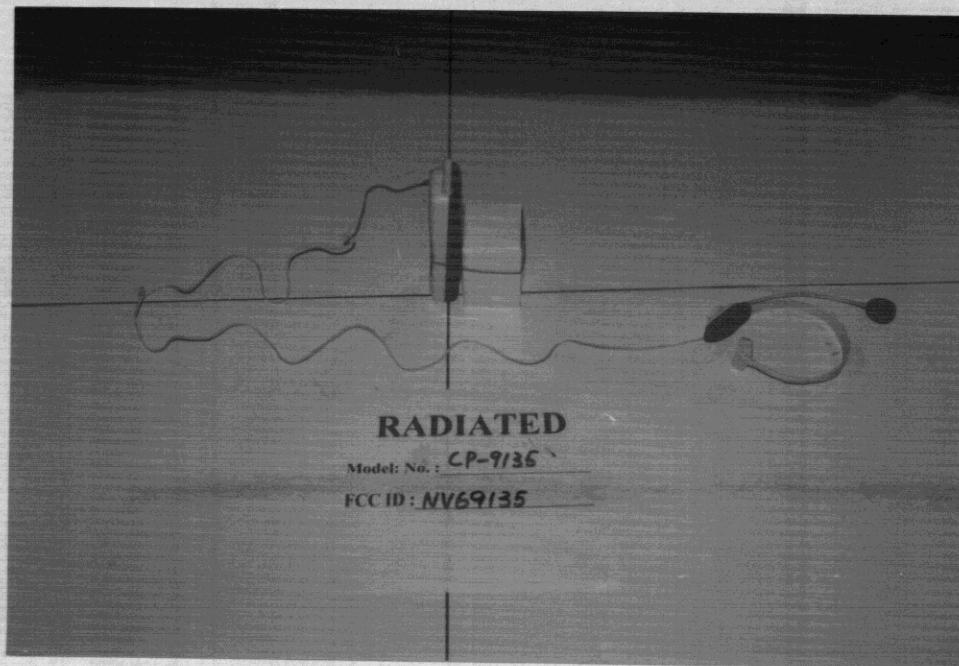
Front View

Worst Case Radiated Emission

at 925.900 MHz

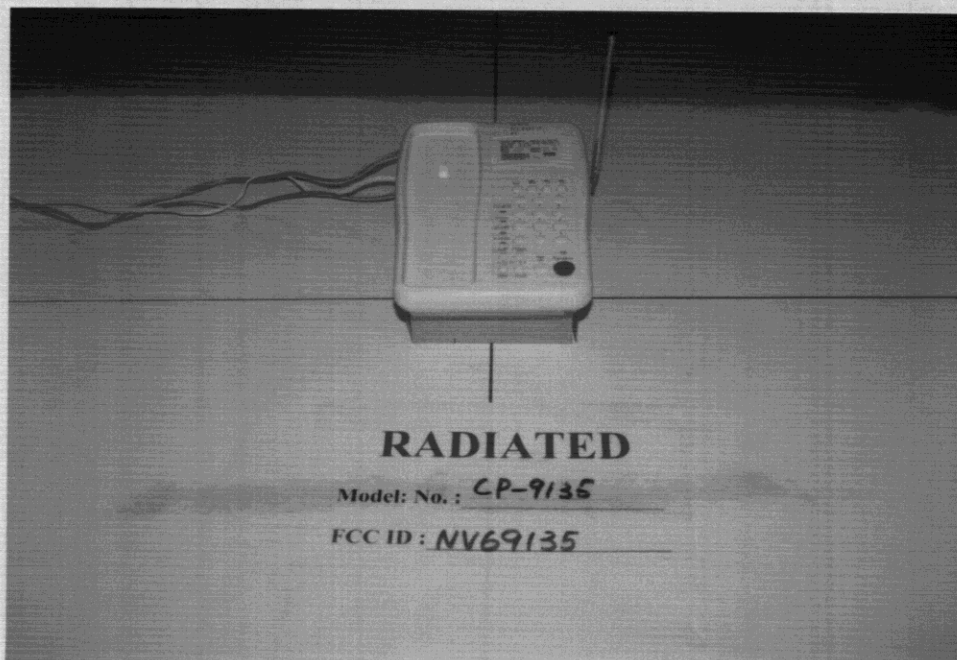
Front View

Worst Case Radiated Emission

at 904.000 MHz

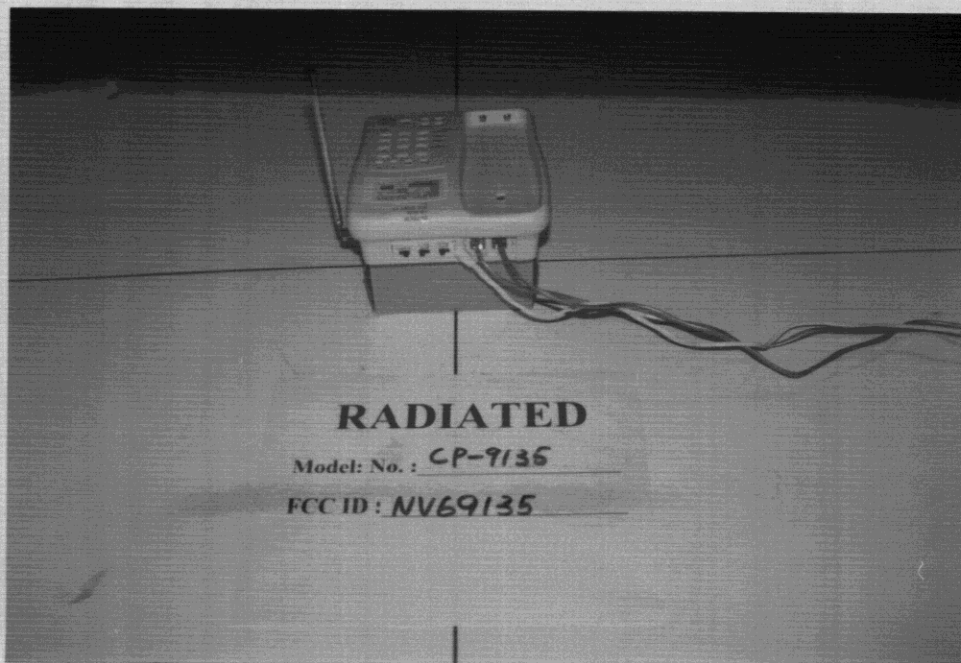
Rear View

Worst Case Radiated Emission

at 904.000 MHz
