## Appendix B: photographs of test setup

Reference to the test report no. BLA-EMC-202404-A4901

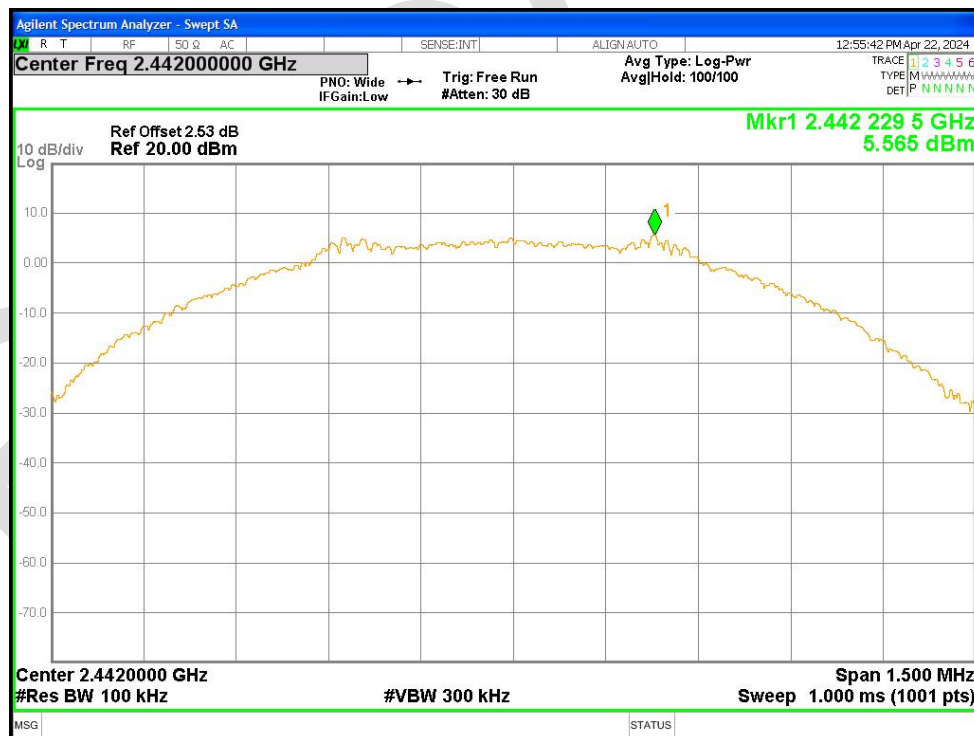
Tx. Spurious NVNT BLE 1M 2442MHz Ant1 Ref

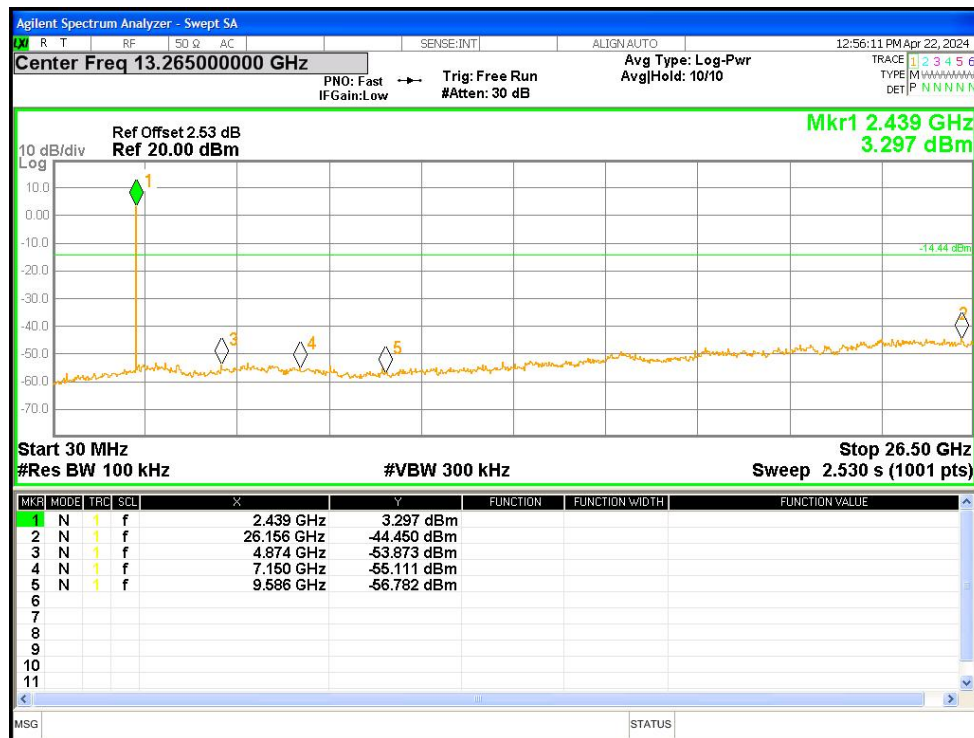
Tx. Spurious NVNT BLE 1M 2442MHz Ant1 Emission

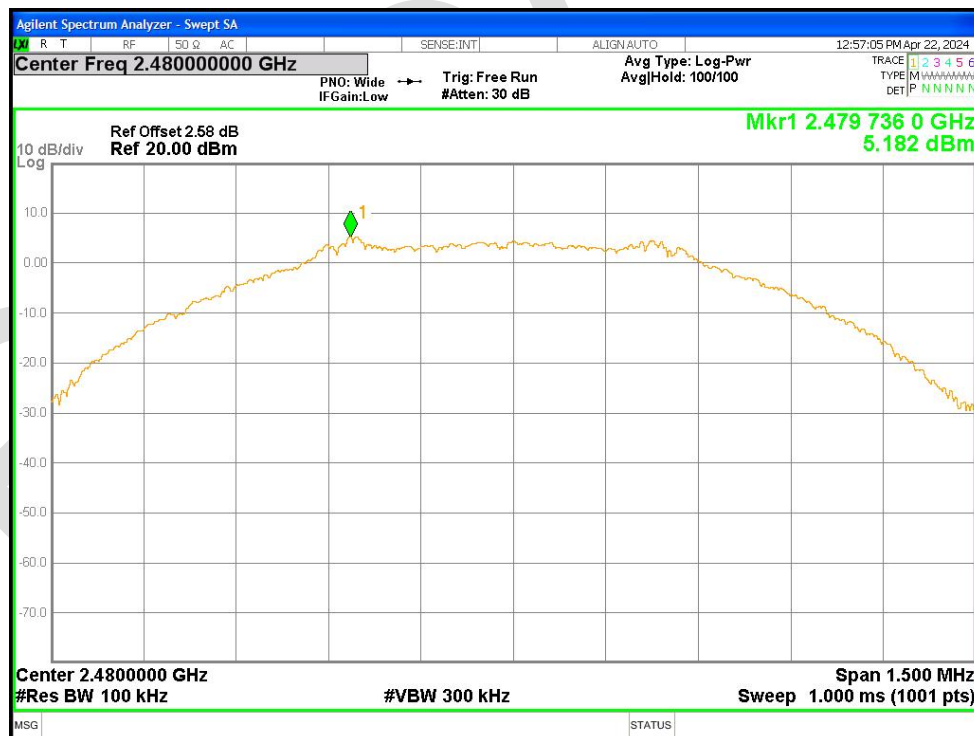
Tx. Spurious NVNT BLE 1M 2480MHz Ant1 Ref

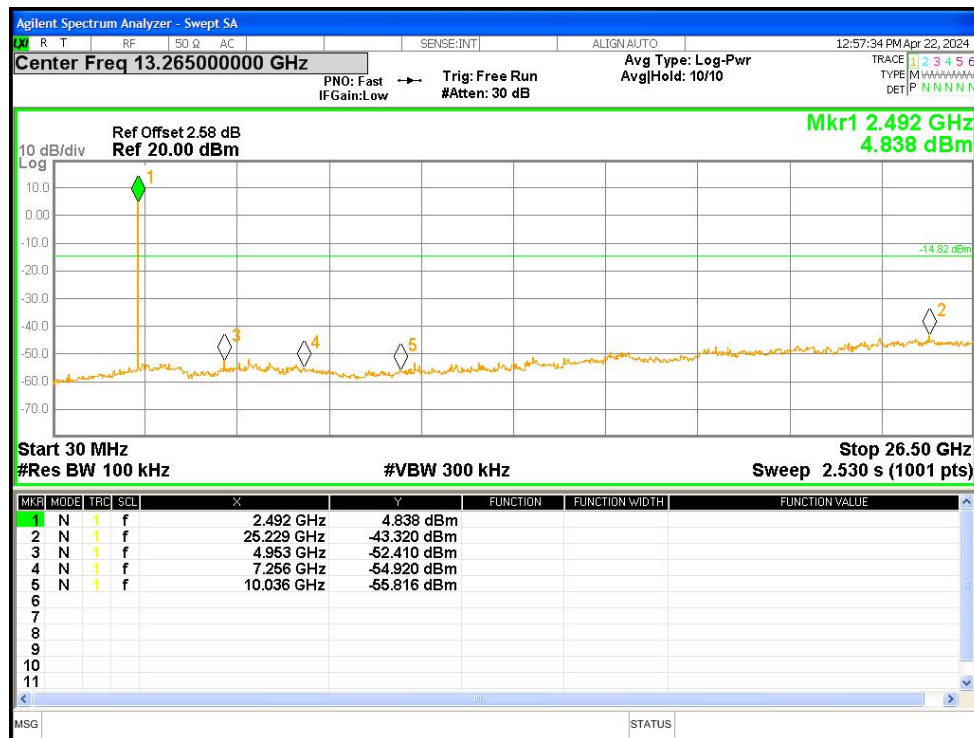
Tx. Spurious NVNT BLE 1M 2480MHz Ant1 Emission

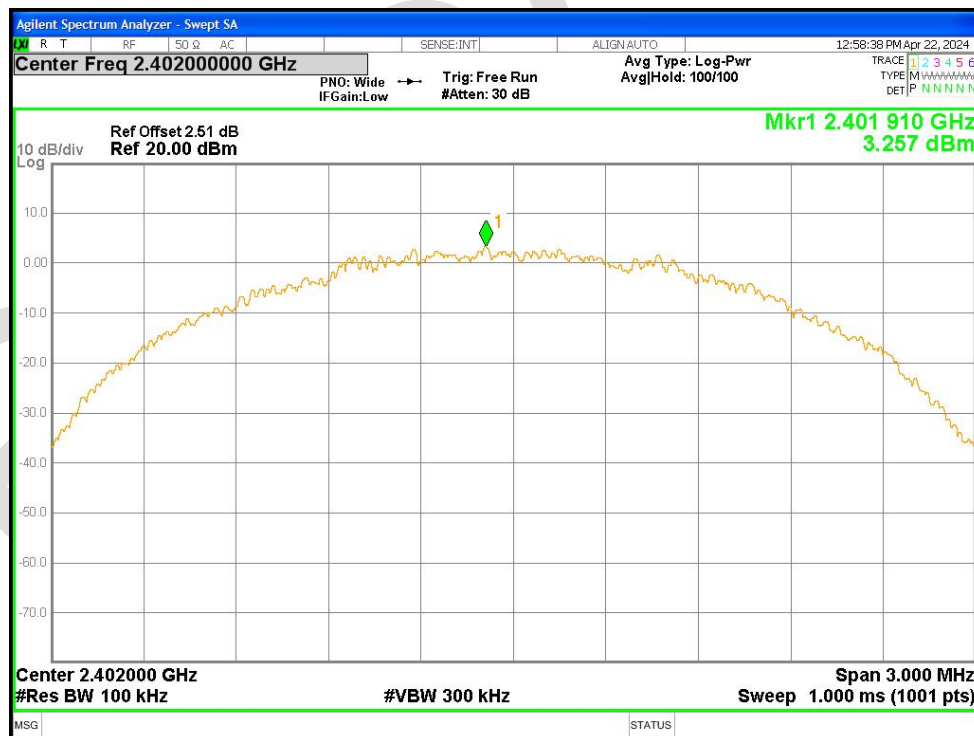
Tx. Spurious NVNT BLE 2M 2402MHz Ant1 Ref

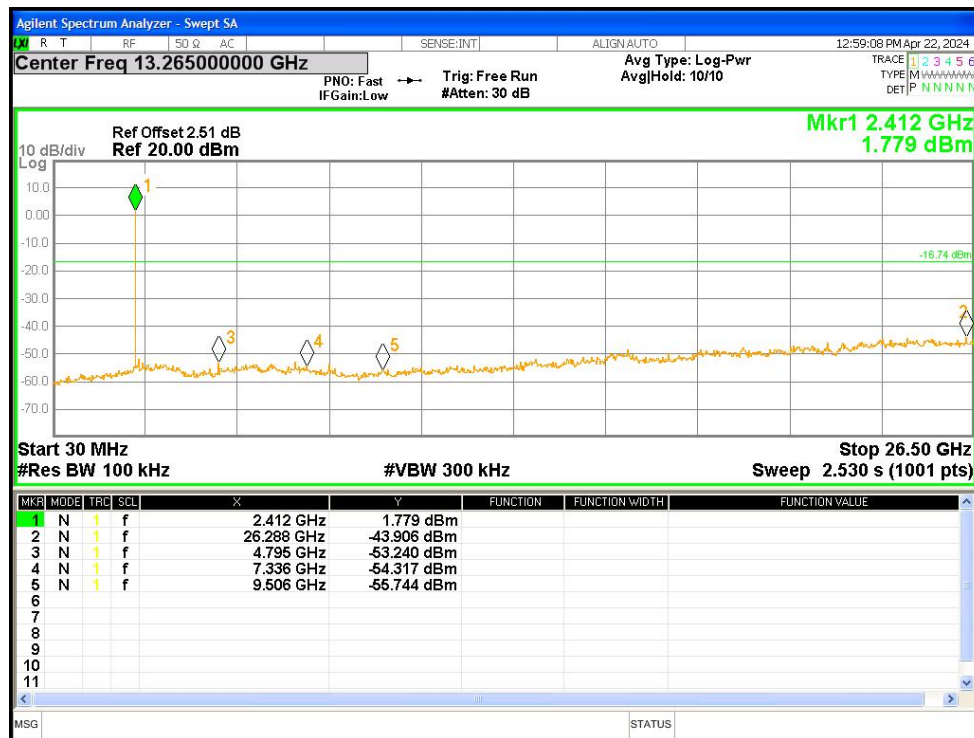
Tx. Spurious NVNT BLE 2M 2402MHz Ant1 Emission

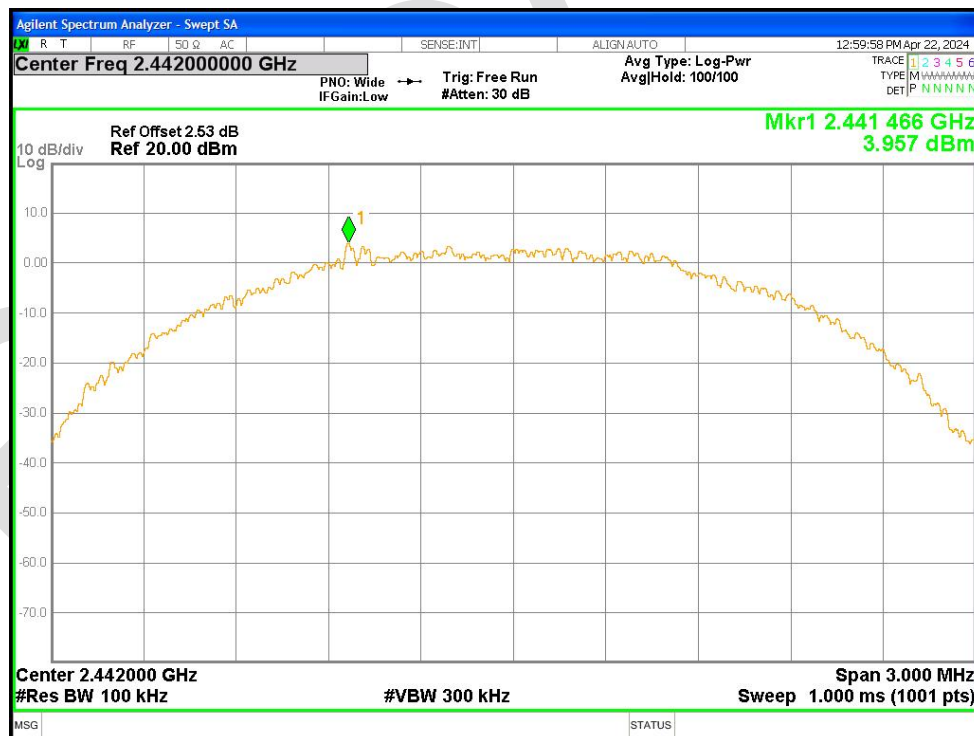
Tx. Spurious NVNT BLE 2M 2442MHz Ant1 Ref

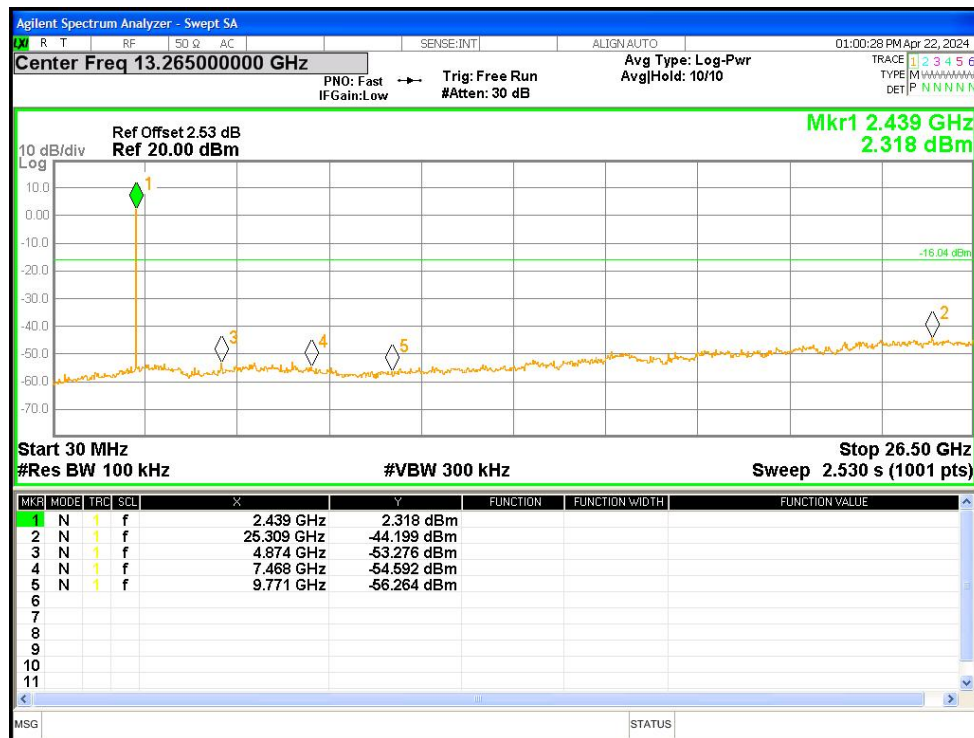
Tx. Spurious NVNT BLE 2M 2442MHz Ant1 Emission

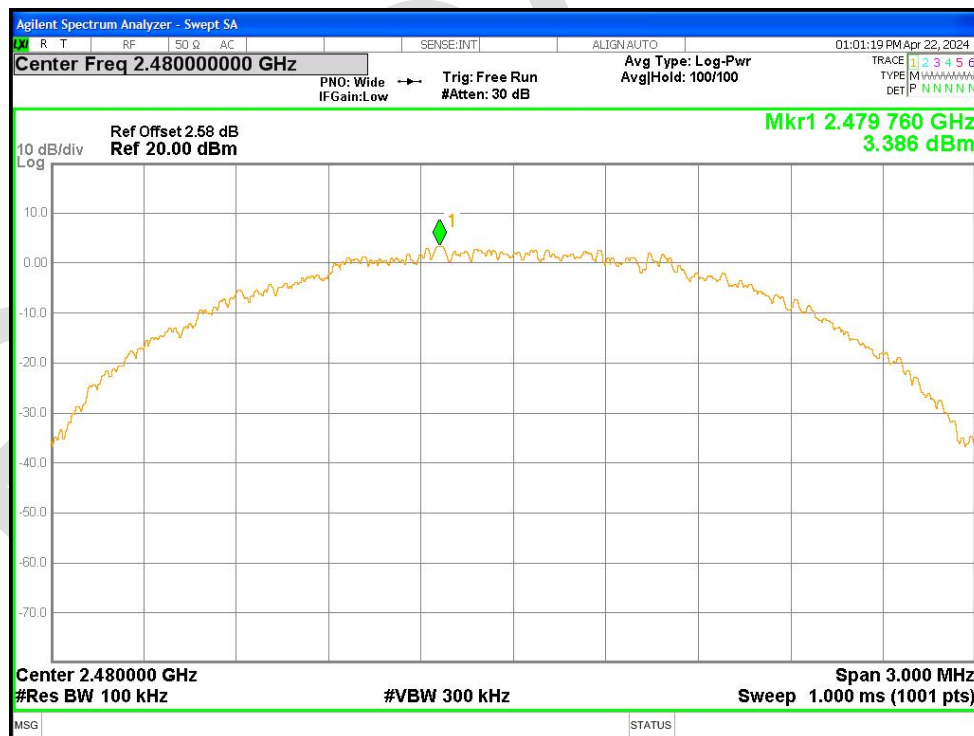
Tx. Spurious NVNT BLE 2M 2480MHz Ant1 Ref

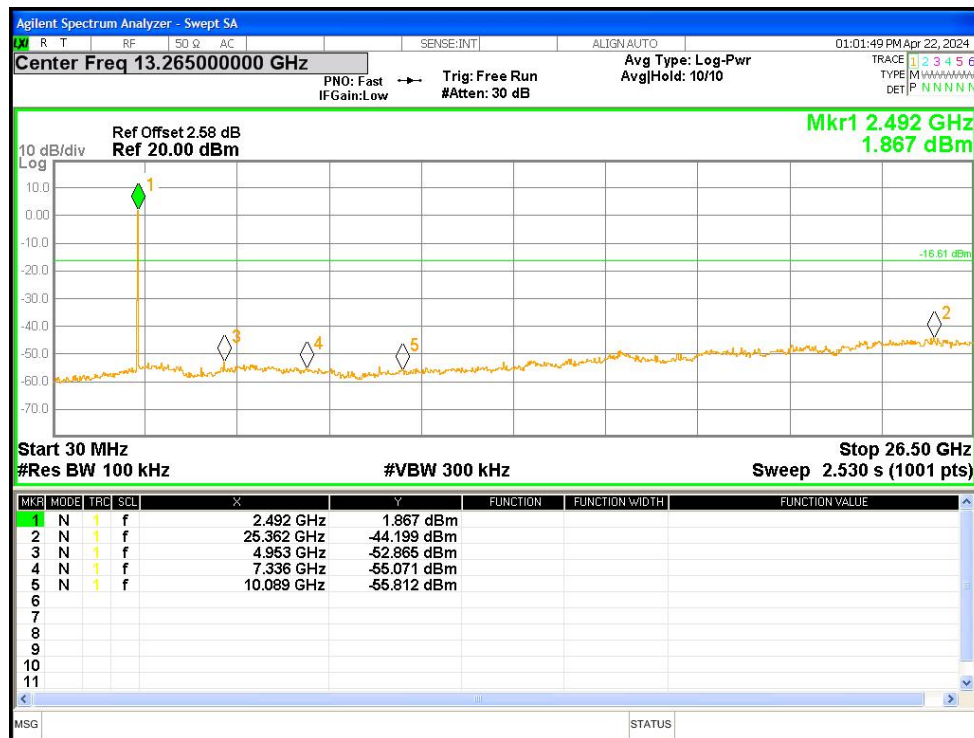
Tx. Spurious NVNT BLE 2M 2480MHz Ant1 Emission

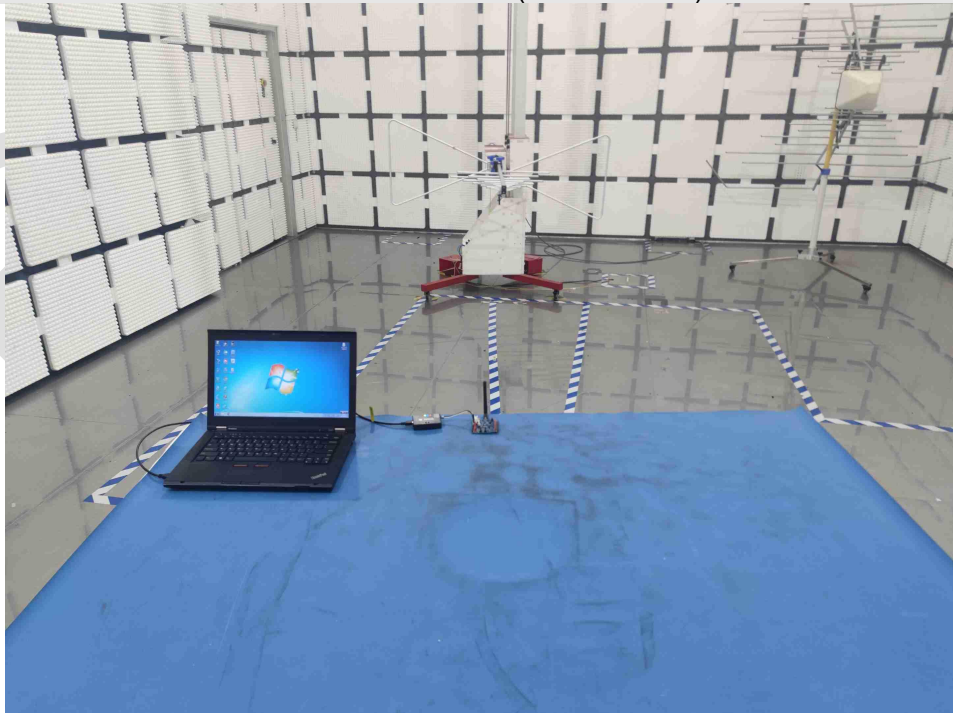
Radiated Emissions (30MHz-1GHz)

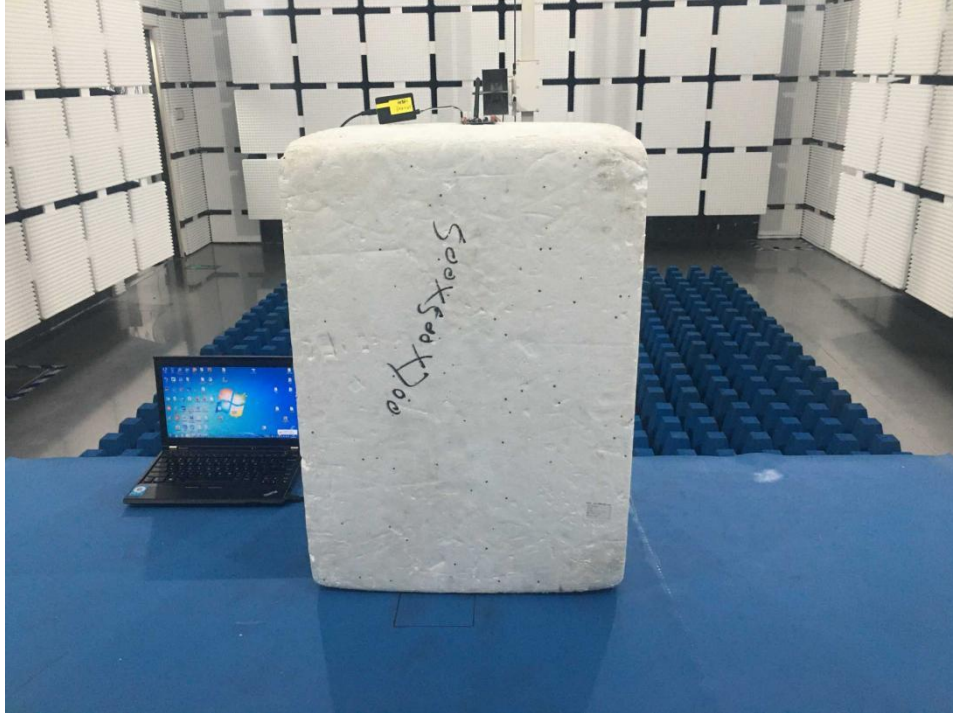
Radiated Emissions (above 1GHz)
