### **APPENDIX 3: Photographs of test setup**

#### **Radiated Emission**

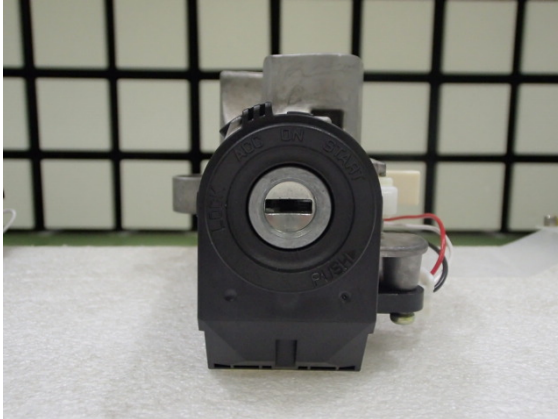
#### Immobilizer

Below 30MHz: X

Above 30MHz: Horizontal X, Vertical X  
X-axis

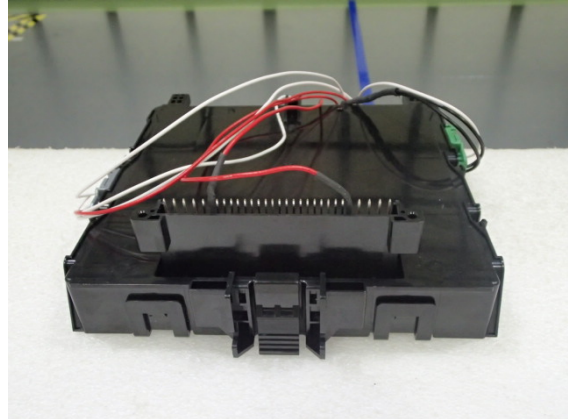
#### ECU

Below 30MHz: X

Above 30MHz: Horizontal X, Vertical X  
X-axis

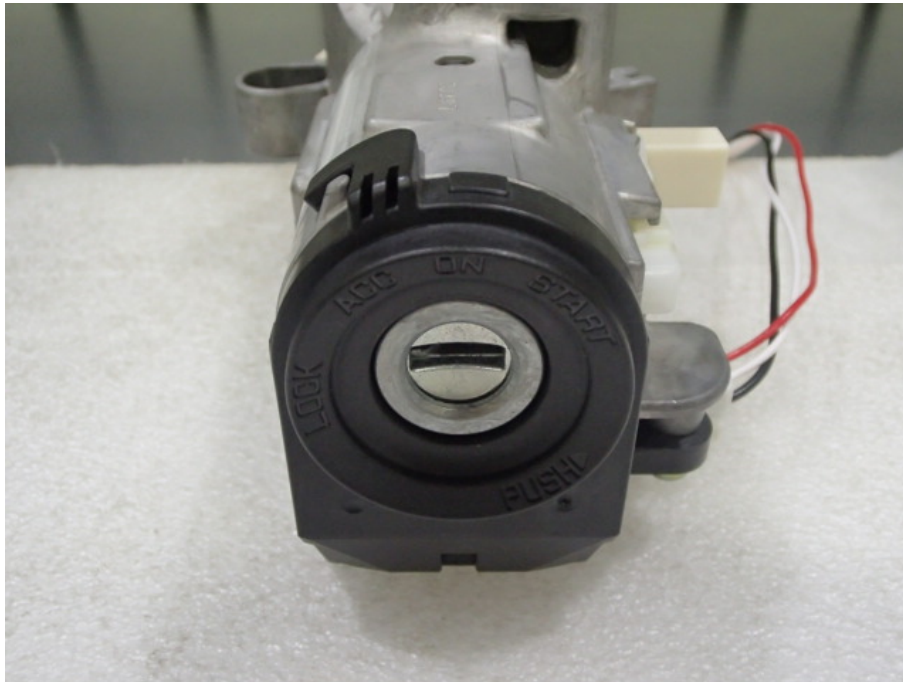
**Worst case position**

**Mechanical Key (Not Inserted) Worst**

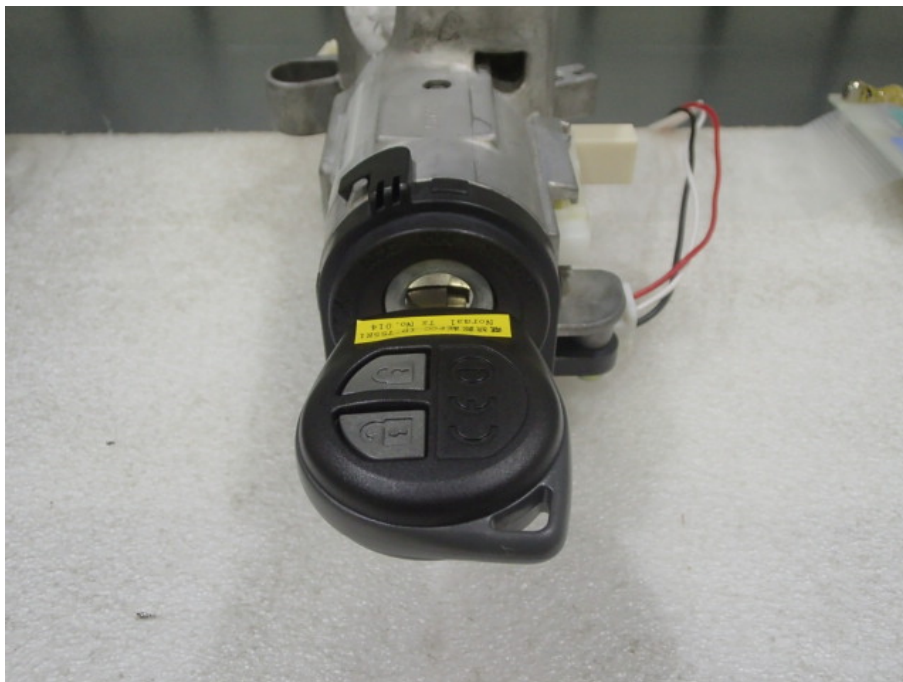
**Mechanical Key (Inserted)**
