**Recognition Source, LLC  
FCC ID#: PM7-IRL2001**

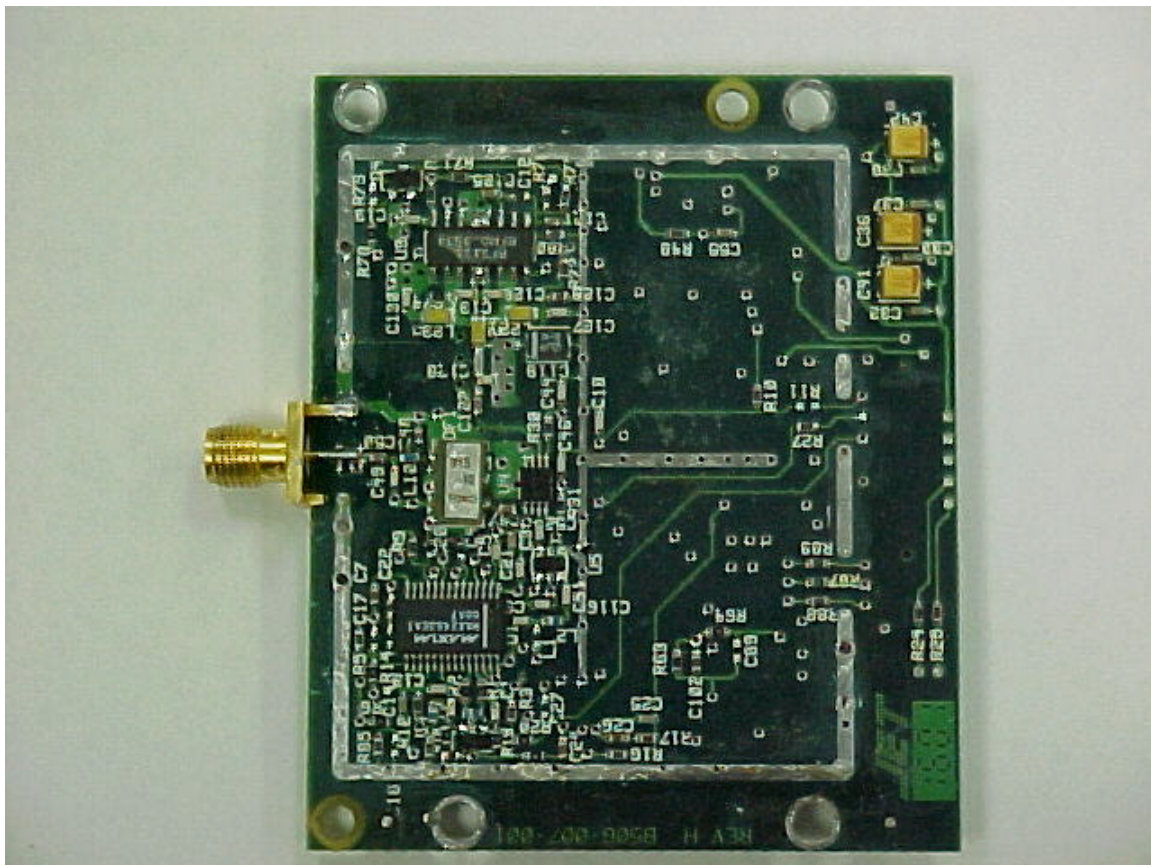
### Photo 12

**In view are the following: Close-up of RF PCB with shield cover removed. This is side B, with SMA connector used during conducted emissions testing.**
