**Sensortronics Industries, Inc.**  
**Strike Sensor**  
**FCC ID#: PSW-SS2001**

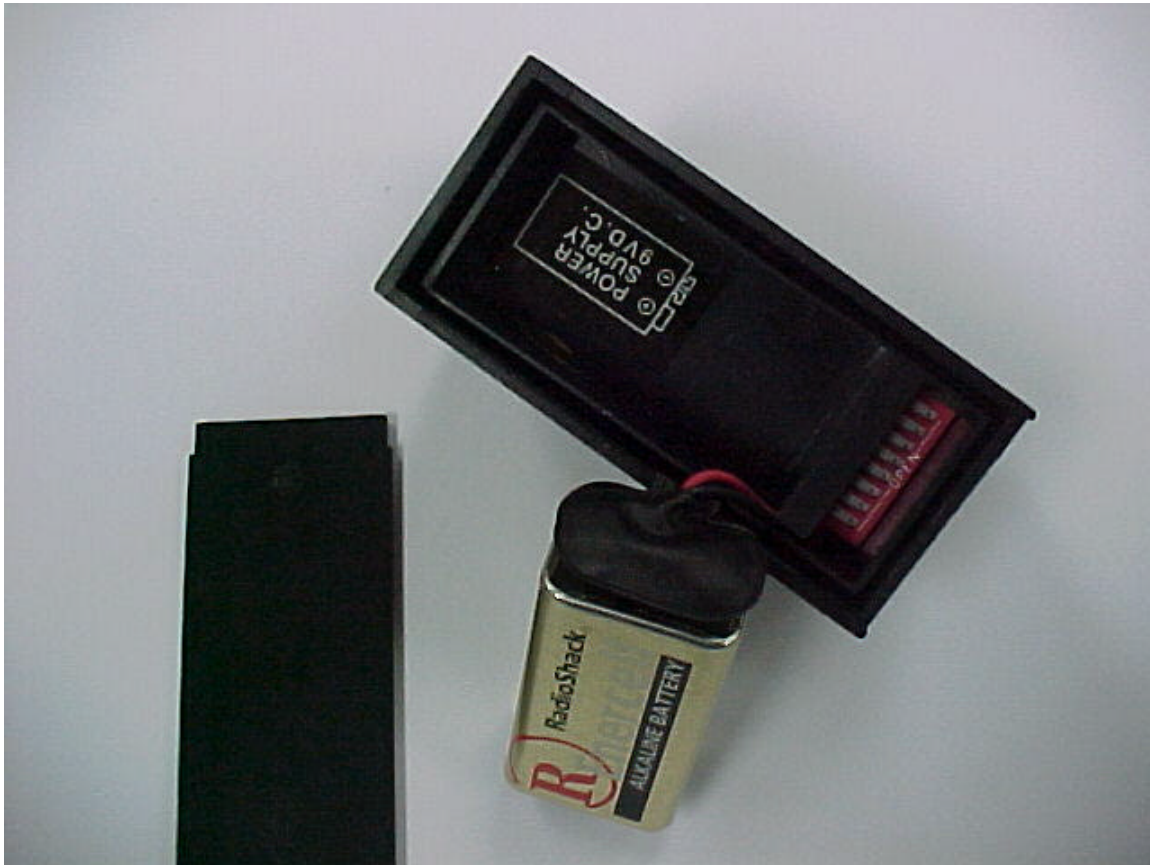
**Photo Four**  
**Battery Case Open with Battery removed – Programming Switches Accessable**

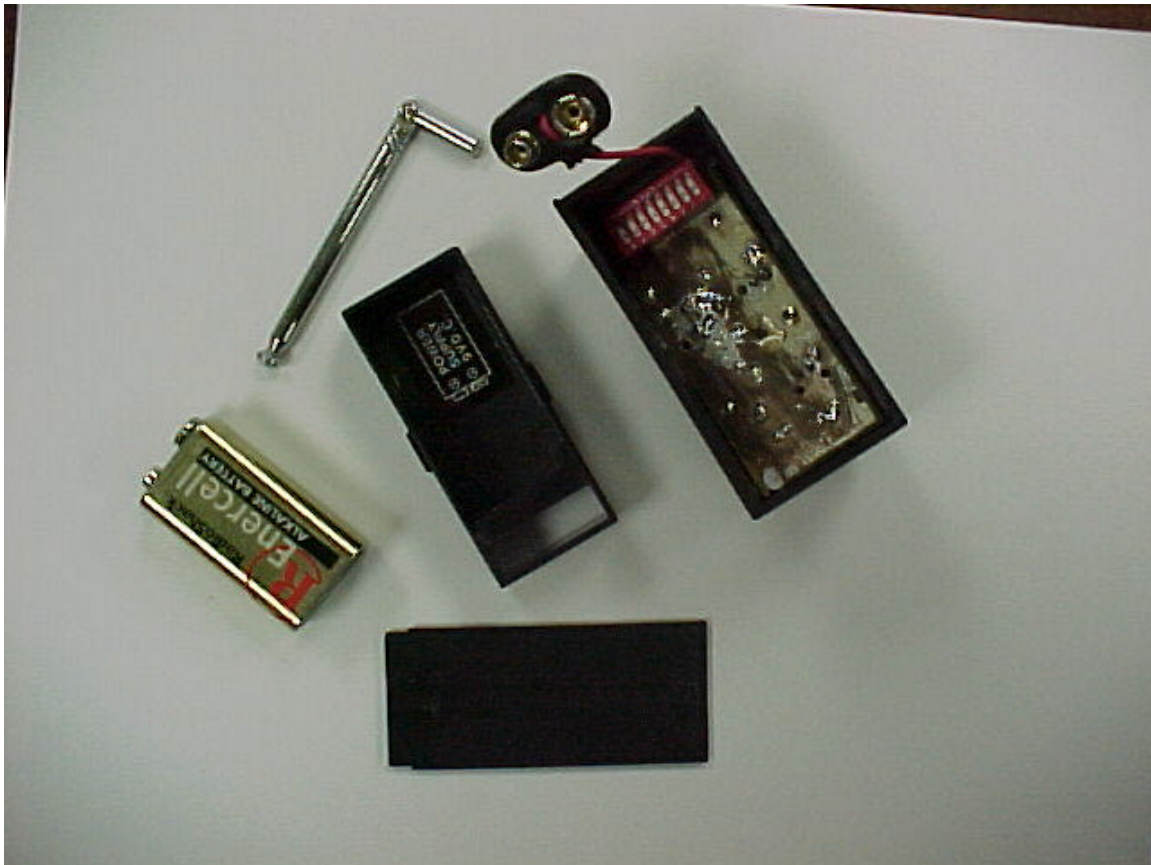
**Photo Five**  
**Battery Compartment Removed exposing the PCB – Open for Inspection**

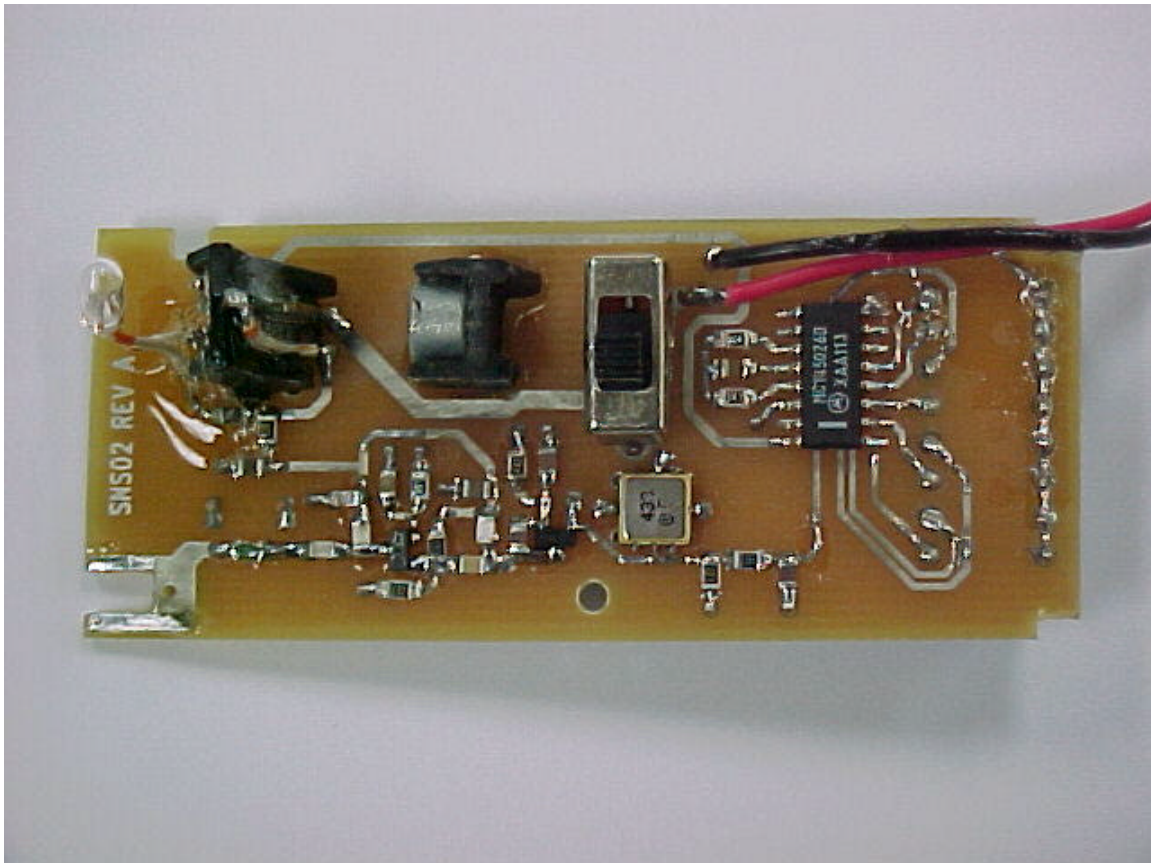
**Photo Six**  
**PCB removed – Component Side**

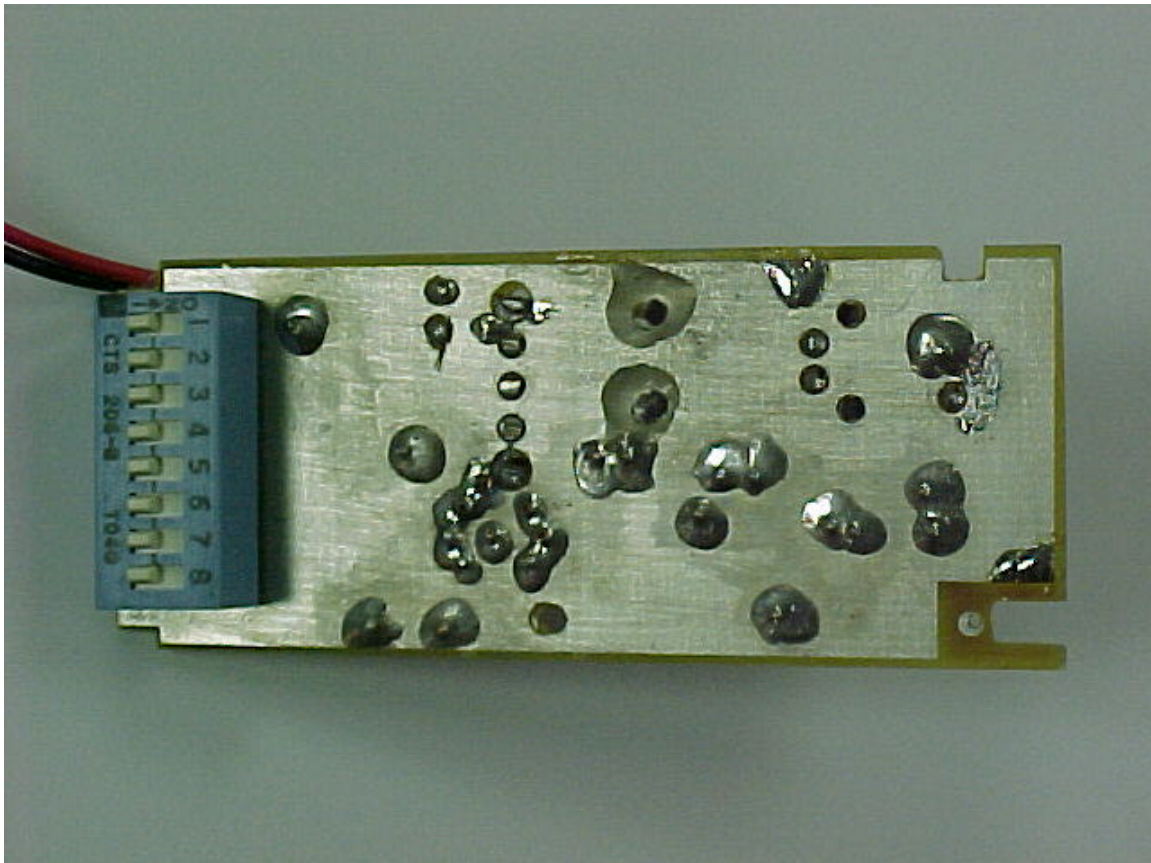
**Photo Seven**  
**PCB removed – Trace Side**

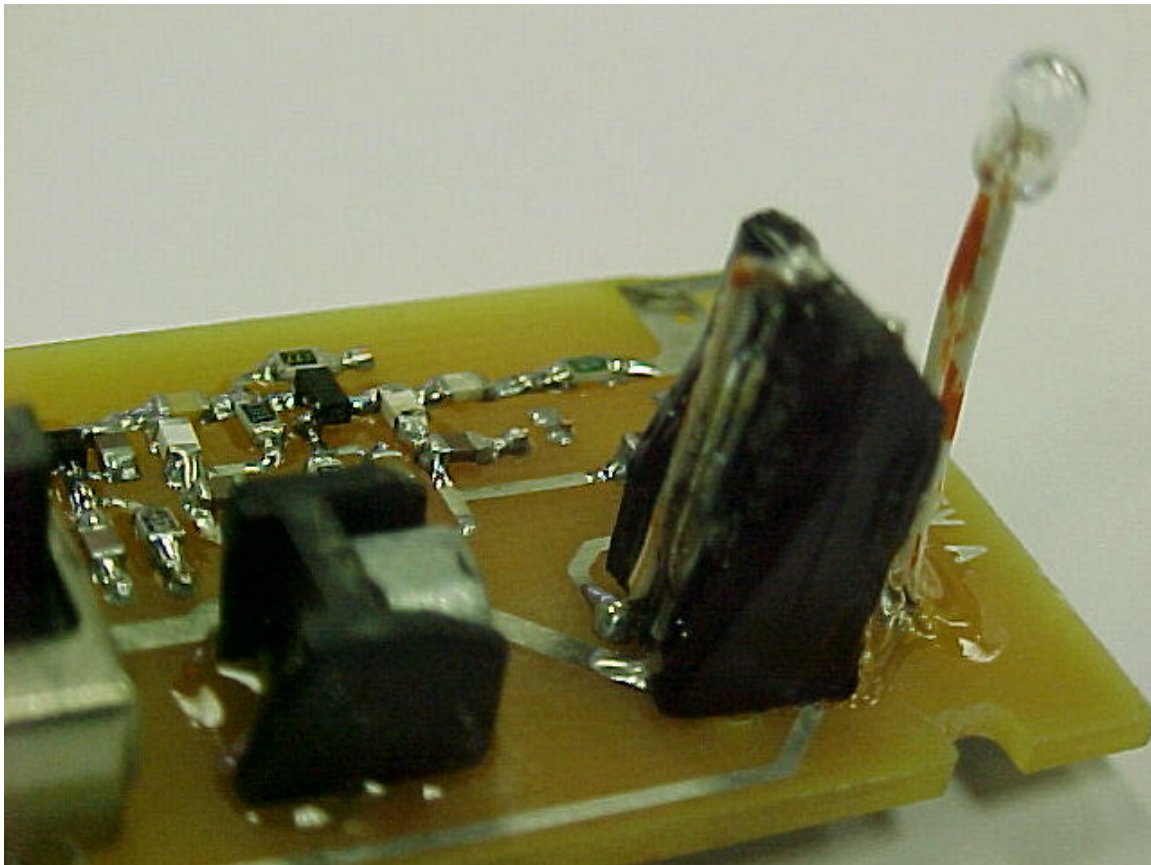
**Photo Eight**  
**PCB close-up of Mercury Switch to engage RF Transmitter**

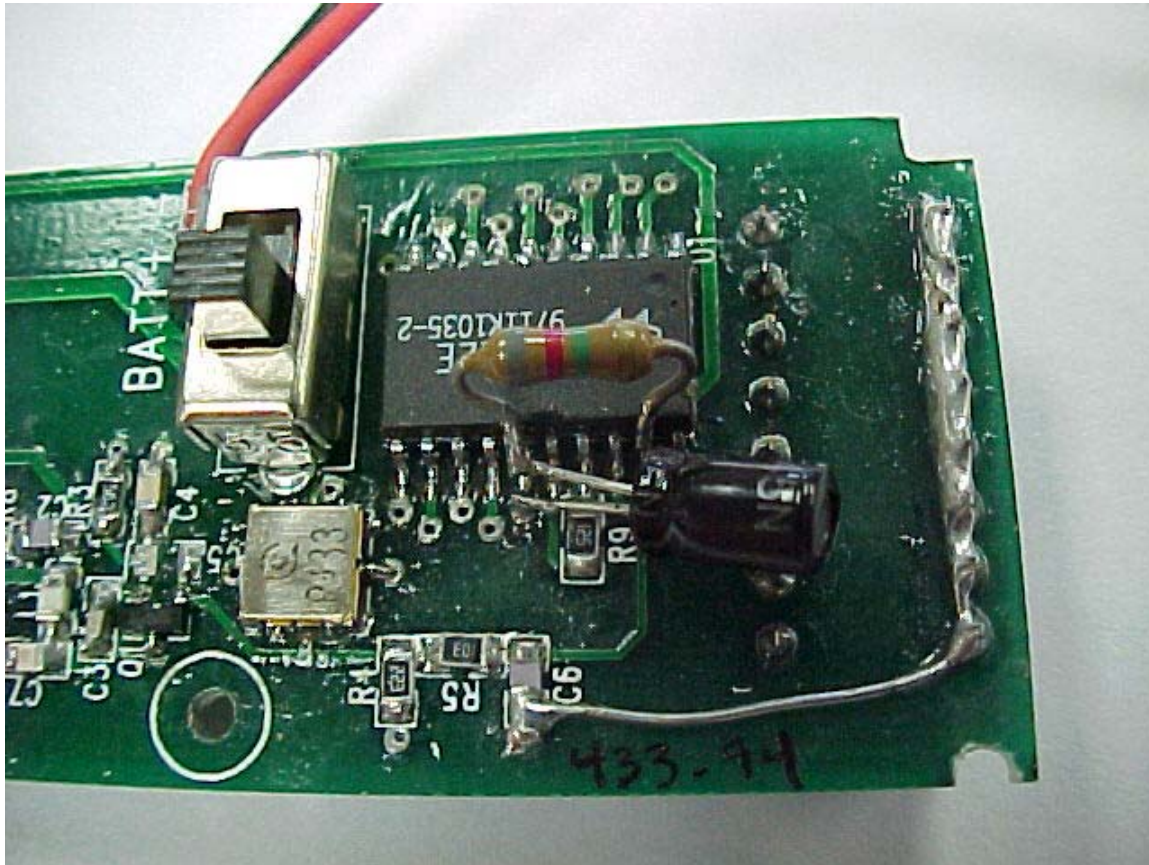
**Photo Nine**  
**RC modification to provide 4 sec. Time Out on the transmitter**  
**Updated schematic supports this modification.**
