### **APPENDIX 3: Photographs of test setup**

#### **Radiated Spurious Emission**

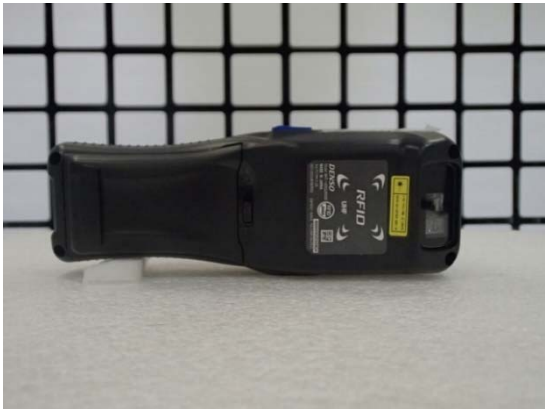
**Worst Case Position**

| Test Range | Horizontal | Vertical |
| Below 1 GHz | Z-axis | Y-axis |
| Above 1 GHz | Y-axis | Y-axis |

**X-axis**

**With Tag**

**Y-axis**

**Without Tag (Worst)**

**Z-axis**
