Beteckning / *Reference*  
P105518

## **"Simulated solar radiation test"**

Simulated solar radiation test according to ISO 4892-2 of a VHF-radio.

One orange VHF-radio, type TRON TR20 GMDSS from JOTRON.

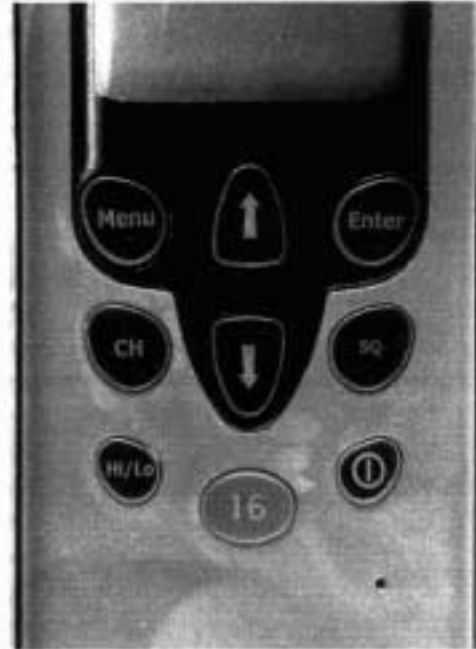
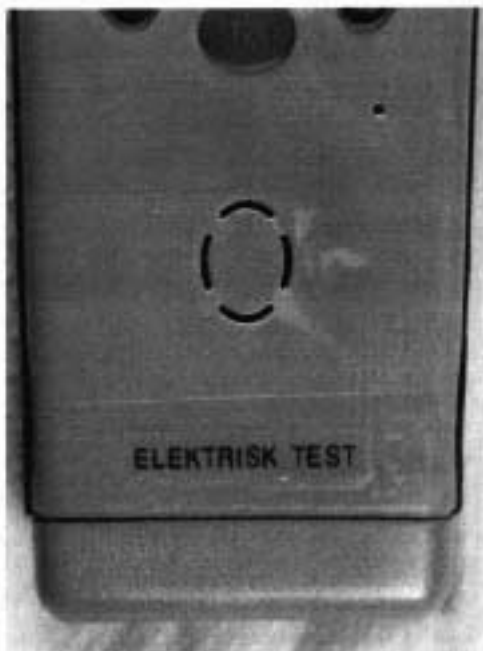
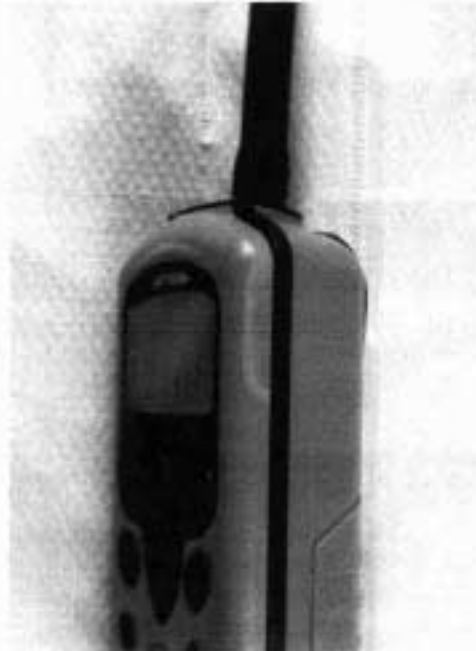
## Photographs taken after exposure

Some local variations of the colour have appeared in the area of the microphone/speaker at the front of the VHF-radio and on both sides of the LCD-display.

See photographs in appendix 1, taken before and after the exposure.
