### **APPENDIX 3: Photographs of test setup**

#### **Conducted Emission**

### **Radiated Spurious Emission**

### Worst Case Position

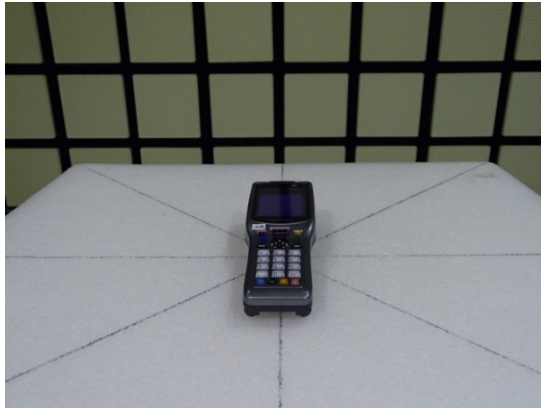
**X-axis**

| | Horizontal | Vertical |
|---|---|---|
| Band edge / 2nd harmonic /<br>18-26.5GHz | X | Y |
| 3rd harmonic / 4th harmonic | Y | X |

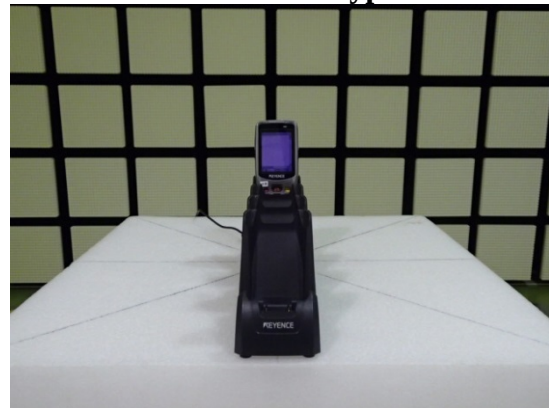
**With Cradle Type2**

| | Horizontal | Vertical |
|---|---|---|
| 10-18GHz | With Cradle Type2 | With Cradle Type2 |
| Below 1GHz | With Cradle Type2 | With Cradle Type2 |
