### **APPENDIX 3: Photographs of test setup**

#### **Conducted Emission**

### Radiated Spurious Emission

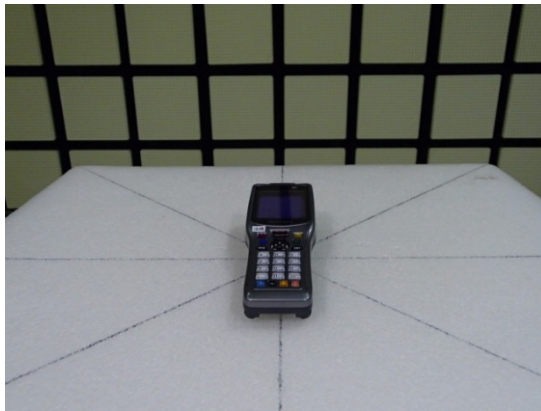
**X-axis**

**Worst Case Position**

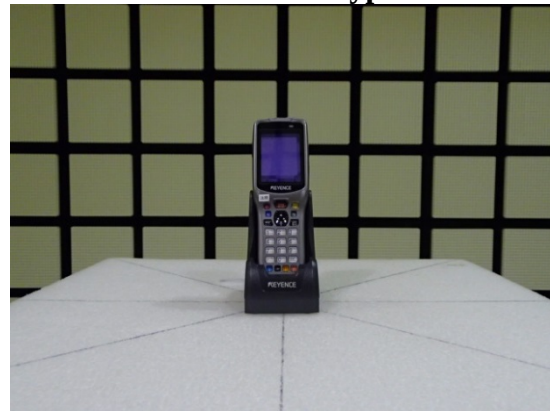
**With Cradle Type1**

| | Horizontal | Vertical |
|---|---|---|
| Below 1GHz | With Cradle Type2 | With Cradle Type2 |
