| | 5969 Robinson Avenue<br>Riverside, CA 92503<br>(951) 637-2630<br>FAX (951) 637-2704 | <b>Occupied Bandwidth</b> | |
| DNB Job Number: | 58129 | Date: 4 Jan 2006 | <b>Conformance Standards</b><br>[X] IC RSS-131<br>[X] FCC Part 22 |
| Model Number: | CB-HP-800 | Serial Number: | |
| Description: | RF amplifier | | |

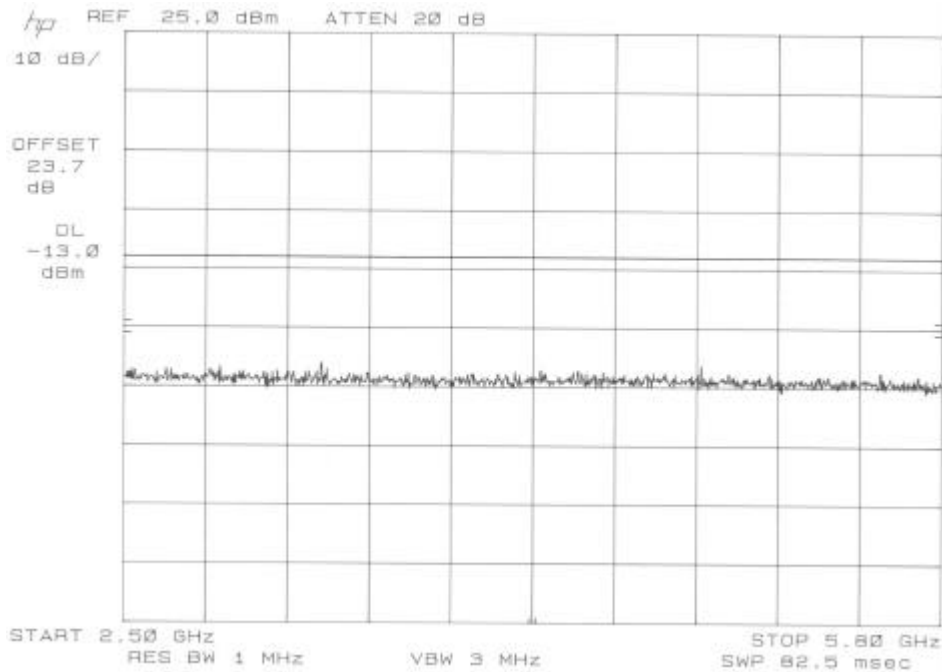
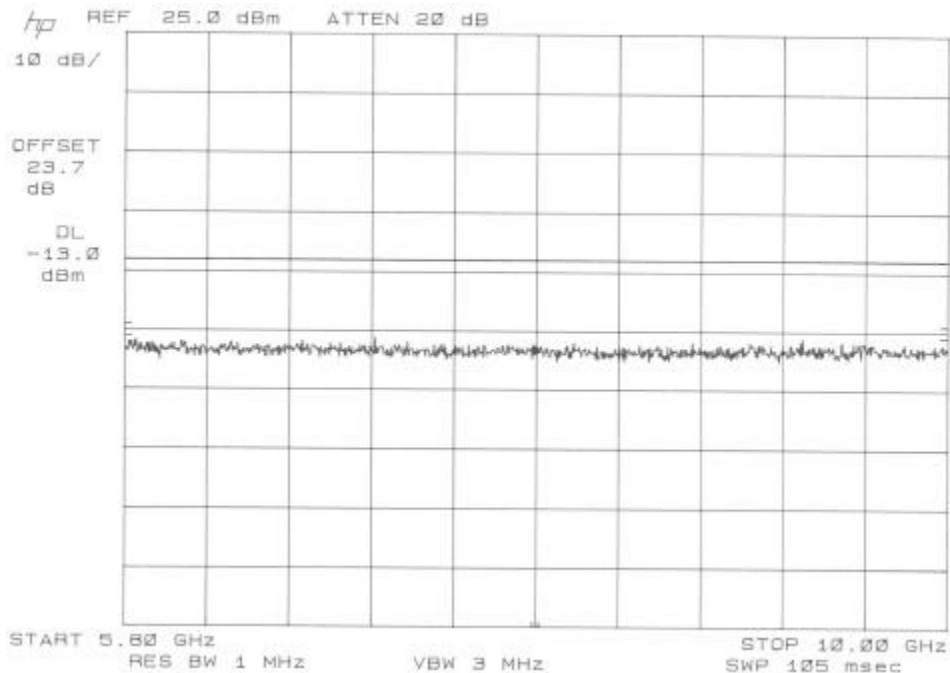
Figure 7: Conducted Spurious Emissions at Antenna Terminals, Uplink.

| | Uplink – CDMA – Mid Channel – 836.5 MHz | | |

All spurious emissions at the antenna terminals are below the IC/FCC specifications
