## Reliability Test Report

Report No.:20230325004

| Product Name | PCB Antenna | Sample Q'TY | 5PCS | | |
| Test Purpose | Verify Pad Tension | Test Purpose | / | | |

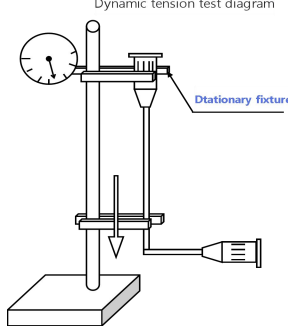
| Test Item : Tension Test Place: laboratory<br>Test Standard : <u>Reference AQA-SIP-C5036-009</u><br>Test SPEC<br>Pad Tension $\cong$ 2.0 kgf<br>Equipment : <u>Tension Testing Machine ZP-200</u><br>Conclusion Due Date : <u>16<sup>th</sup> Feb, 2024</u> | | Test status diagram:<br> | | | |

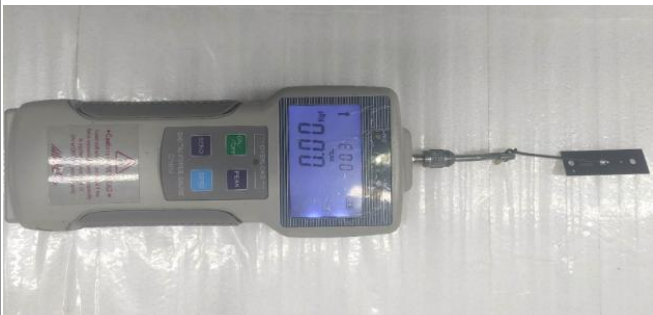
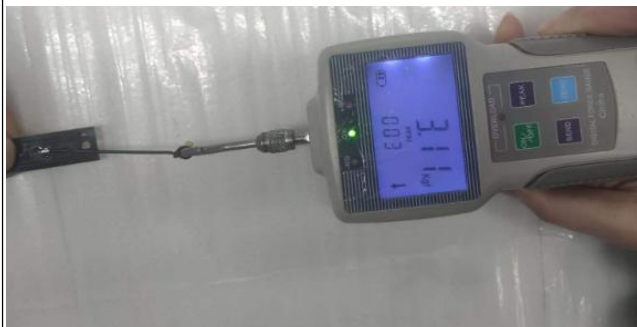
| Connector Tension $\cong$ 1.0kgf | 3.11 | 3.19 | 3.05 | 3.18 | 3.21 |
| Judgement : OK | | | | | |
| Mark : The pull is far beyond the standard pull | | | | | |

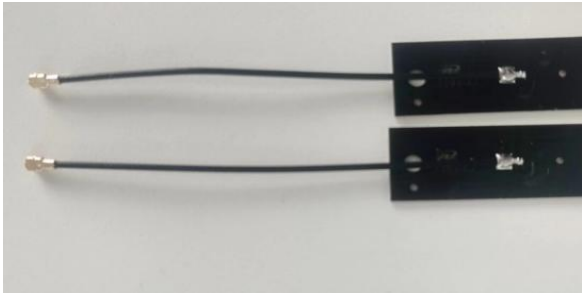
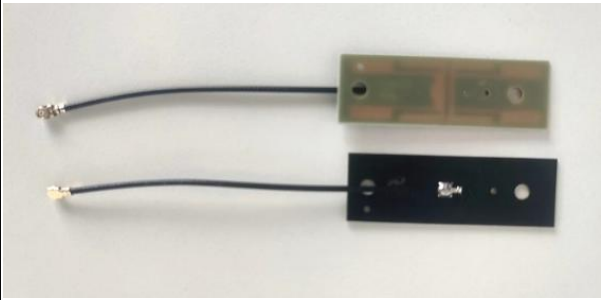
| Sample before test | sample after test |

| <p>Test Item: salt spray test Place: laboratory</p> <p>Test Standard: <u>GB/T 2423.17</u></p> <p>Test Time: <u>48H</u></p> <p>Test SPEC: Temperate <u>35°C</u> Salt-liquor thickness: <u>5%</u></p> <p>Equipment: Salt spray tester</p> <p>Conclusion Due Date : 16th April, 2023</p> | <p>Test status diagram:</p> |

| Test Result | | | | | | | | | | |
|---|---|---|--|--|--|--|--|--|--|--|
| Come away | OK | OK | | | | | | | | |
| Oxidation | OK | OK | | | | | | | | |
| VSWR | OK | OK | | | | | | | | |

Judgement: OK

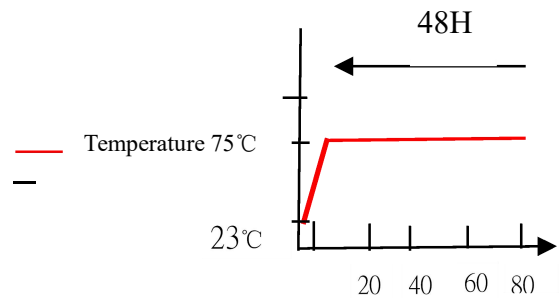
Test status diagram:

Test Item: high temperature test Place: laboratory  
 Test Standard: GB/T 2423.3  
 Test Time: 48H  
 Test SPEC: Temperate 75°C  
 Equipment: High temperature and high humidity testing machine

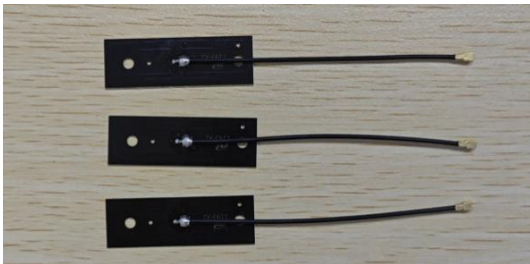
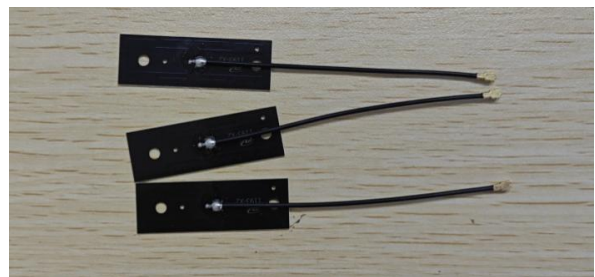
Sample before test

sample after test

| Sample | Sample1 | Sample2 | Sample 3 | | | | | | |
|---|---|---|---|--|--|--|--|--|--|
| Variation | ok | ok | ok | | | | | | |
| Come Away | ok | ok | ok | | | | | | |
| Crack | ok | ok | ok | | | | | | |

Judgement: OK

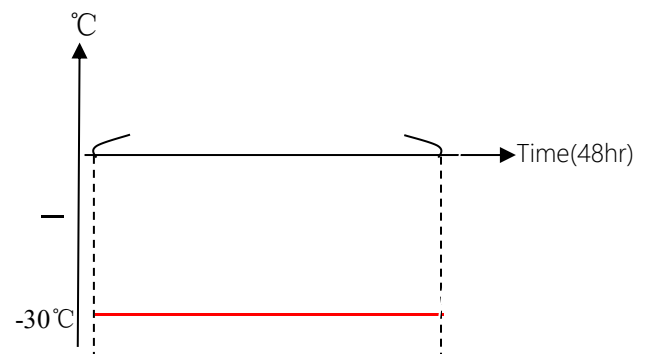
Test status diagram:

Test Item: low temperature test Place: laboratory  
 Test Standard: GB/T 2423.1  
 Test Time: 48H  
 Test SPEC: Temperate -30°C  
 Equipment: TEMP&HUMI chamber

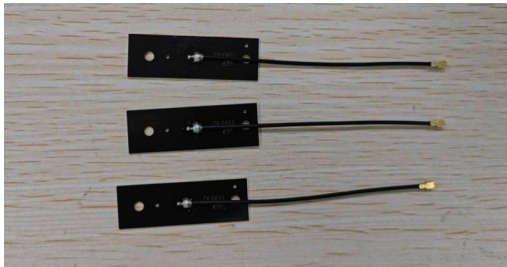
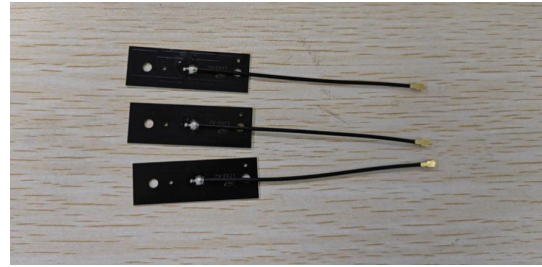
Sample before test

sample after test

| Sample | Sample1 | Sample2 | Sample 3 | | | | | | |
|---|---|---|---|--|--|--|--|--|--|
| Variation | ok | ok | ok | | | | | | |
| Aberration | ok | ok | ok | | | | | | |
| Crack | ok | ok | ok | | | | | | |

Judgement: OK

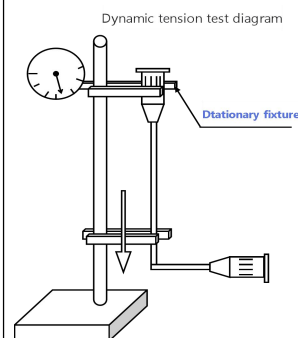
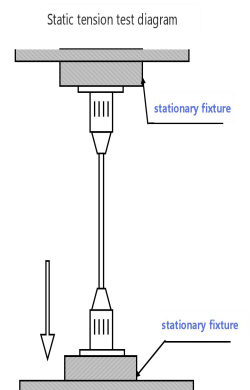
Test status diagram:

Test Item : Tension Test Place: laboratory

Connector Tension  $\geq$  1.0 kgfEquipment : Tension Testing Machine NK-300Conclusion Due Date : 2024.02.16

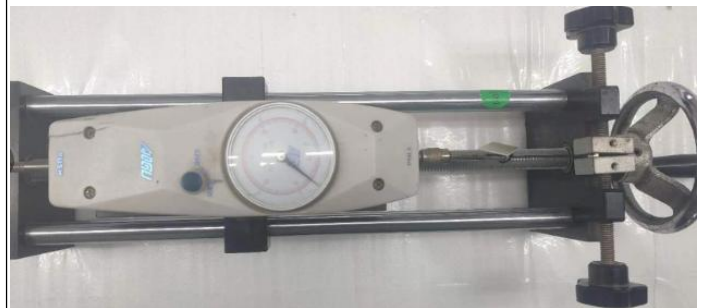
Sample after test

| Connector Tension $\geq$ 1.0kgf | 2.8 | 3.1 | 3.3 | 3.2 | 3.0 |

Judgement : OK

Mark : The pull is far beyond the standard pull
