### **APPENDIX 3: Photographs of test setup**

#### **Radiated Spurious Emission**

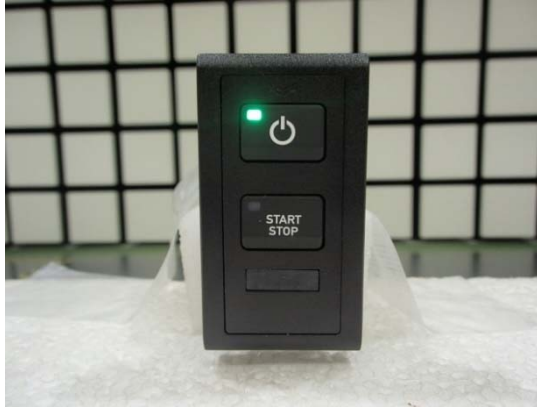
**X-axis**

**Worst Case Position**

**Below 30 MHz: (X-axis)**

**Above 30 MHz: (Horizontal: X-axis / Vertical: X-axis)**

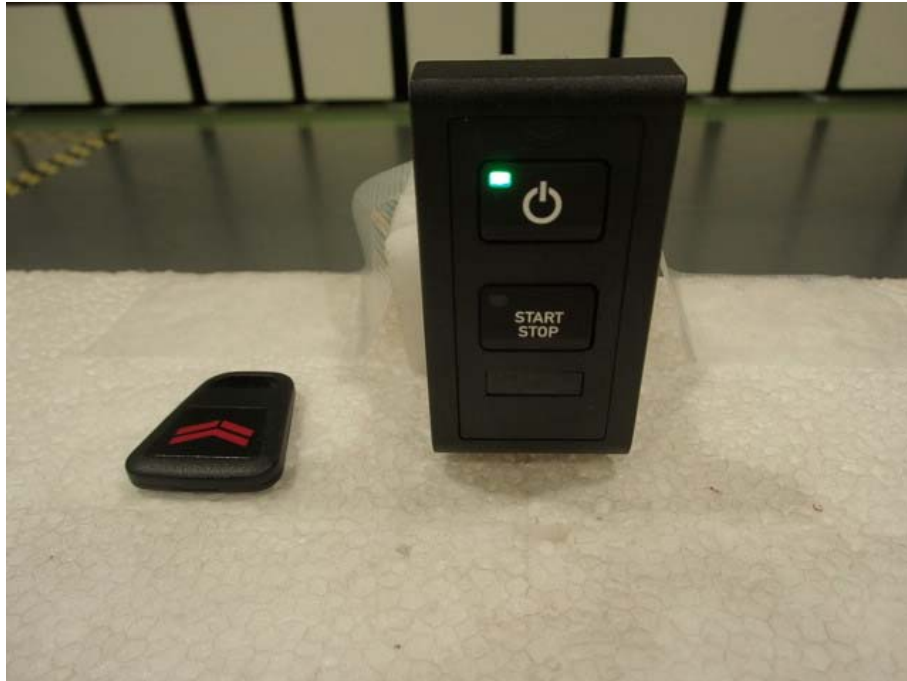
**Worst case position**

**Without Key (Worst)**

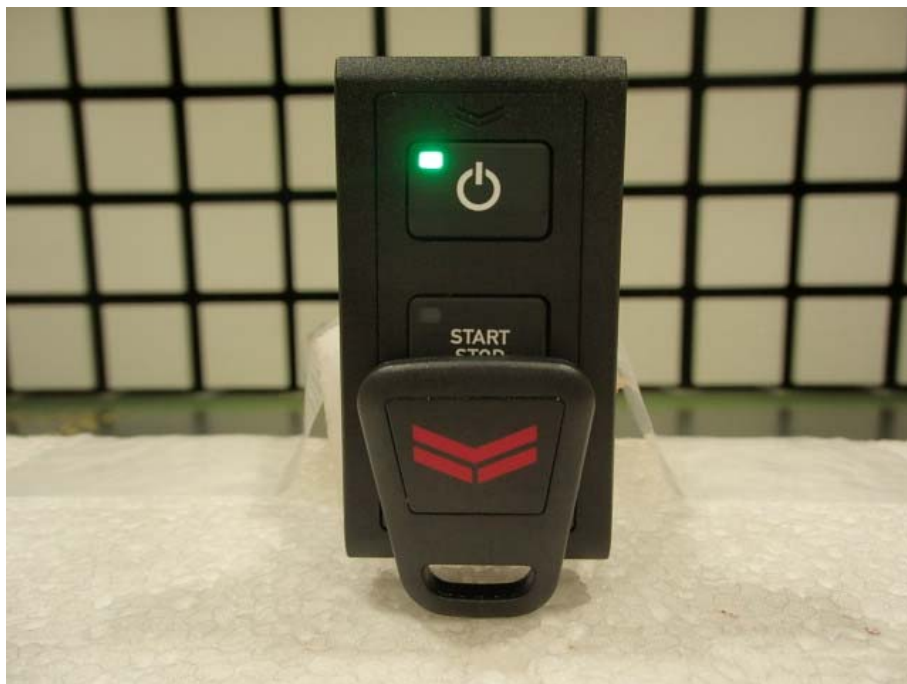
**With Key**
