## Test Photographs Radiated Emissions

Test Report No. R-2911P, Rev. A

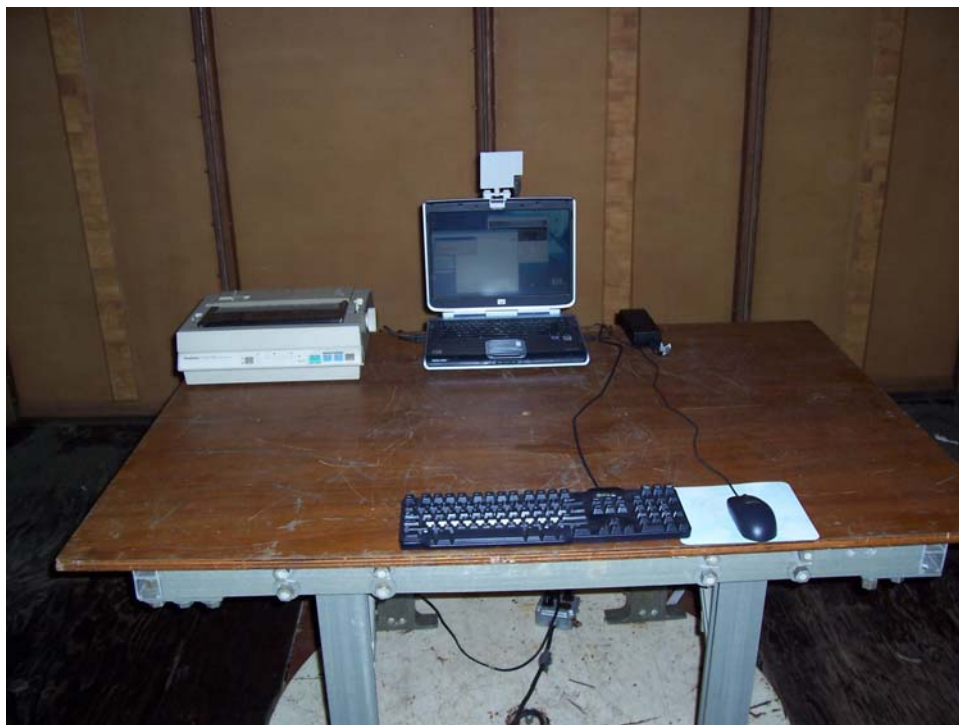
Test Setup, Front View

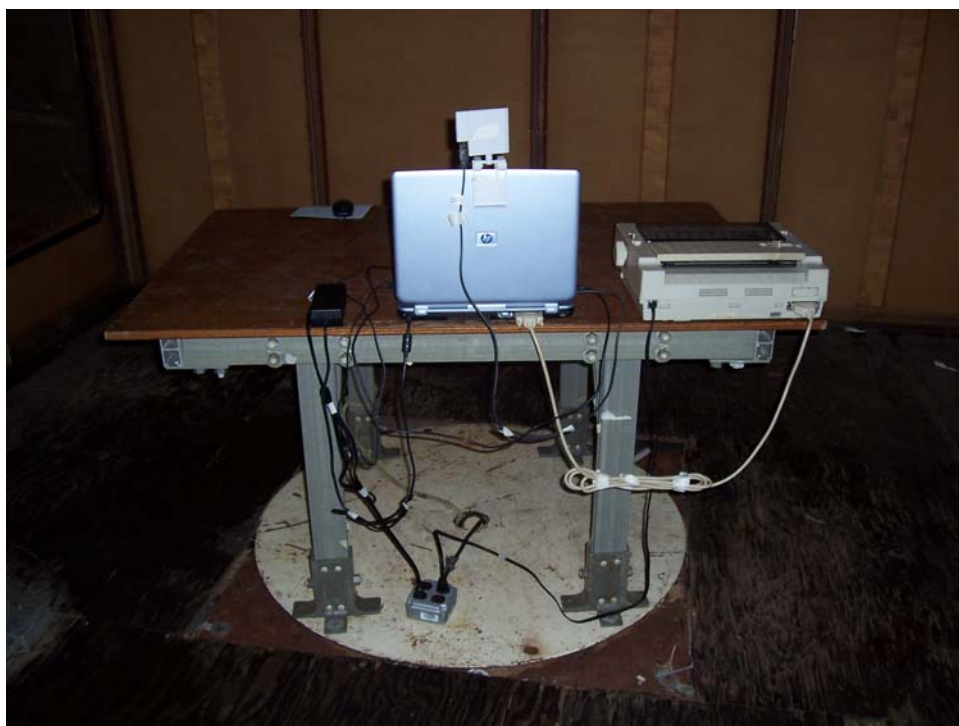
Test Setup, Rear View

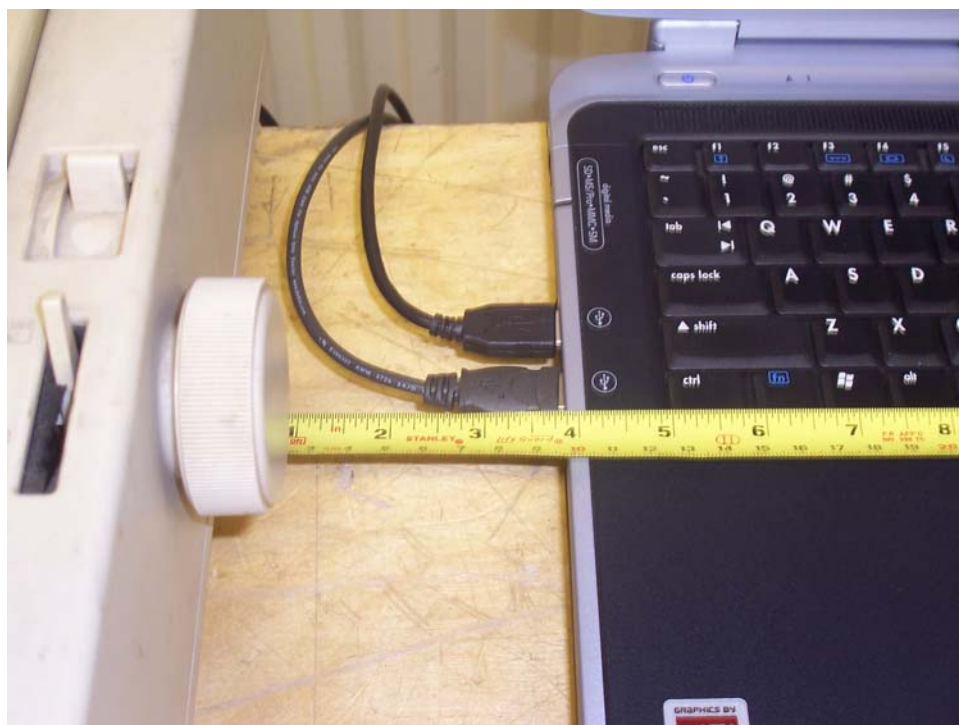
10 cm Spacing

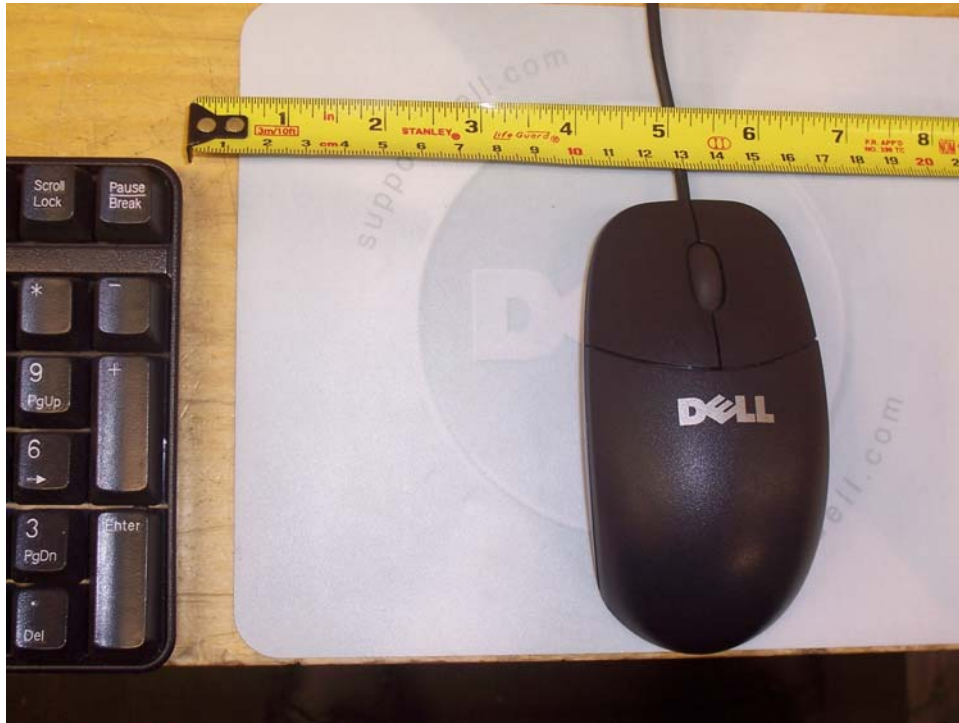
Mouse Setup

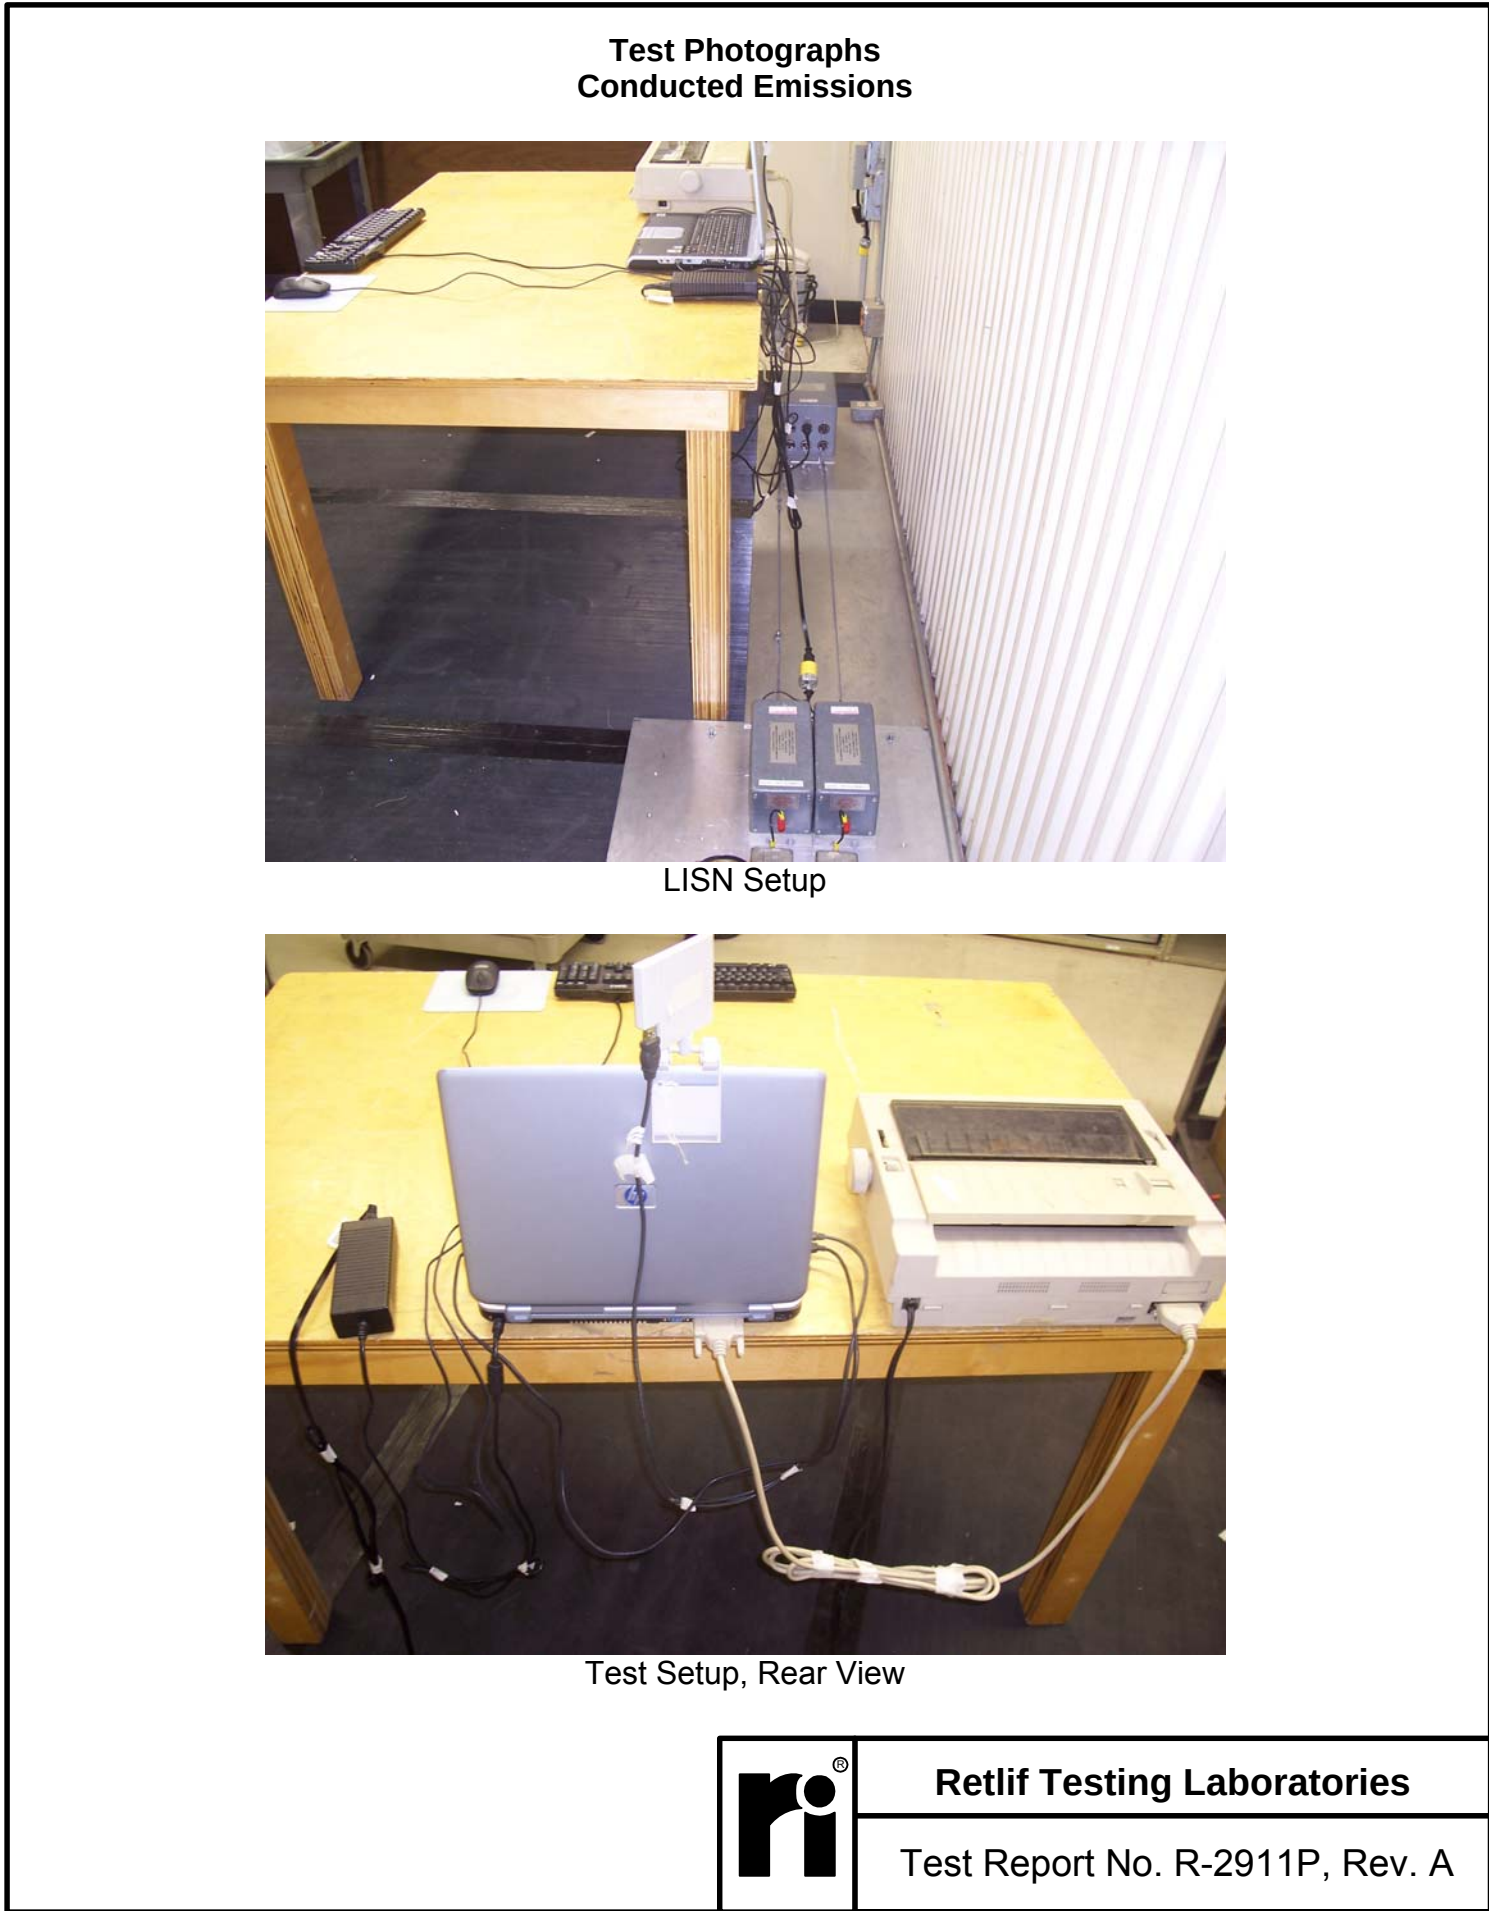
A photograph showing the LISN (Line Impedance Stabilization Network) setup. A yellow table holds a laptop, keyboard, and mouse. Cables connect the equipment to a power source and a LISN unit on the floor. A white corrugated metal wall is visible in the background.

LISN Setup

A photograph showing the rear view of the test setup. A laptop is connected to a power supply and a LISN unit. A white computer monitor is also connected to the setup. Cables are visible on the floor and under the table.

Test Setup, Rear View

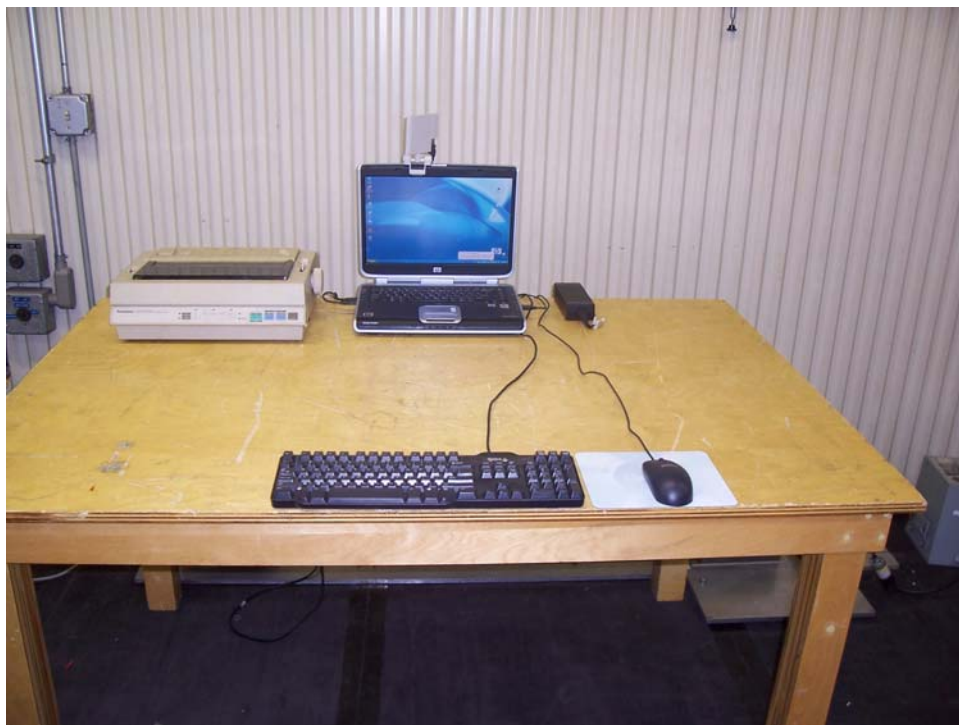
Test Setup

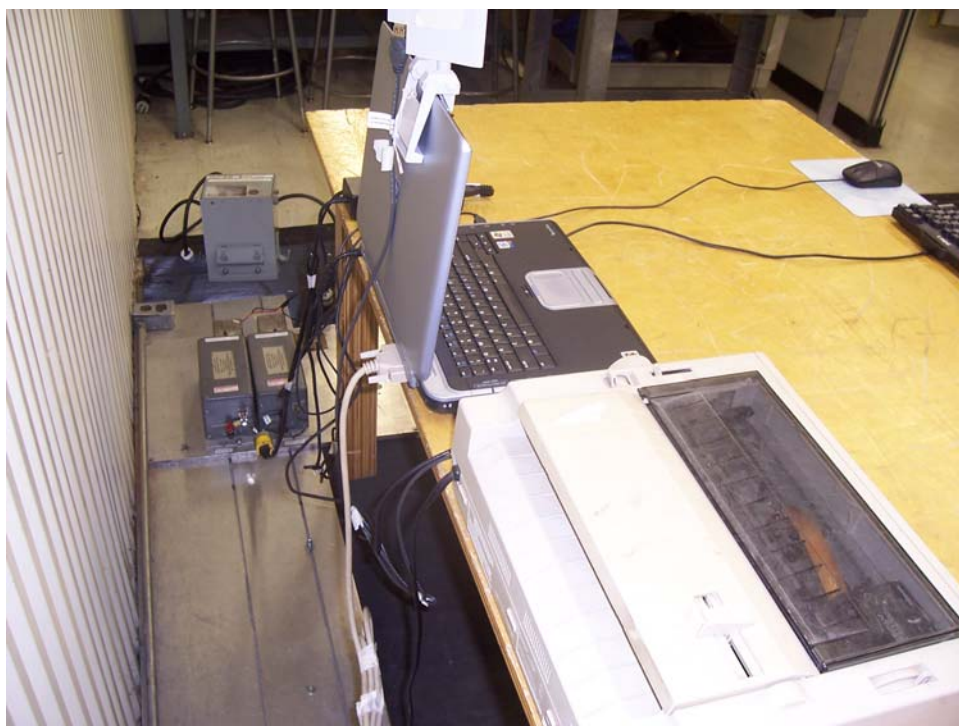
Rear Test Setup

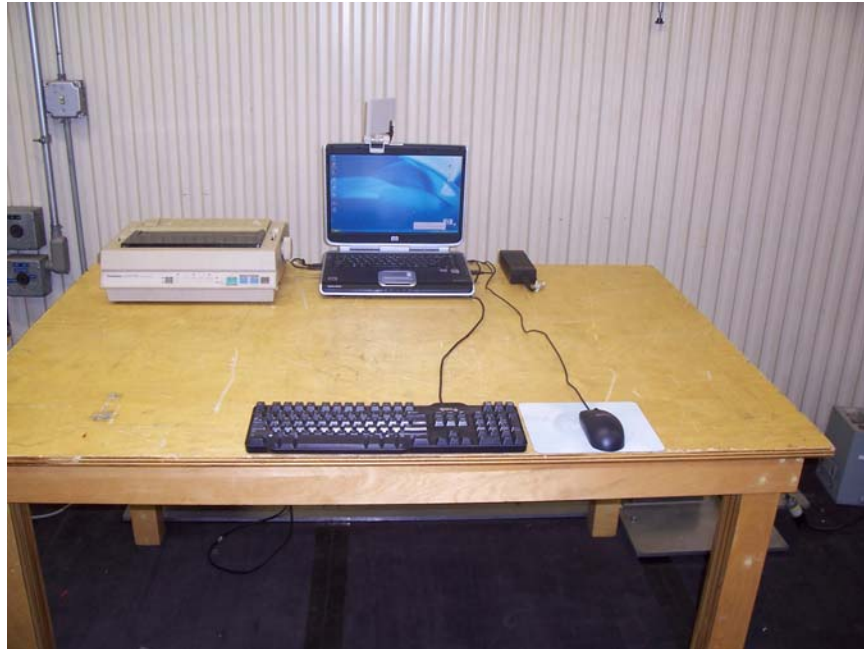
Figure 1 - General Setup Photographs

Conducted Emissions

NOTE: During preliminary emissions testing the placement of the EUT was varied between the 10 cm offset location and the laptop screen mounting position. It was determined that the later produced maximum emissions and was in line with expected operation. Formal emissions measurements were therefore carried out with the EUT in this configuration.

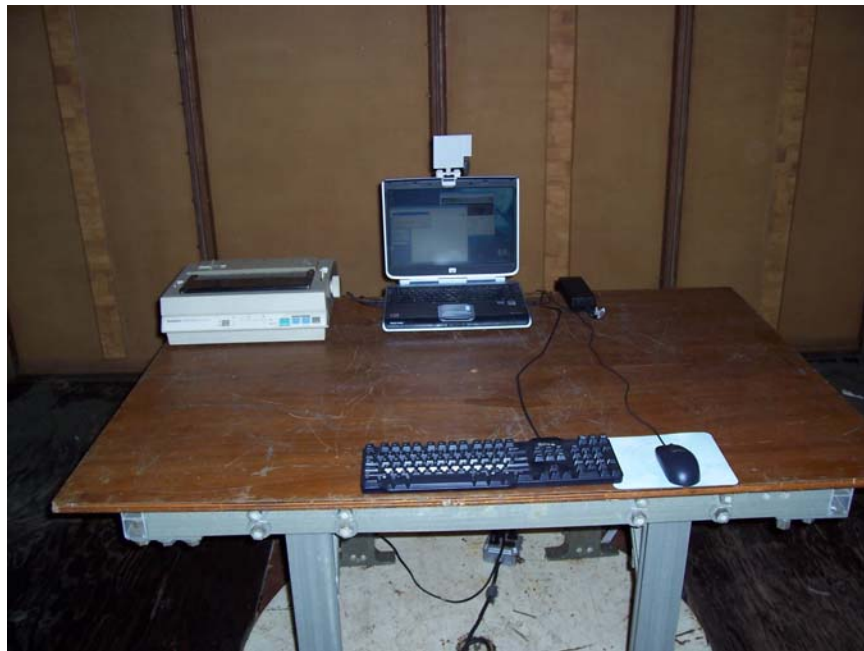
Radiated Emissions
