### **APPENDIX 3: Photographs of test setup**

#### **Radiated Spurious Emission**

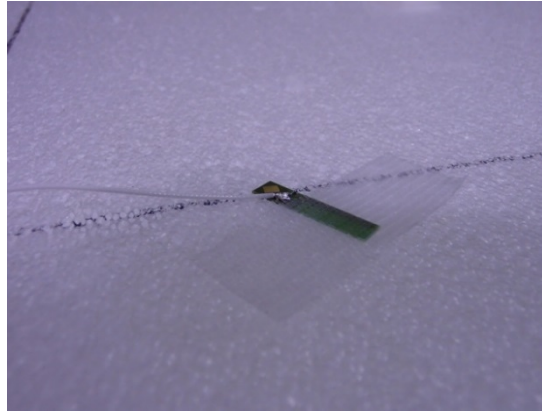
**X-axis**

### **Worst Case Position (Antenna)**

Above 1GHz (Horizontal: Y-axis/ Vertical: Z-axis)

Below 1GHz (Horizontal: Z-axis/ Vertical: Z-axis)

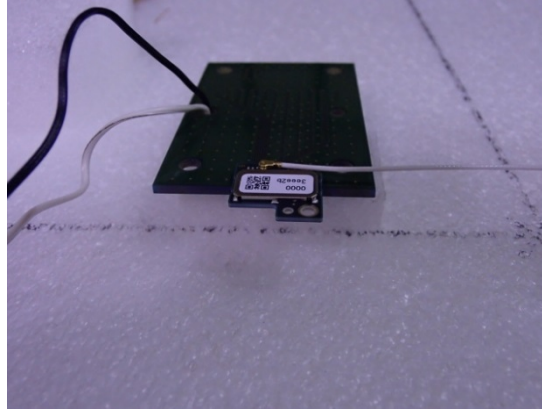
**X-axis**

### **Worst Case Position (Module)**

Above 1GHz (Horizontal: X-axis/ Vertical: Y-axis)  
Below 1GHz (Horizontal: X-axis/ Vertical: X-axis)
