### **APPENDIX 3: Photographs of test setup**

#### **Radiated Spurious Emission**

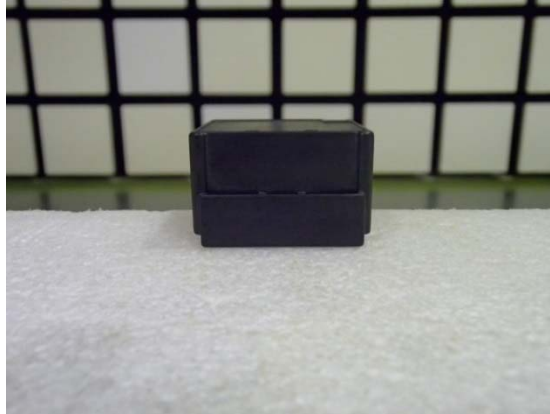
**X-axis**

### **Worst Case Position**

Above 1 GHz (Horizontal: Z-axis/ Vertical:X-axis)

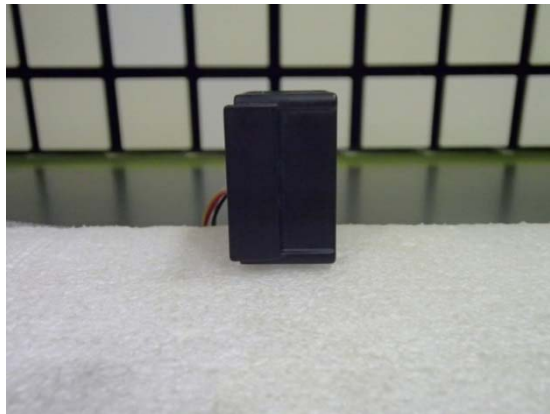
**Z-axis**

Below 1 GHz (Horizontal: Z-axis/ Vertical:Z-axis)
