### **APPENDIX 3: Photographs of test setup**

#### **Conducted Emission**

### Radiated Spurious Emission

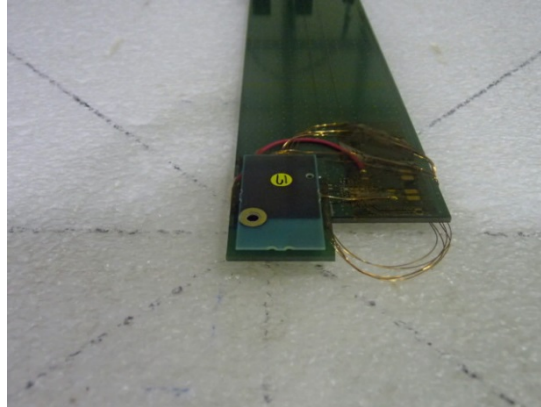
**X-axis**

**Worst Case Position**

Above 1GHz (Horizontal: X-axis/ Vertical: X-axis)

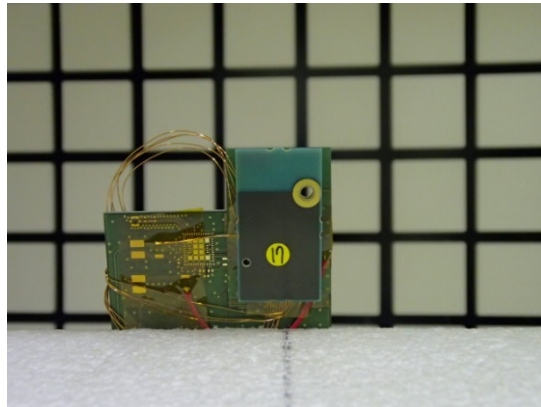
**Y-axis**

Below 1GHz (Horizontal: Y-axis/ Vertical: Y-axis)
