## Appendix B: photographs of test setup

## Appendix C: photographs of EUT

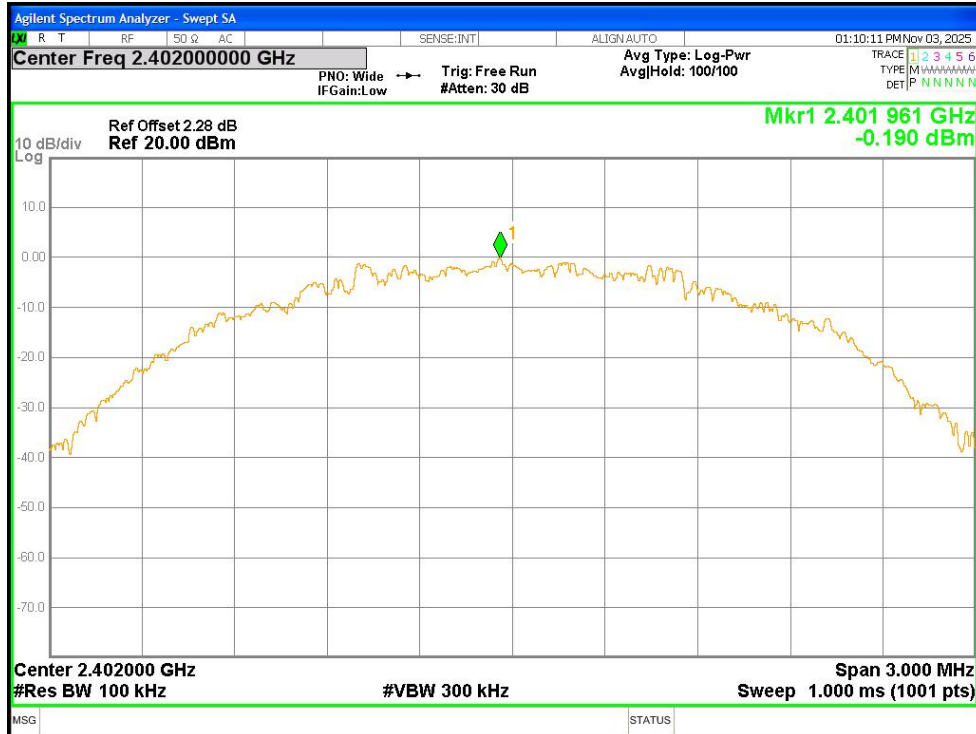
Tx. Spurious NVNT BLE 2M 2402MHz Ant1 Ref

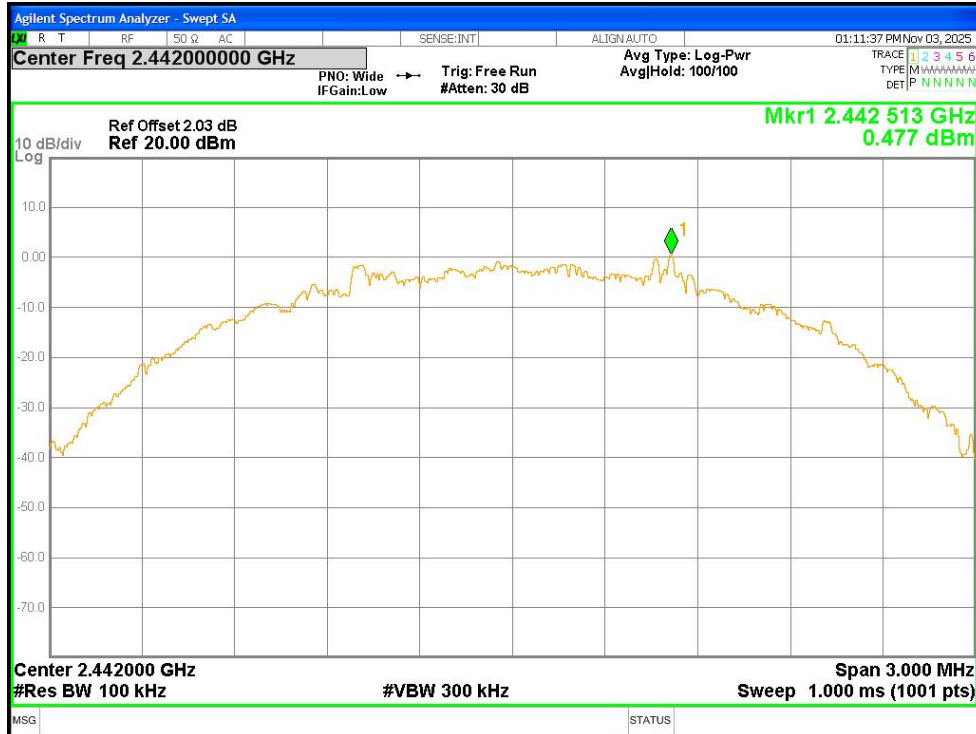
Tx. Spurious NVNT BLE 2M 2442MHz Ant1 Ref

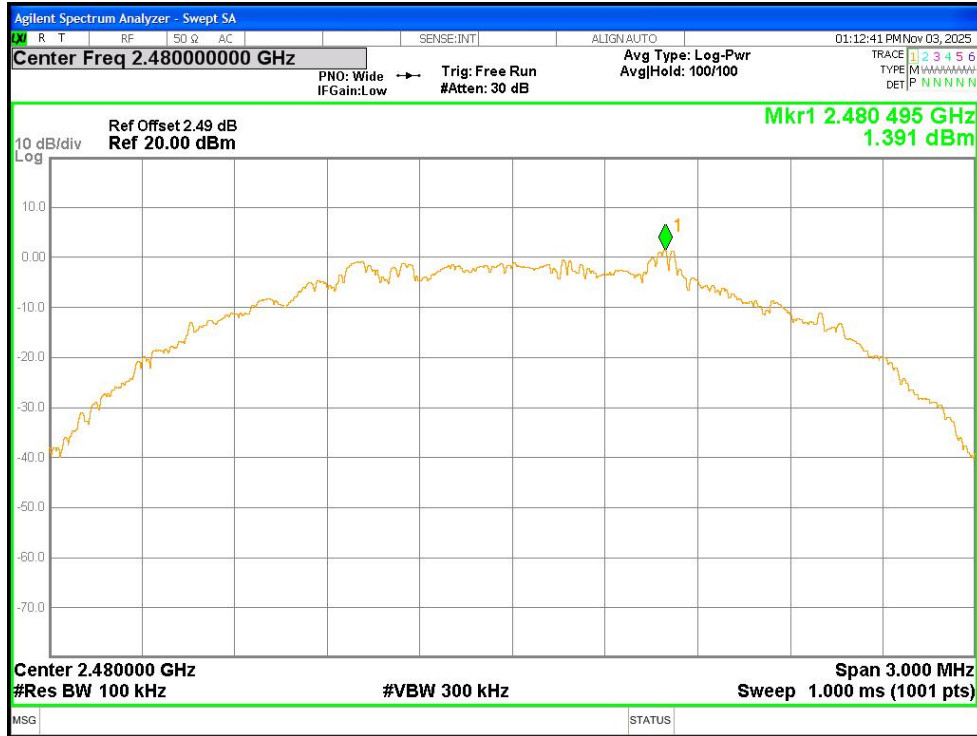
Tx. Spurious NVNT BLE 2M 2480MHz Ant1 Ref

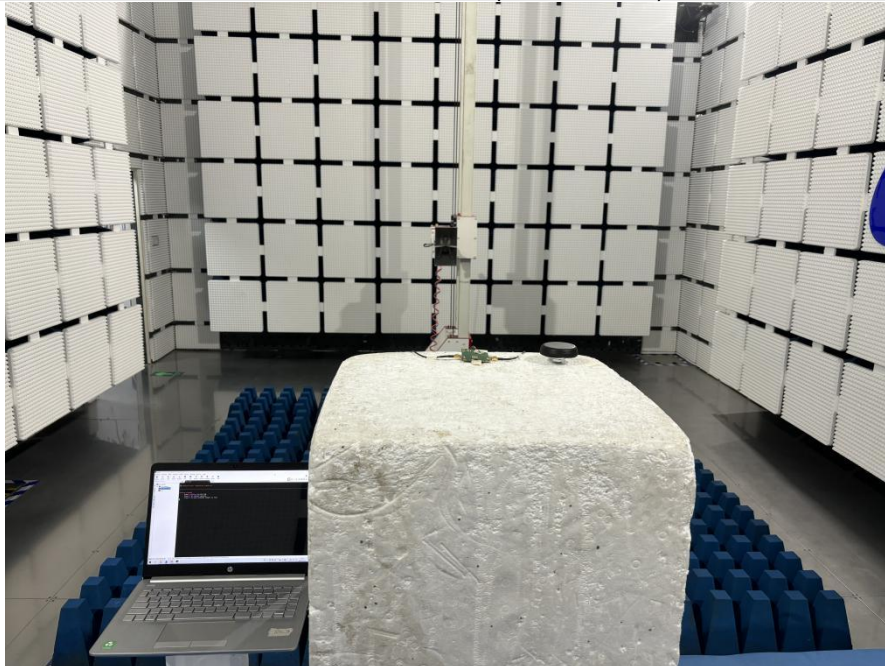
Radiated Emissions (above 1GHz)

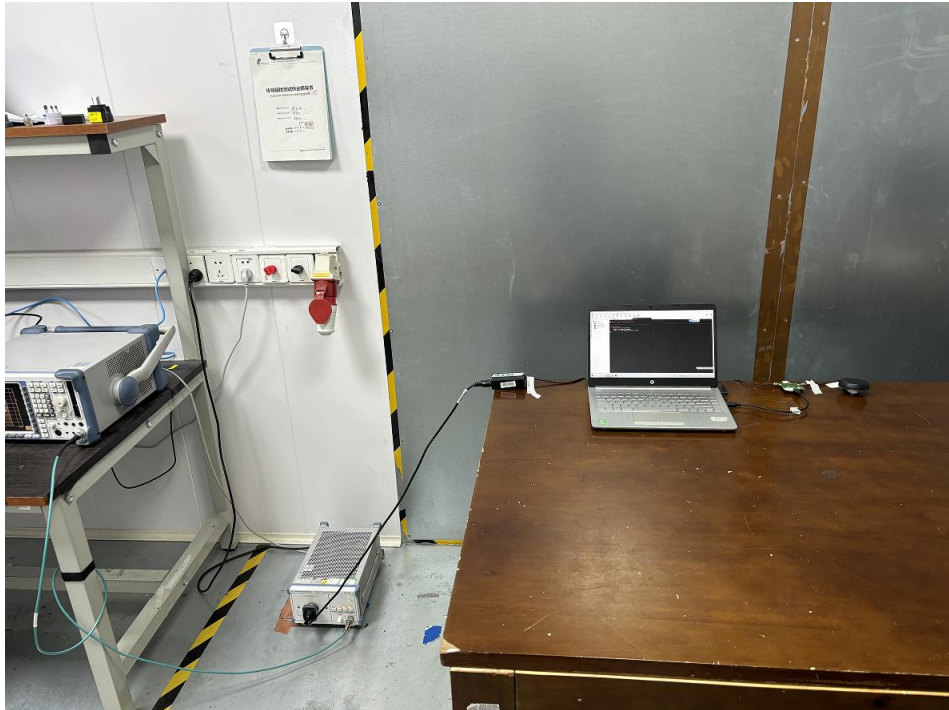
Conducted Emissions at Mains Terminals (150 kHz-30MHz)
