### 3.9 Transmission Burst Length

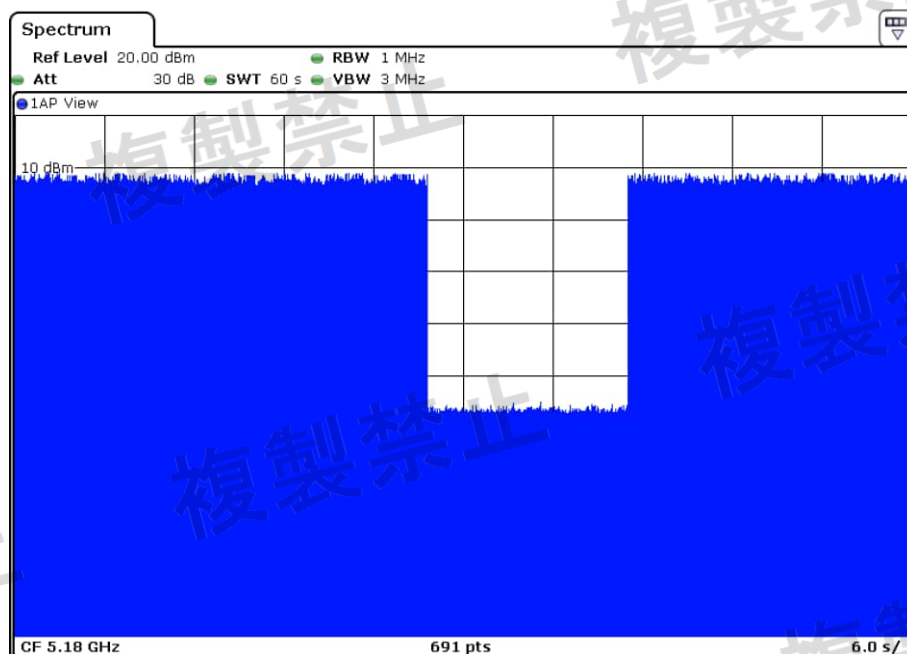
BW=20M

### 3.11.3 Test Result

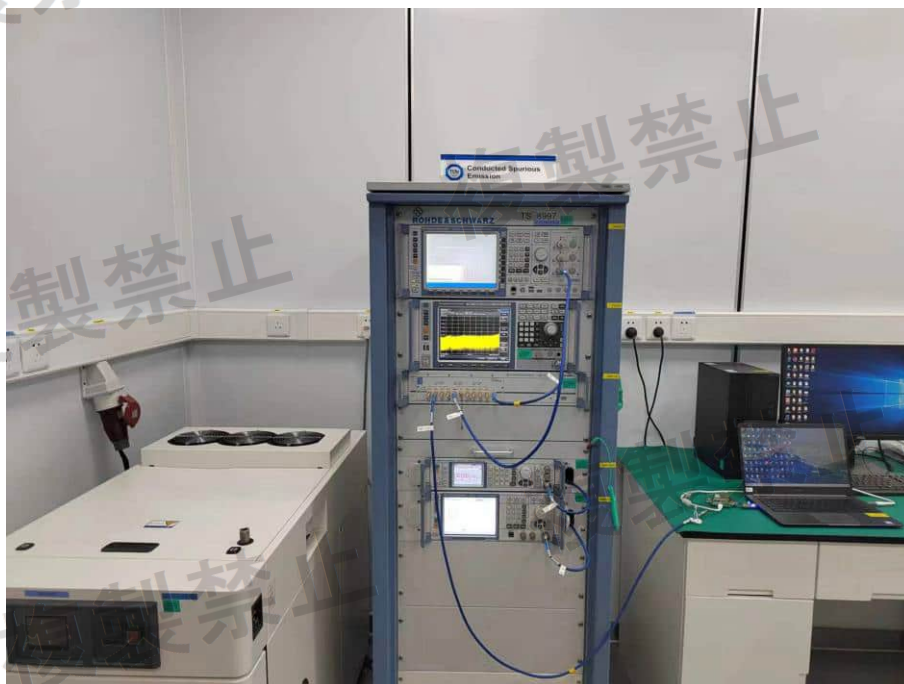
#### 4 Photographs of Test Set-ups
