## . A.8 Restrict-band band-edge measurements

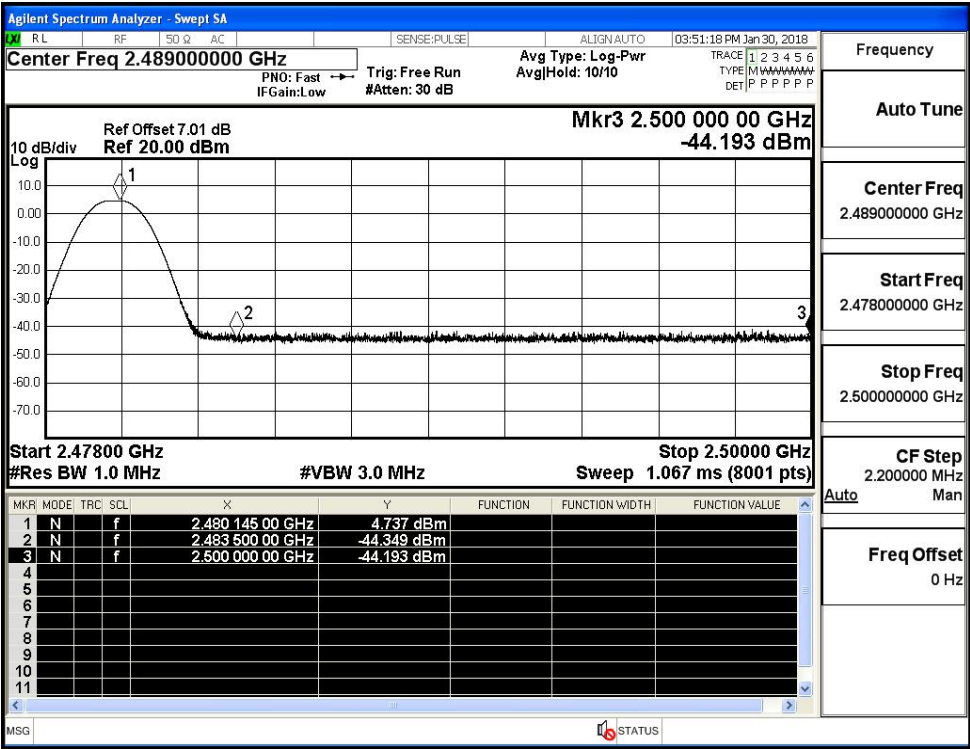
Restrict-band band-edge measurements\_2480\_PEAK\_DH5

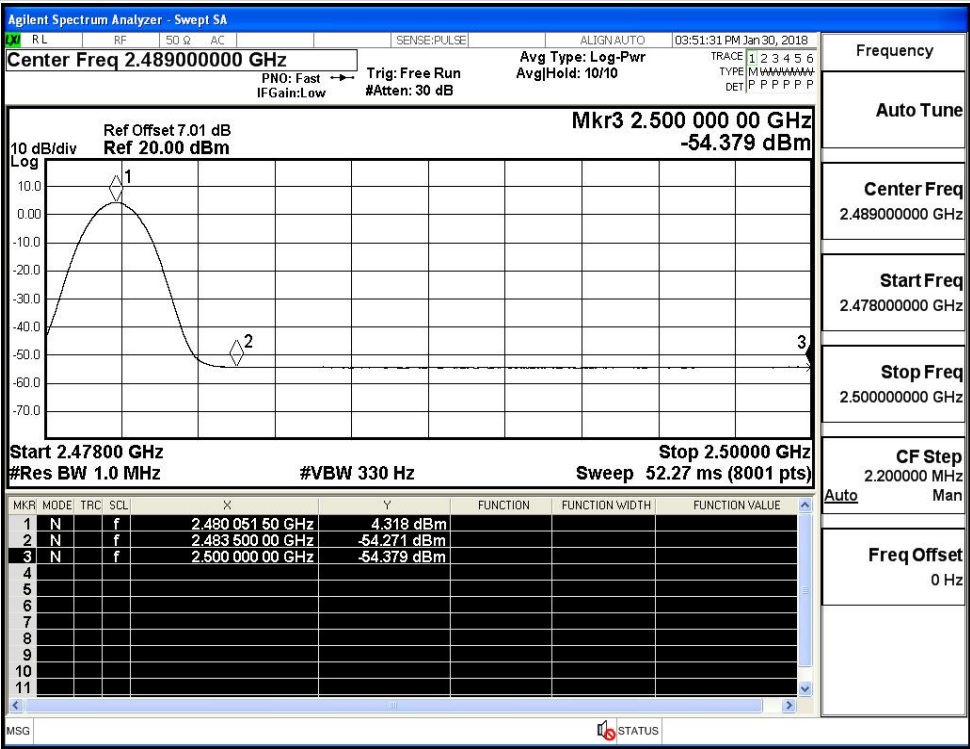
Restrict-band band-edge measurements\_2480\_AV\_DH5

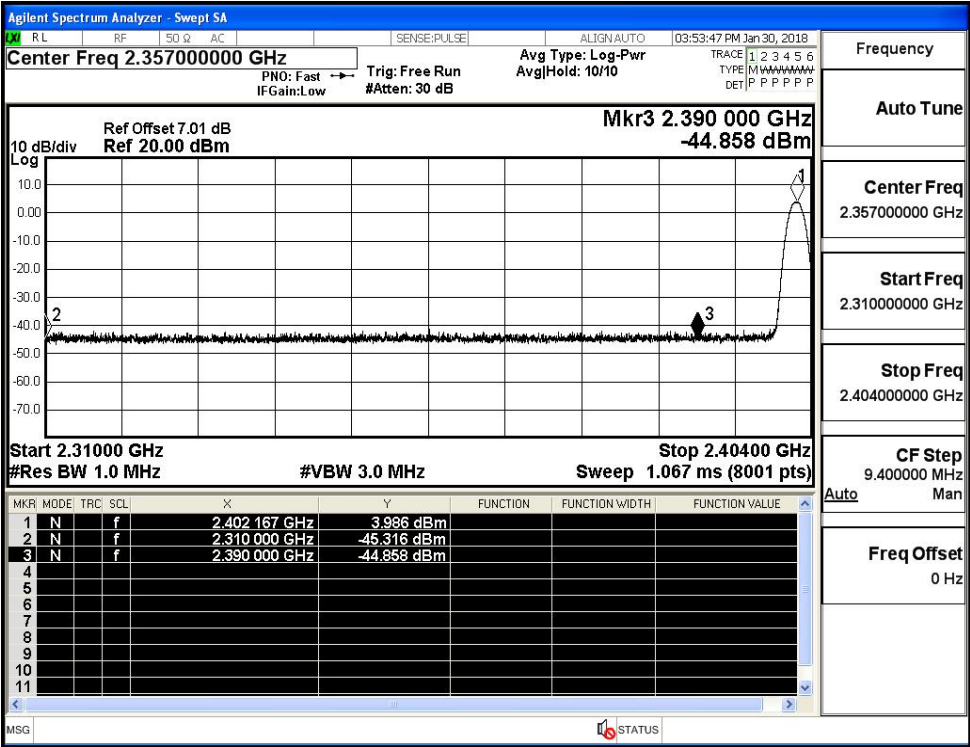
Restrict-band band-edge measurements\_2402\_PEAK\_2DH5

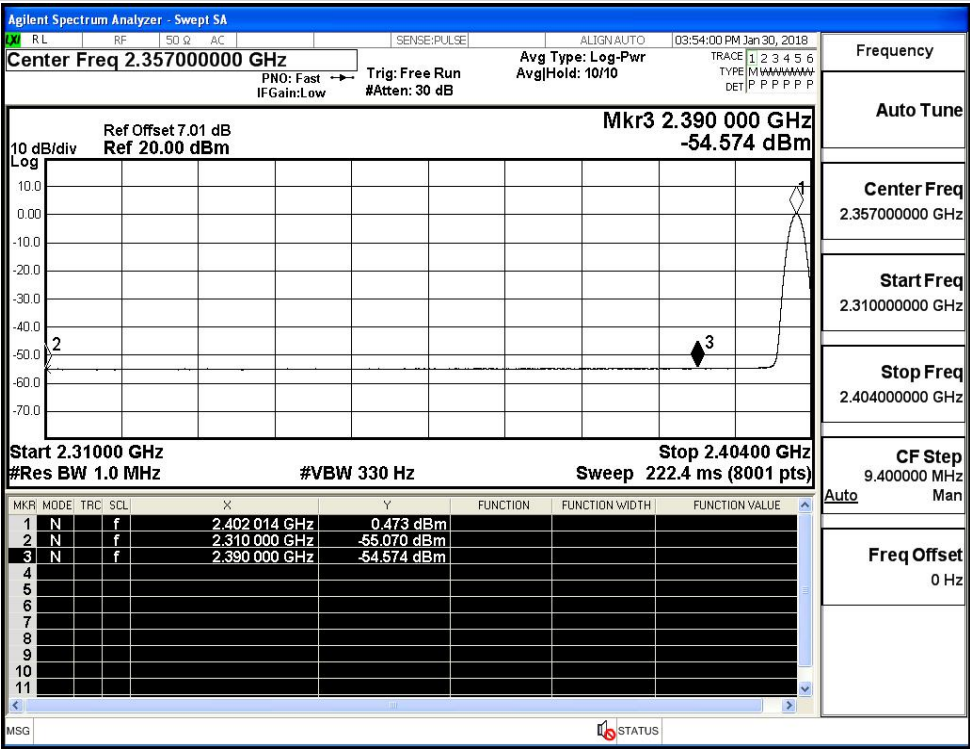
Restrict-band band-edge measurements\_2402\_AV\_2DH5

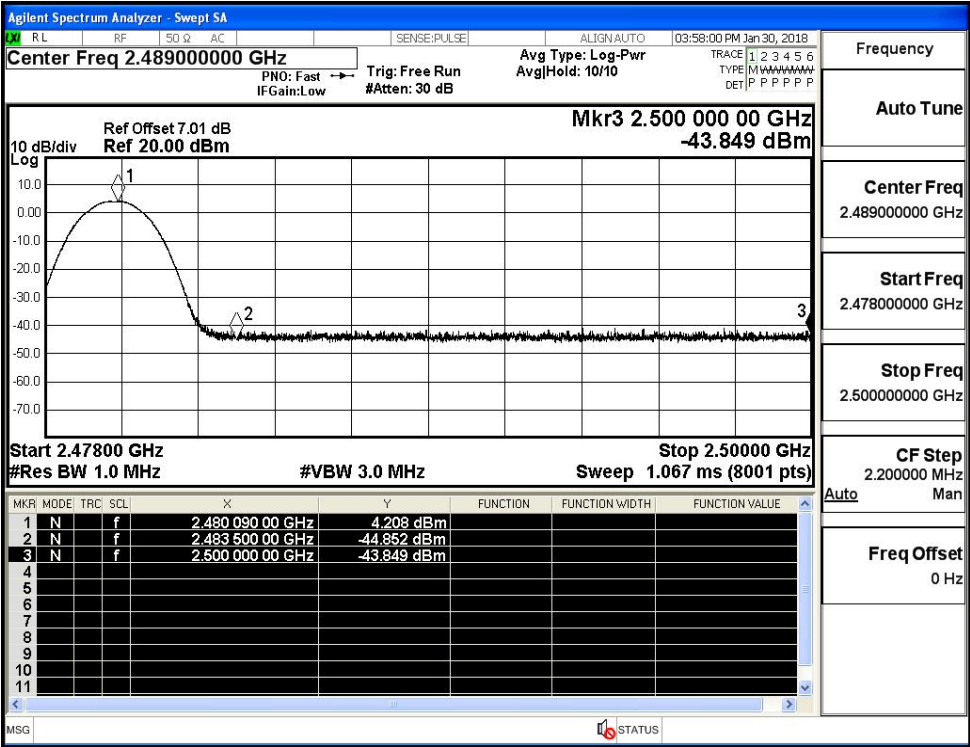
Restrict-band band-edge measurements\_2480\_PEAK\_2DH5

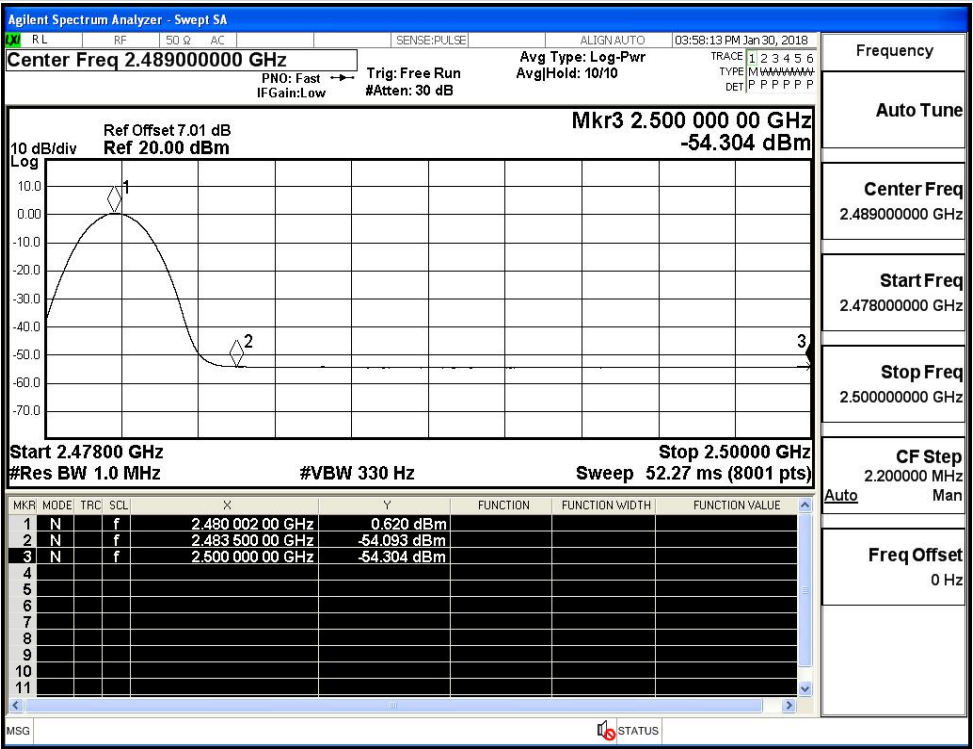
Restrict-band band-edge measurements\_2480\_AV\_2DH5

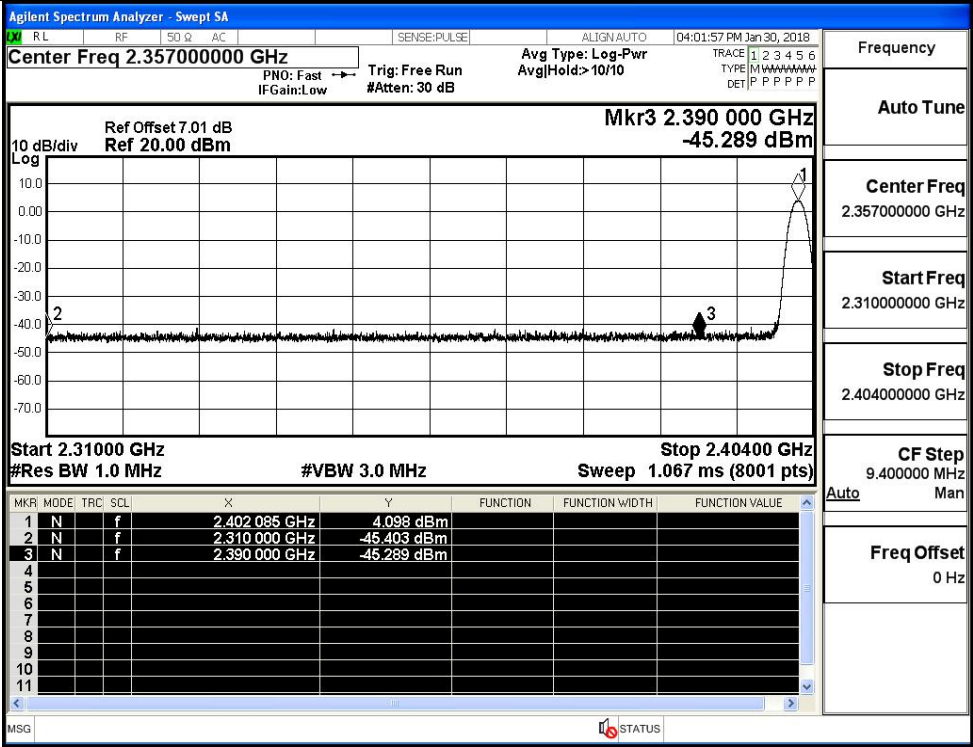
Restrict-band band-edge measurements\_2402\_PEAK\_3DH5

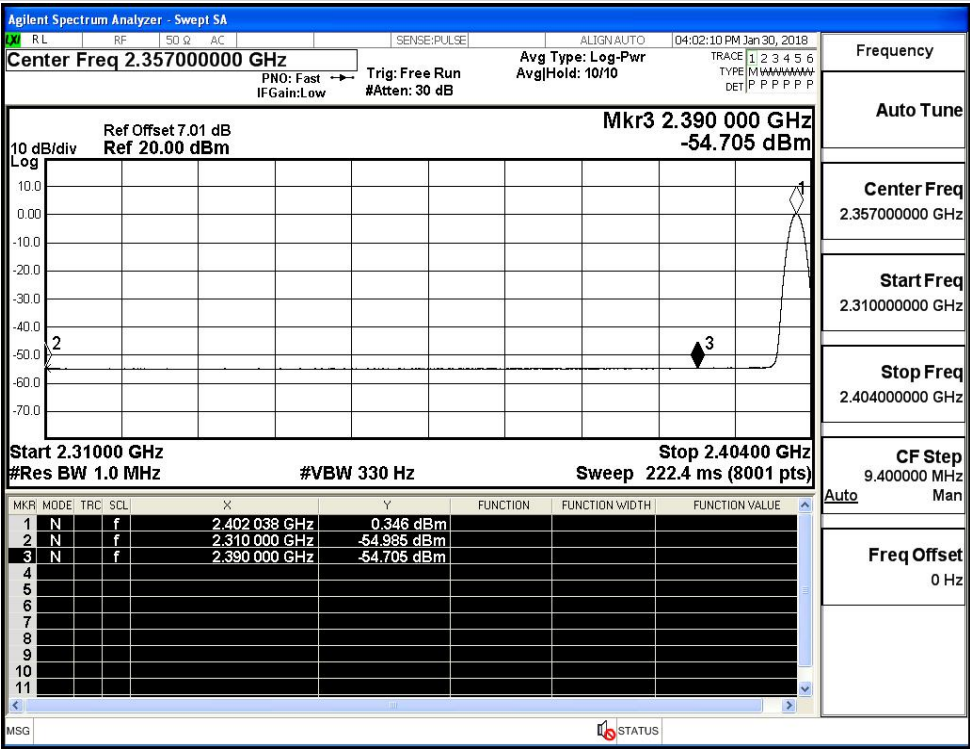
Restrict-band band-edge measurements\_2402\_AV\_3DH5

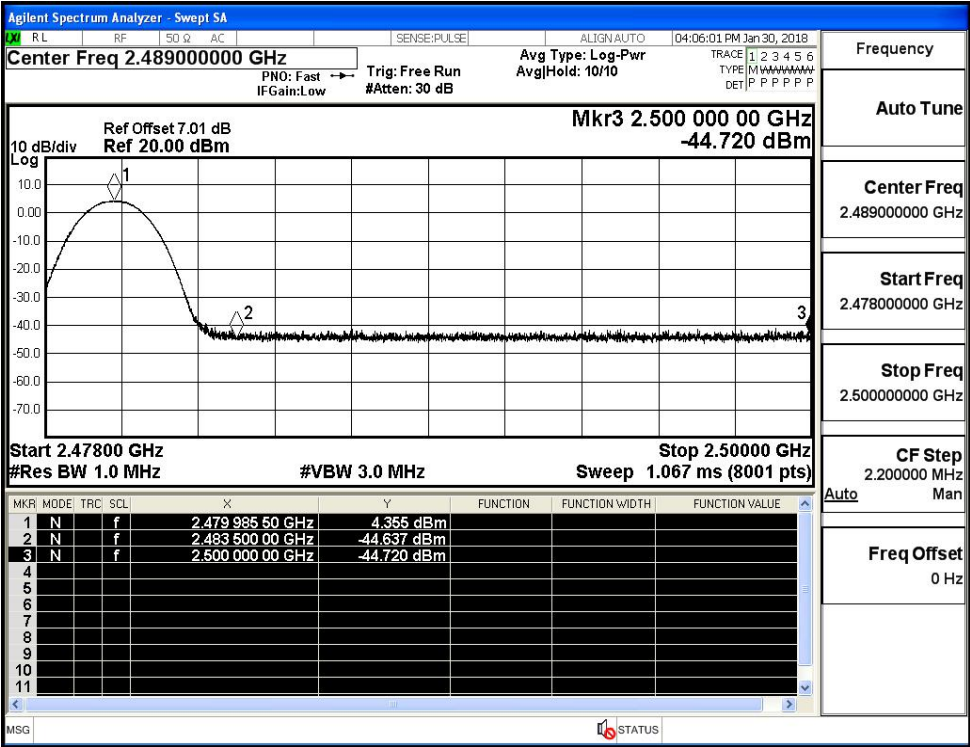
Restrict-band band-edge measurements\_2480\_PEAK\_3DH5

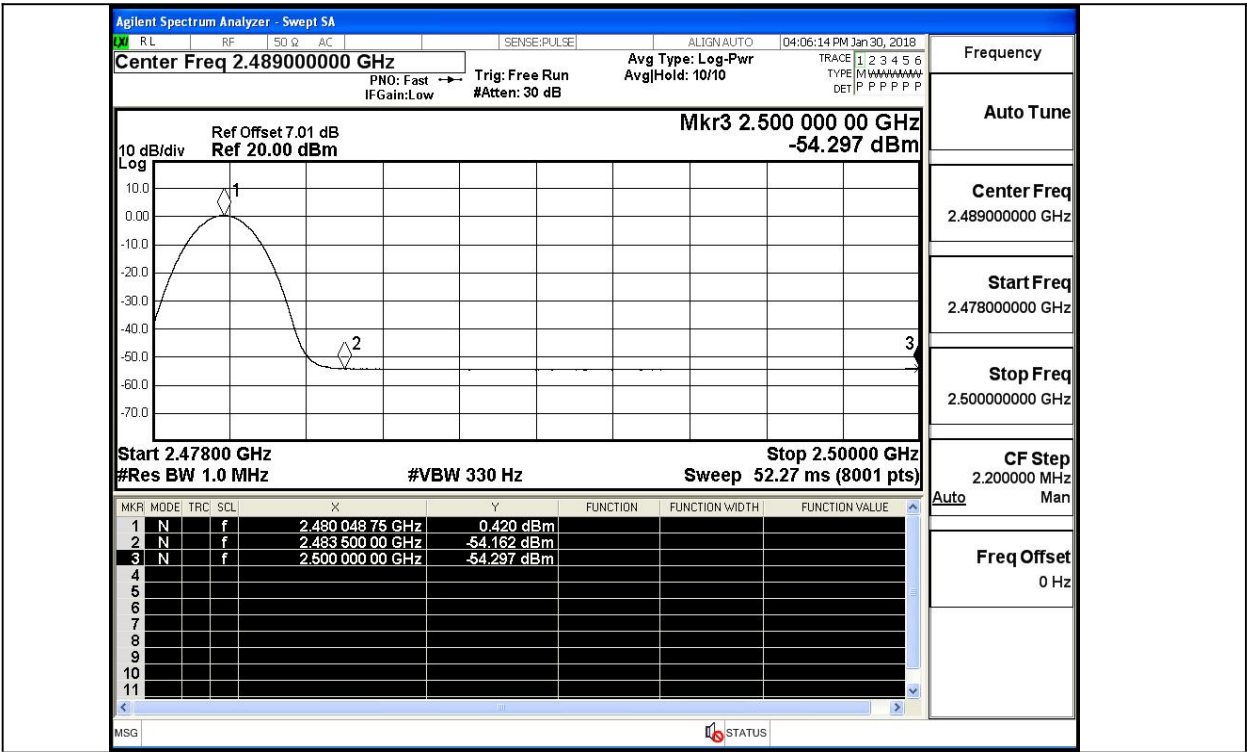
Restrict-band band-edge measurements\_2480\_AV\_3DH5

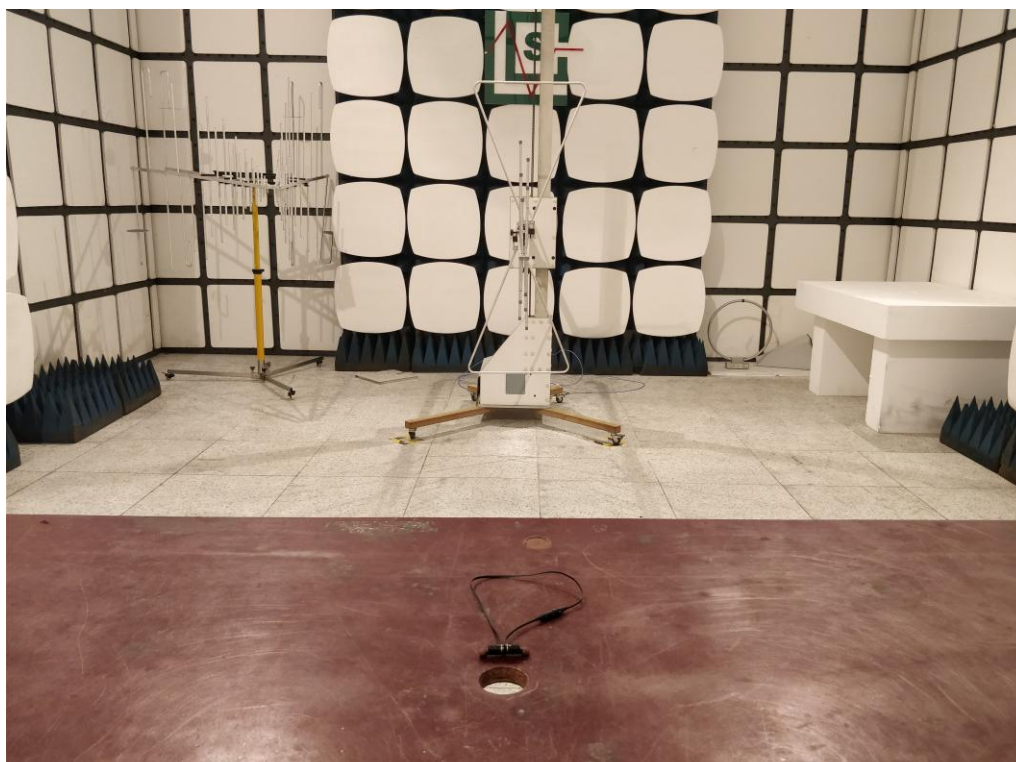
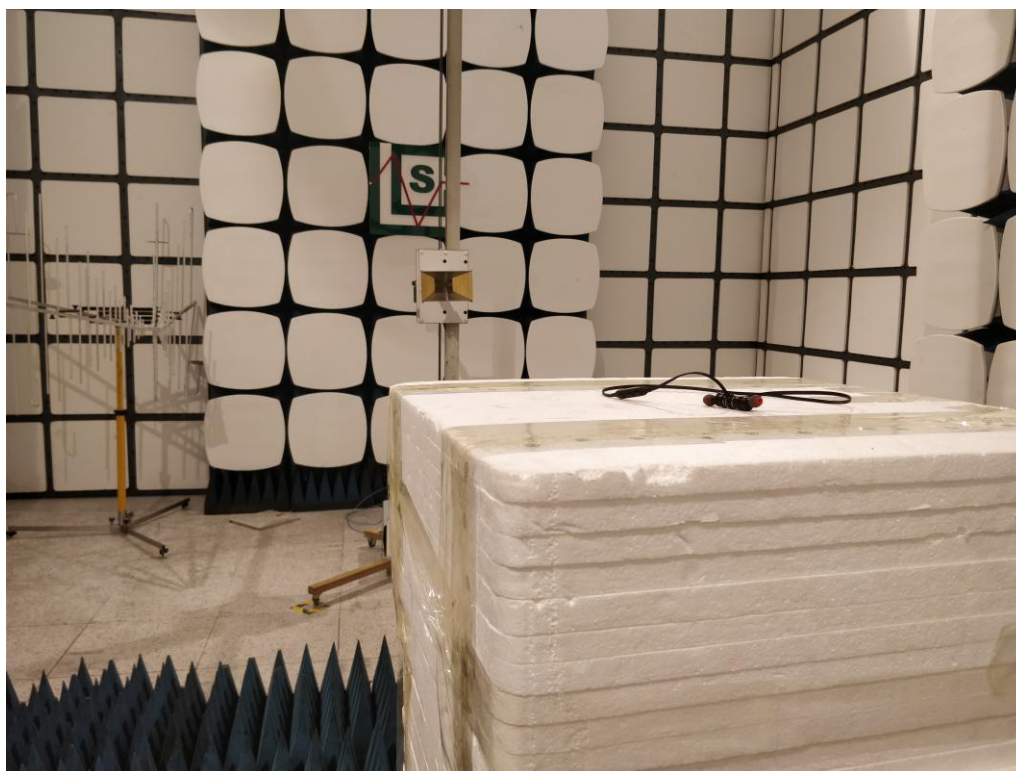
### Test Setup Photo(s) of Radiated Emissions Measurement

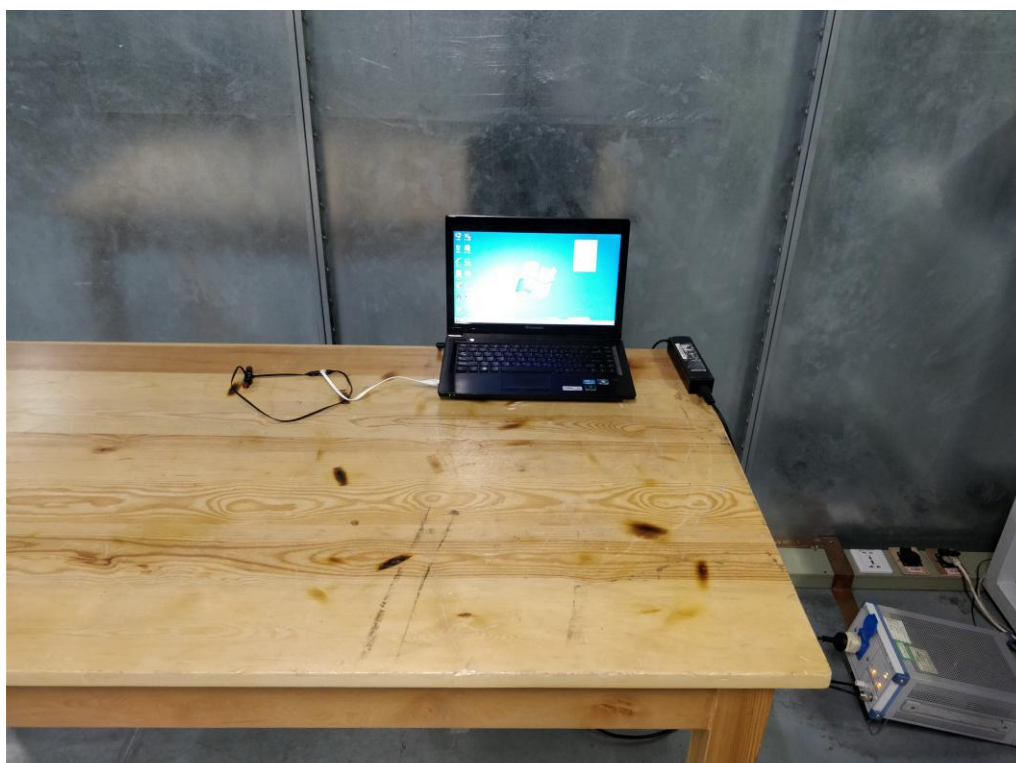
Fig. 3

Test Setup Photo of Line Conducted Emissions Measurement
