## DASY/EASY - Parameters of Probe: EX3DV4 - SN:3911

**CUSTOMER  
COPY****PROBE REPAIR REPORT – SPEAG Production Center**

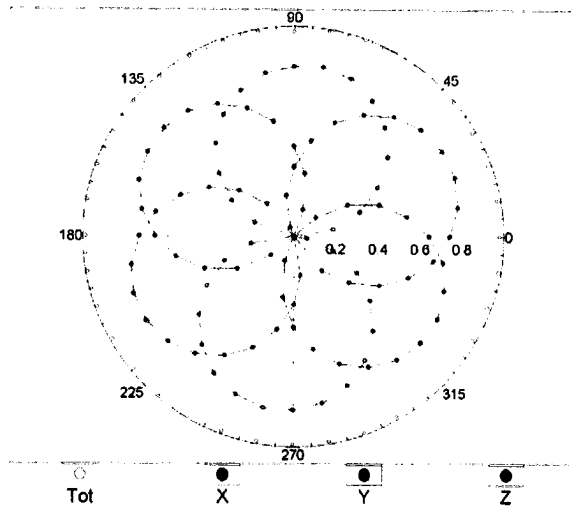
f=600 MHz,TEM

## Receiving Pattern ( $\phi$ ), $\vartheta = 0^\circ$

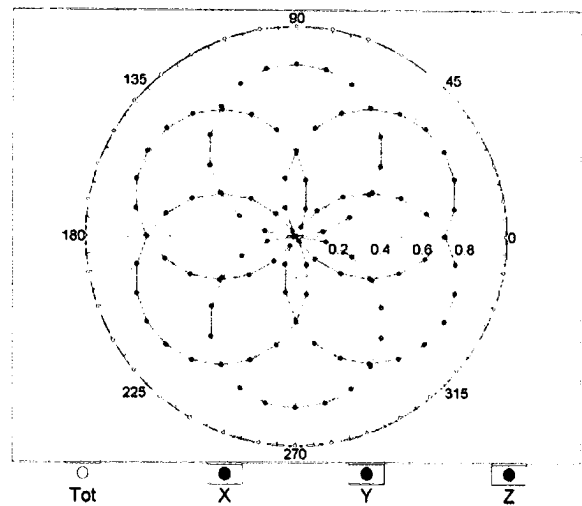
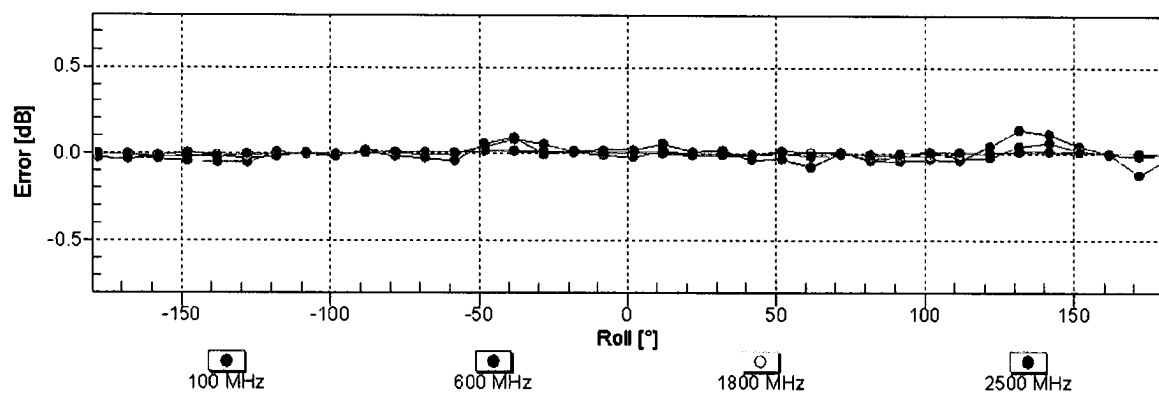
f=1800 MHz,R22

Uncertainty of Axial Isotropy Assessment:  $\pm 0.5\%$  ( $k=2$ )

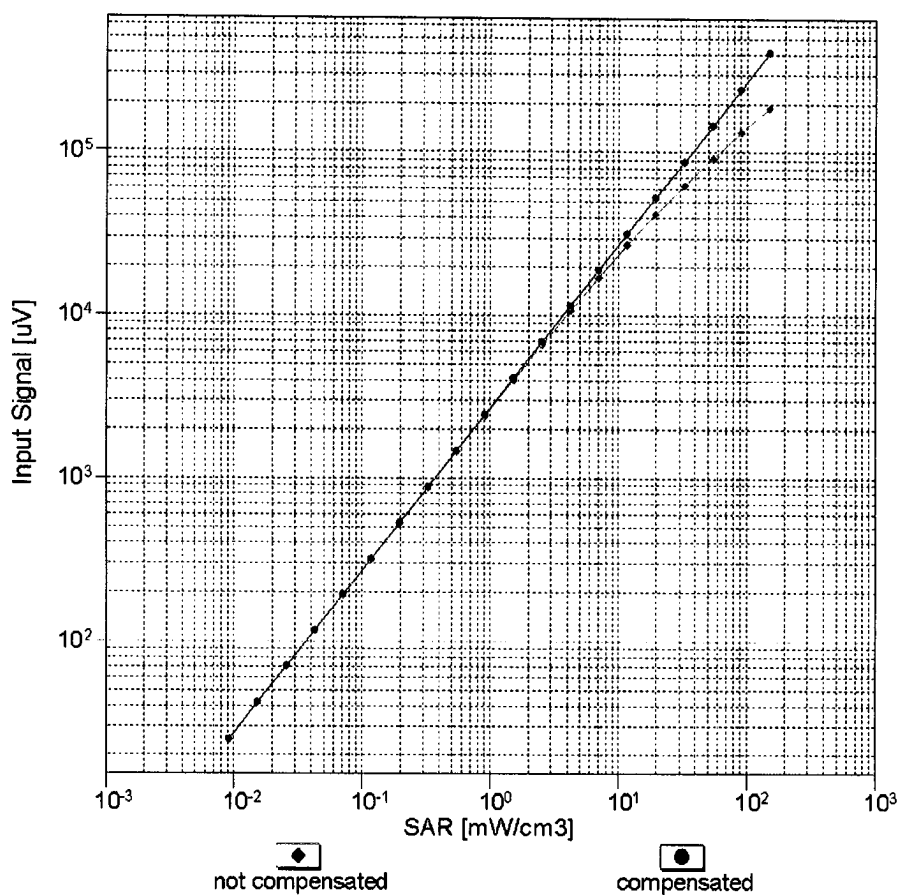
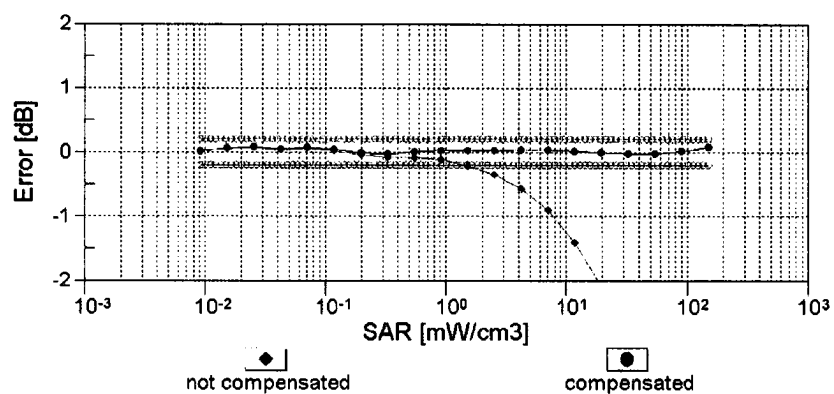
# Dynamic Range $f(\text{SAR}_{\text{head}})$ (TEM cell , $f_{\text{eval}} = 1900 \text{ MHz}$ )

Uncertainty of Linearity Assessment:  $\pm 0.6\%$  ( $k=2$ )

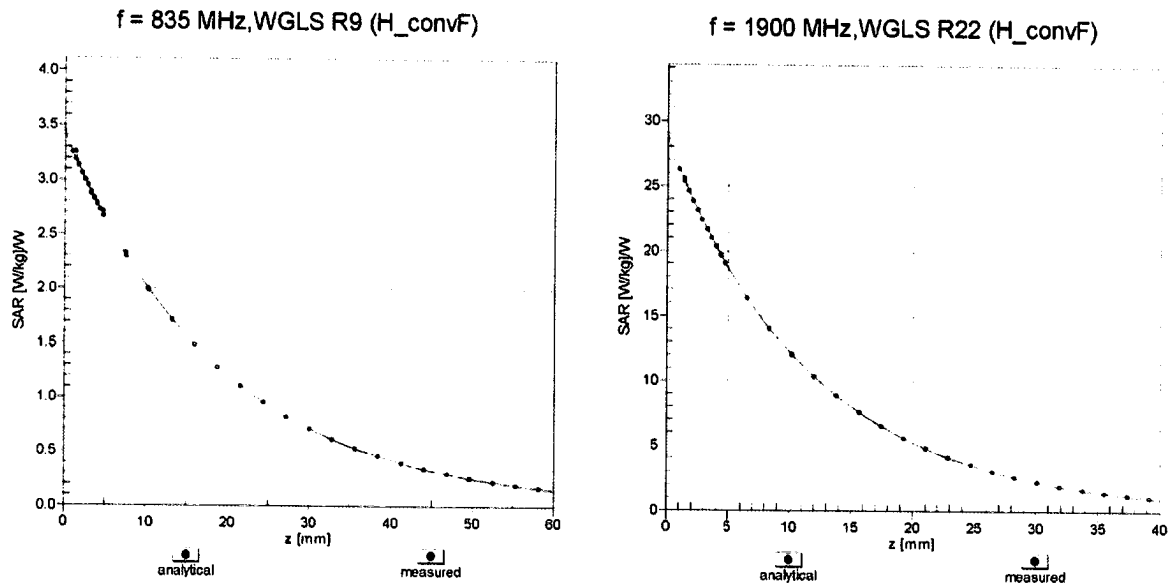
## Conversion Factor Assessment

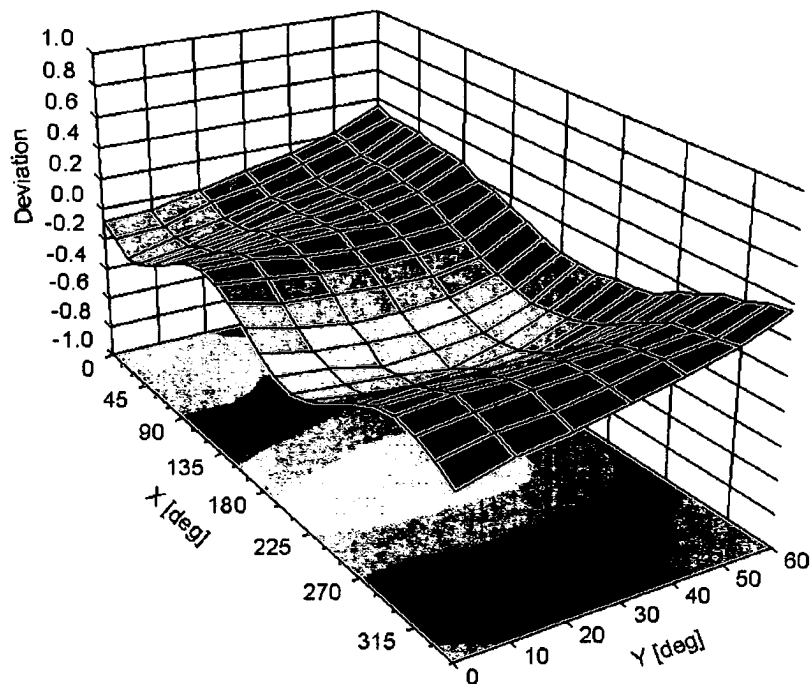
## Deviation from Isotropy in Liquid

Error ( $\phi, \theta$ ),  $f = 900 \text{ MHz}$
