## 2. BT/WIFI antenna matching optimization.

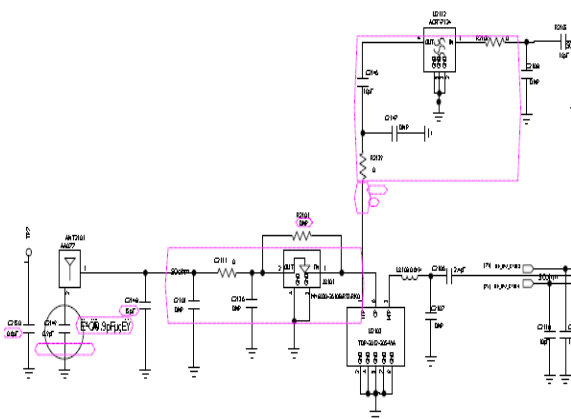
**P708-B1-BOT**

C2149 change from 0402 0.75 PF to 0402 0.9 PF;  
C2150 change from 0402 0.5 PF to 0402 DNP;  
C2148 change from 0402 9 PF to 0402 1.2NH;  
J2101 change from MM8030-2610B/RJ3/RK0 to DNP;  
R2101 change from DNP to 0201 0R.

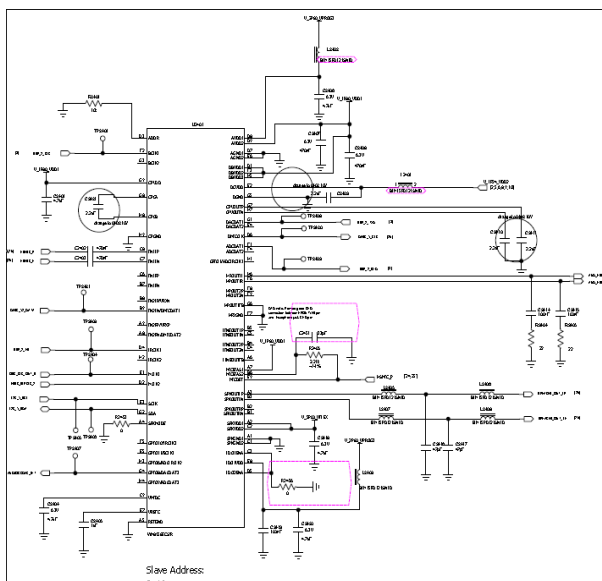
**P708-B1-BOT**

Add R2457 0R 0201 L2410;  
Delete R2456, L2401, L2402, L2409.

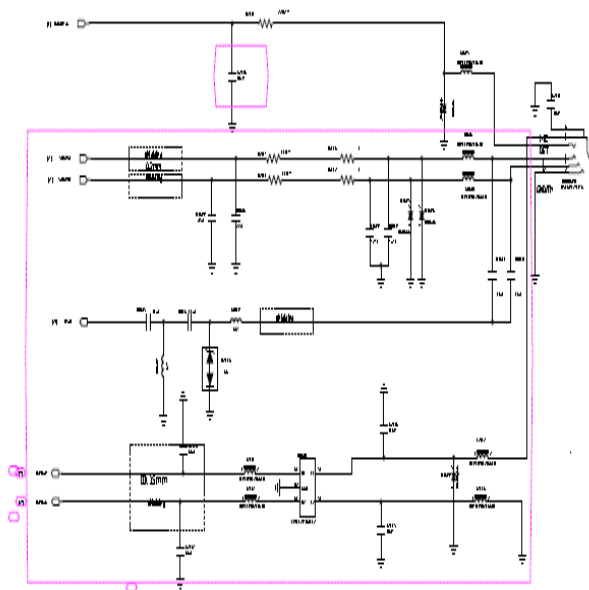
**P708-B1-BOT**

Add C2452 4.7uF 0402;  
 R2506 change from 0R 0402 to BLM15AG601SN1D;  
 R2507 change from 0R 0402 to BLM15AG601SN1D;  
 C2506 change from 0201 DNP to 0201 100nF;  
 R2504 change from 10R 0201 to 33R 0201;  
 R2505 change from 10R 0201 to 33R 0201;  
 Add C2515 33pF 0201.

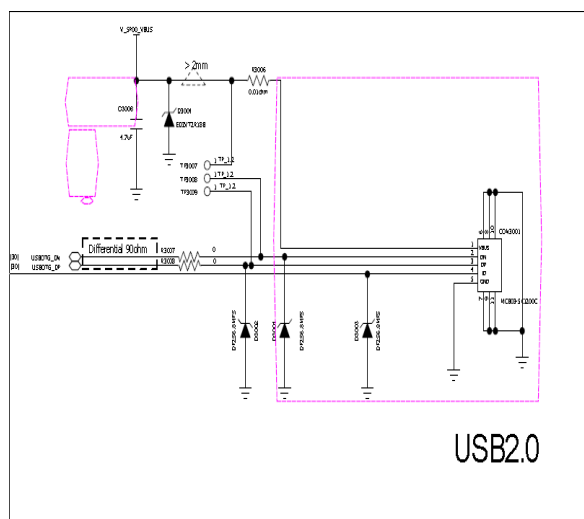
**P708-B1-BOT**

Connector changed from CON3001 MCB03-5K1200C to 3FU005S-7W200CR007.

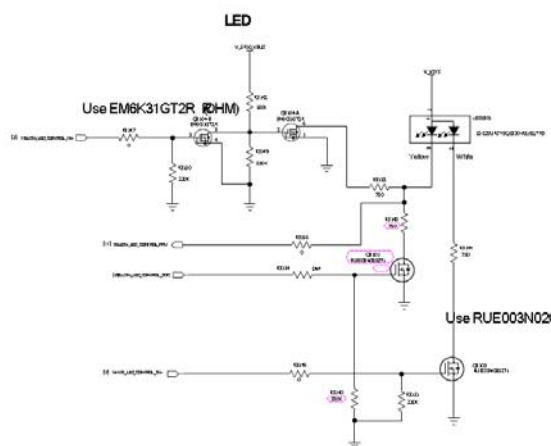
**P708-B1-BOT**

Q3101 change from RUE003N02GZTL to DNP;

R3148 change from 750 R to DNP;

R3140 change from 220K to DNP.

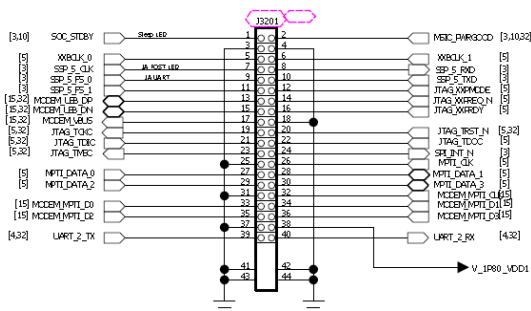
**P708-B1-BOT**

## 7. Delete Debug connector DNP J3201.

**Debug connector**

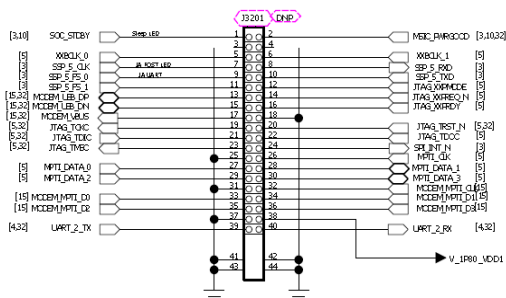
**B2**

**Debug connector**
