RE: Netgear Incorporated, FCC ID: PY3-ANT24BX

Our responses to your comments on the above referenced application, are embedded with the issues that you raised.

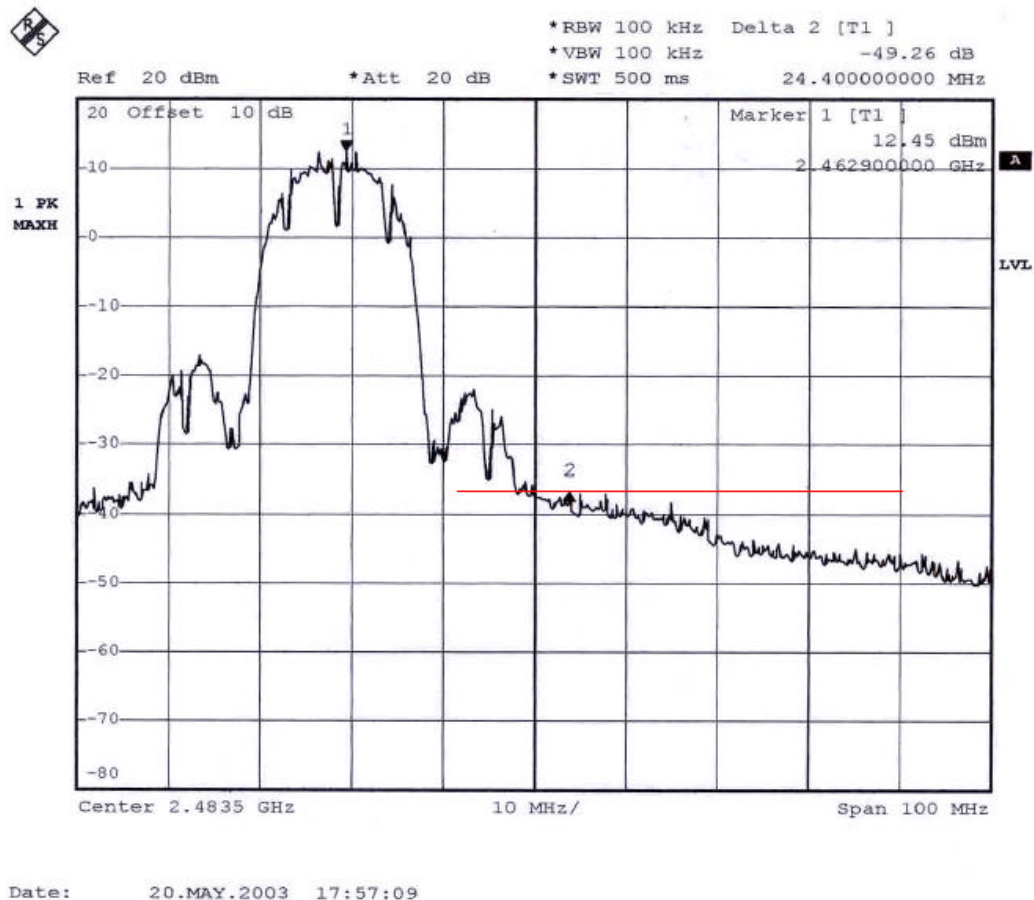
Plot2 (Channel 11) ☐

*The marker 2 is on the correct point on the graph. The tip of the marker's triangle and not the center/base of the triangle indicates the trace value. The tip is above all other out-of-band signals*
