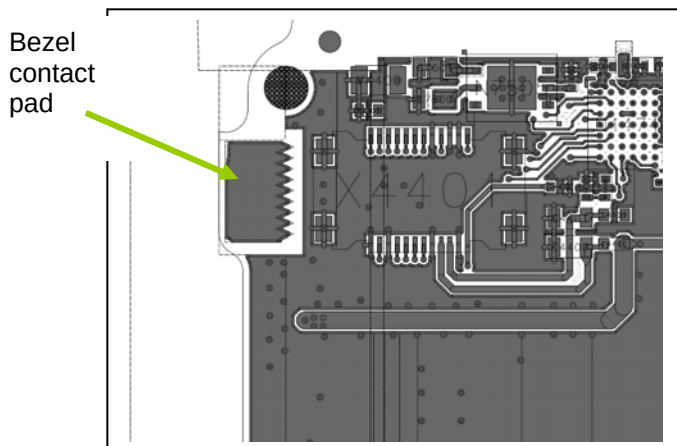
Prior to change, the A-cover bezel was not grounded. Satisfactory ESD performance was achieved by connecting the bezel through a spring on the A-cover, to a clip on the UI frame and then to the Bezel contact pad on the main pwb as shown in Figure 1. A spark gap was implemented on the pwb as shown in Figure 1 below

Figure 1 – Ungrounded Pad

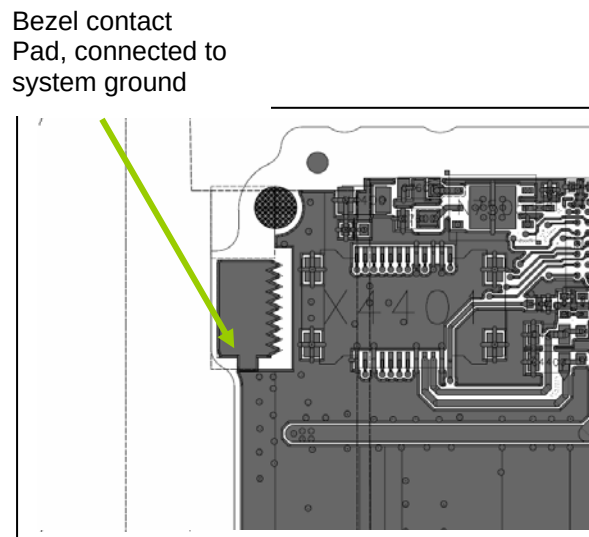
With the new PWB this spark gap has been shorted as shown in Figure 2. This is a copper only change; no component values have been changed.

Figure 2 – Grounded Pad
