## TEST REPORT

Report No.: HCD0137A/2009

Product Description: GPS Antenna  
Style/ Item No.: AGGRESSOR-111-C/ No.1, No.2  
Manufacturer/Vendor: Alltek Technology Corp.  
Country of Origin: Taiwan  
Quantity: Total 2 pieces  
Testing Period: Jan. 12, 2010 to Jan. 18, 2010  
Note: (Client's declaration) H/W: M-PCB-AISPF03P51, M-PCB-AISCTL01P52;  
S/W: Version 1.0

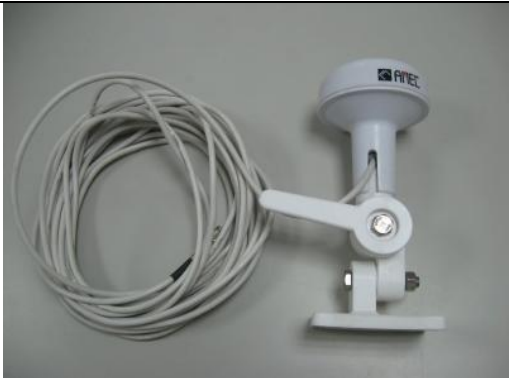
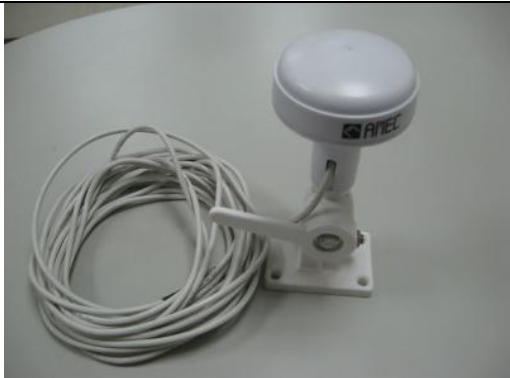
| 1. Appearance of specimen:<br>AGGRESSOR-111-C | 2. Appearance of specimen:<br>AGGRESSOR-111-C |

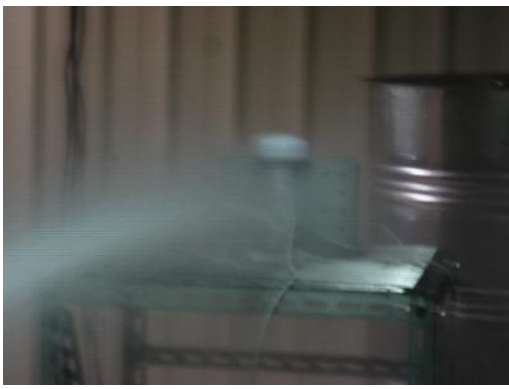
| 3. Test for protection against water | 4. Test for protection against water |

Lab Environmental Conditions:Ambient temperature: 25±3°CRelative humidity: 55±20%RHTest Method/ Specification:Test method: According to IEC 60529 Edition 2.1: 2001-02--IPX6Sample condition: Non-operatingTest means: Spraying the enclosure from all practicable directions with a stream of water from a standard test nozzle as specified in test standard.

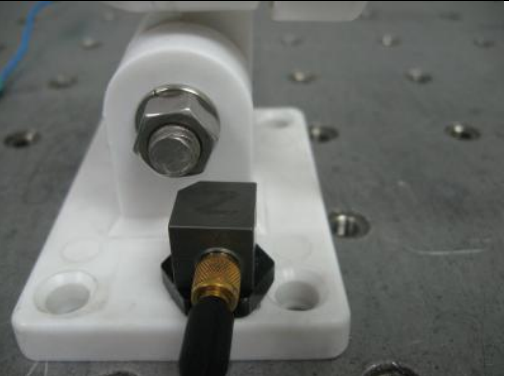
| 5. Location of measuring accelerometer | 6. Mechanical Shock test: -Z axis |
