# Cisco Firmware Upgrade Guide for 4G LTE and 5G Cellular Modems

This guide provides information about upgrading Cisco 4G LTE and 5G cellular modem firmware on Cisco routers and cellular gateways.

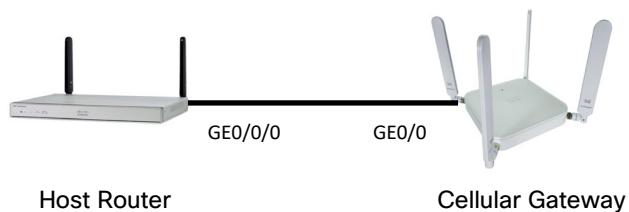
### Topology:

**Note:** The following examples are used with 17.06.01a version on CG418-E cellular gateway.
