## Band Edge

## Conducted RF Spurious Emission

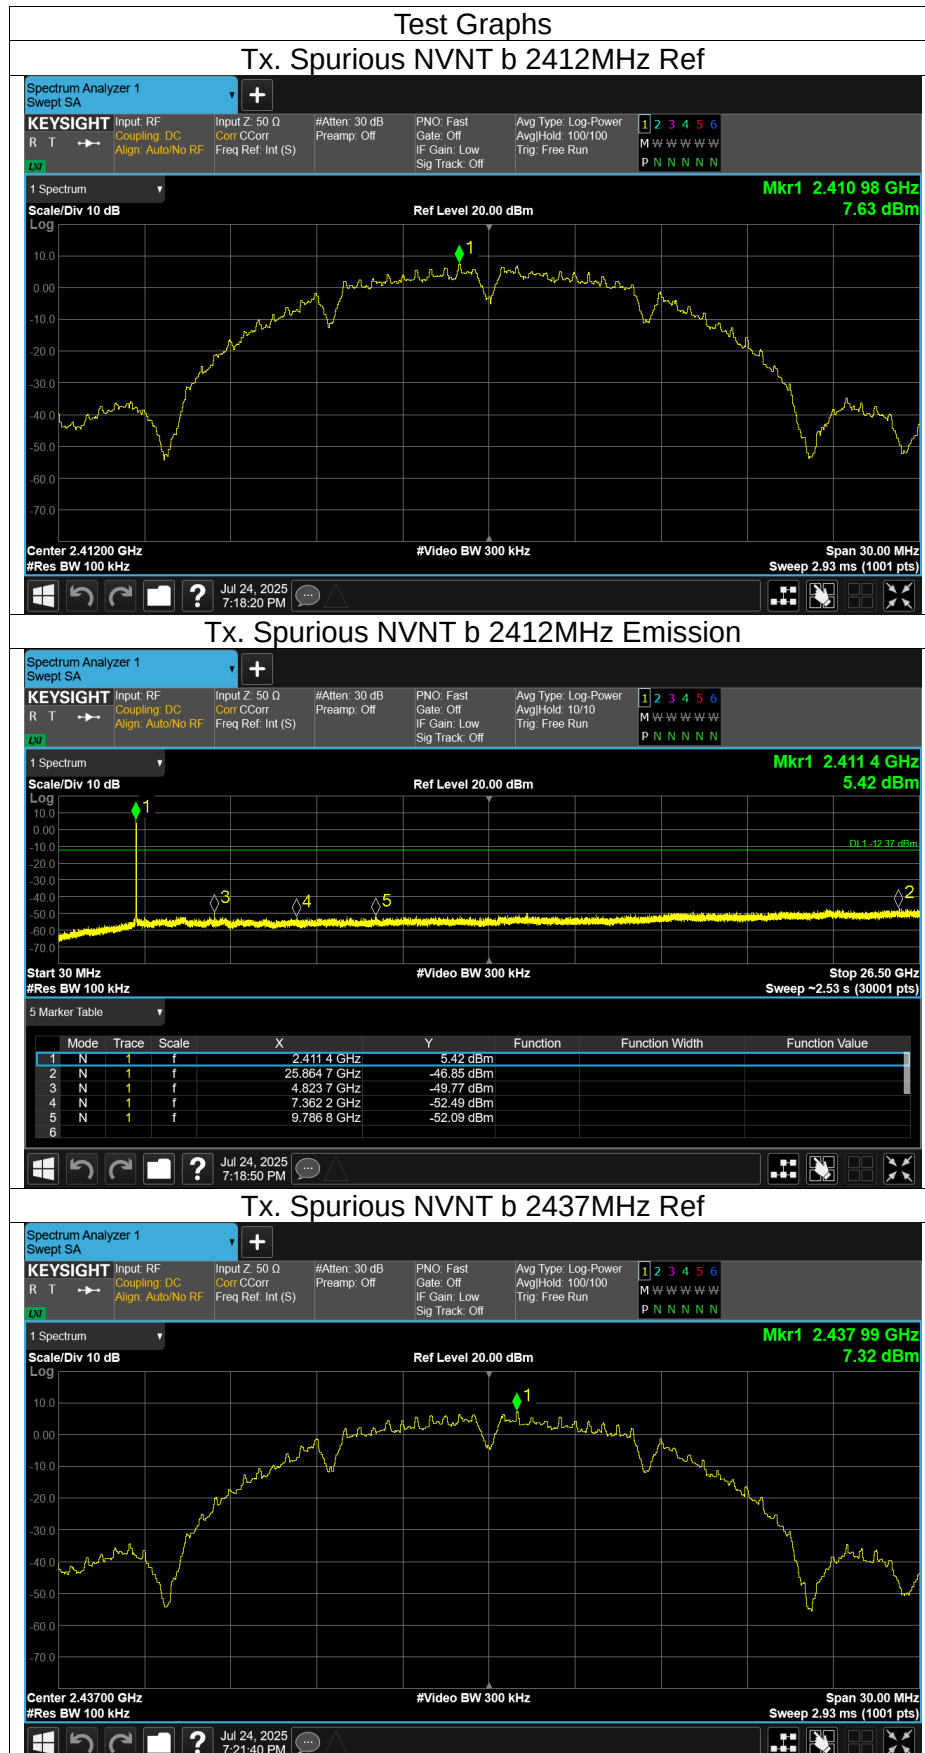
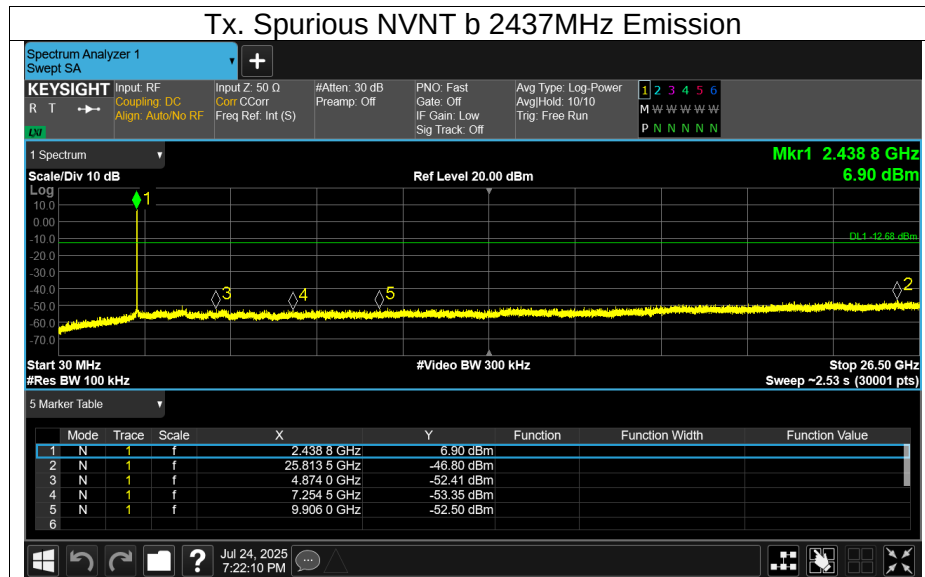
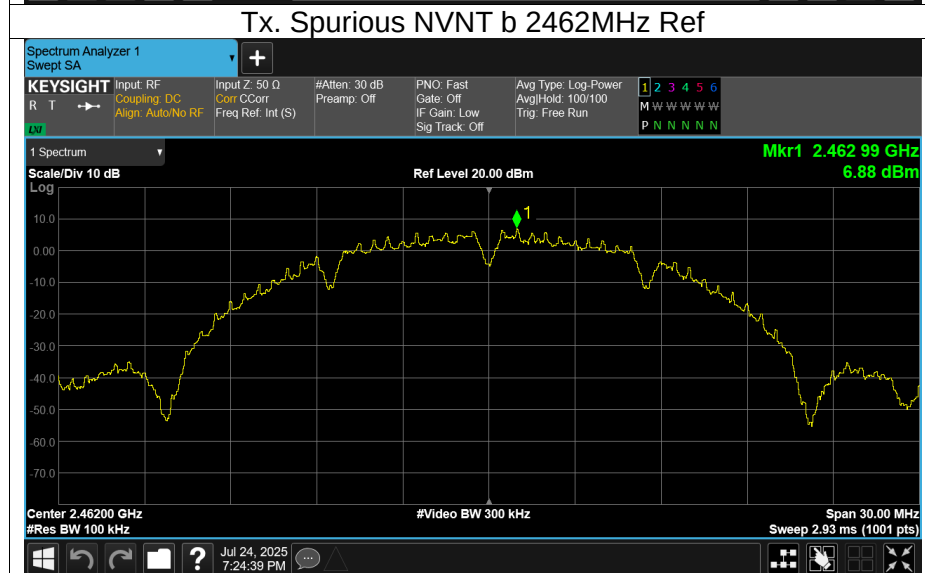
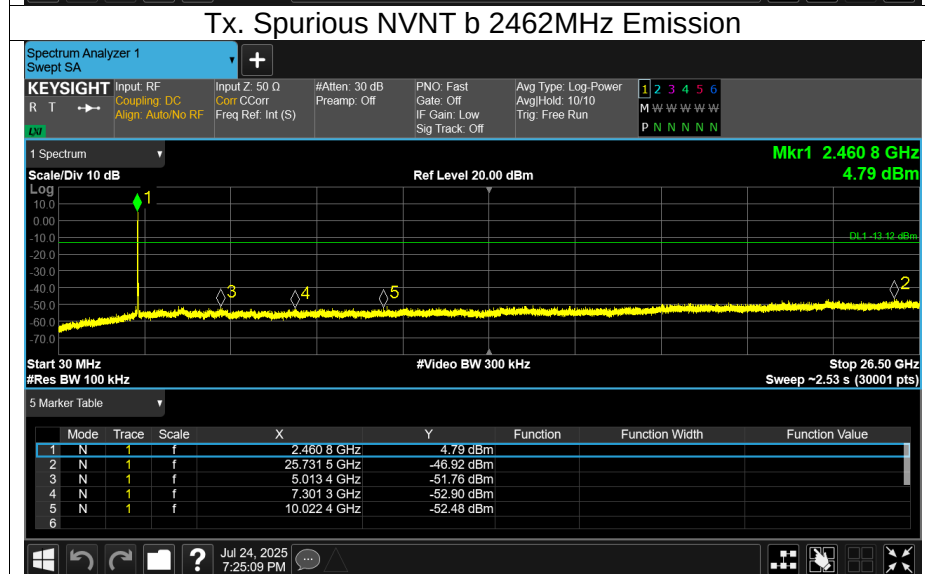
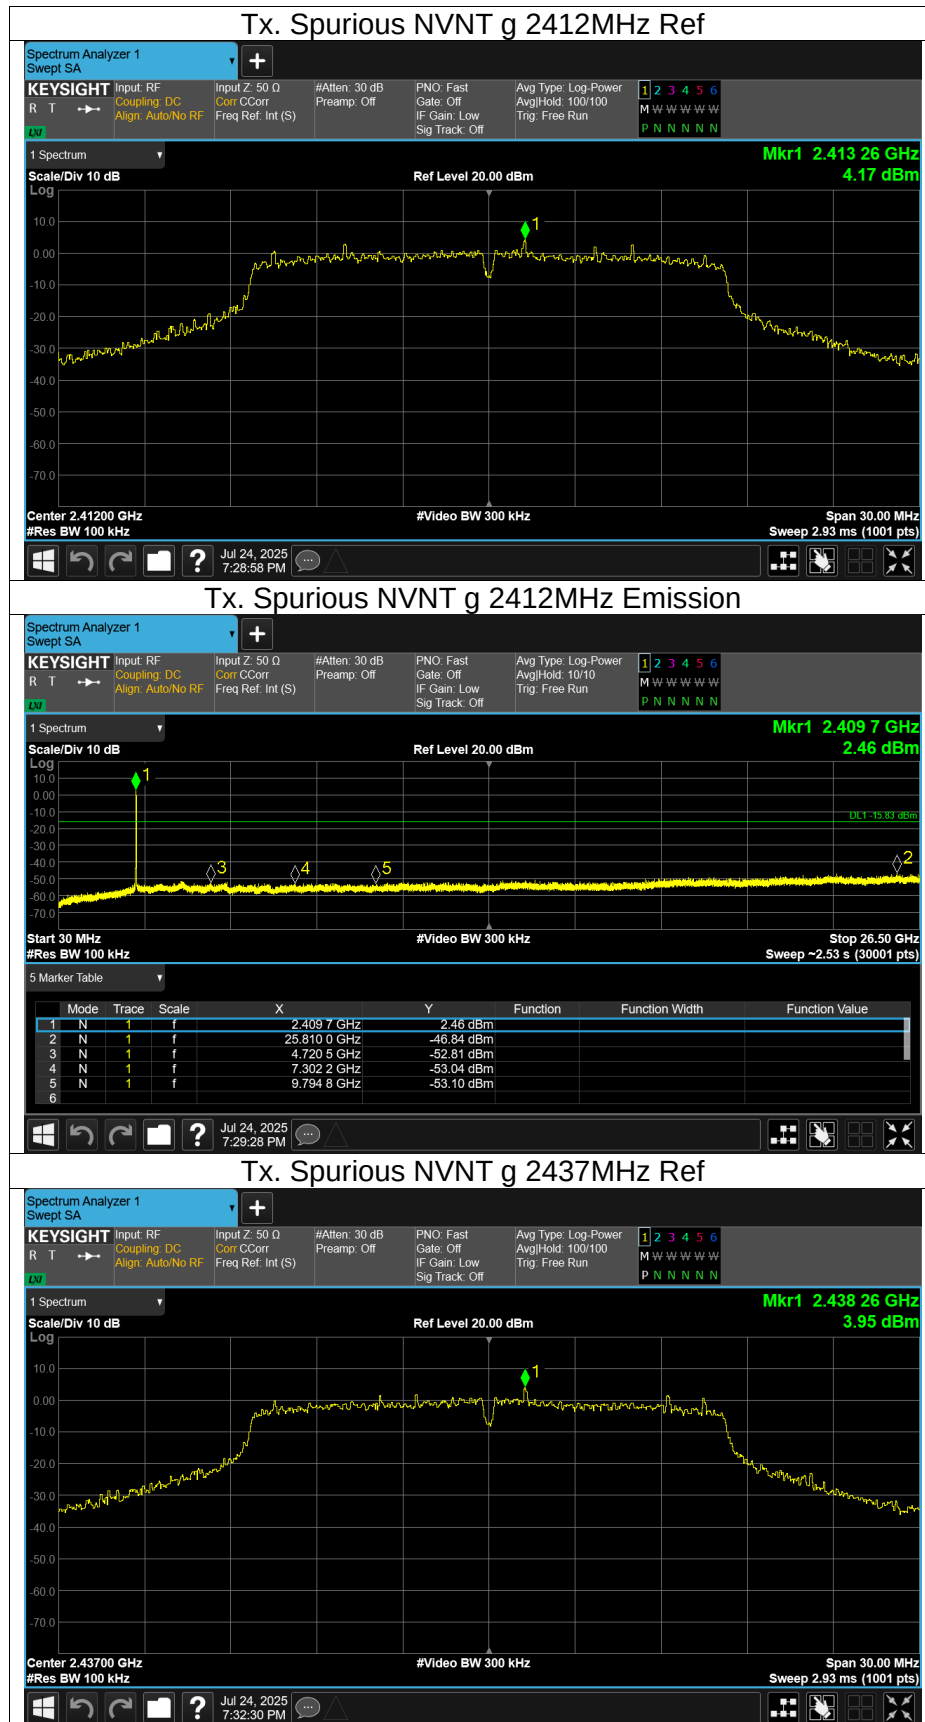
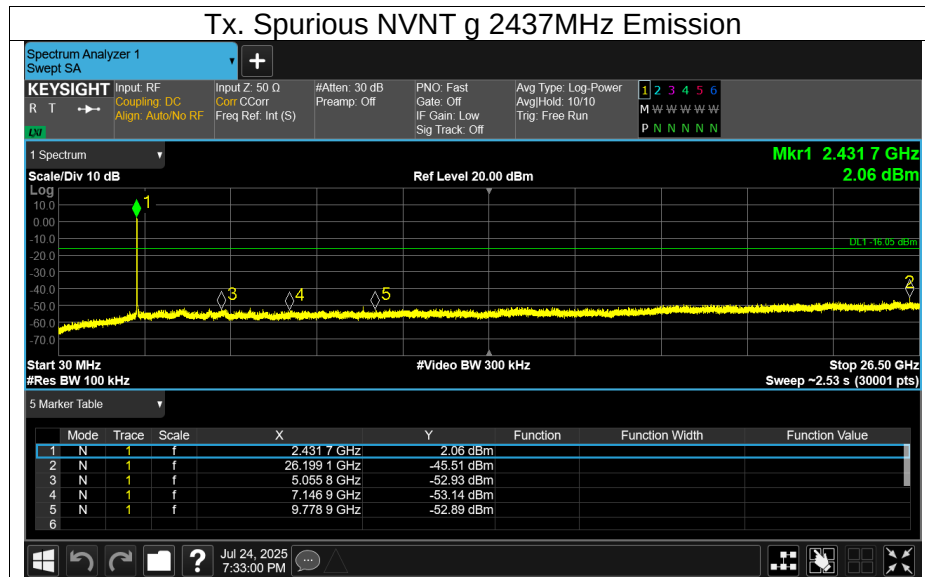
| Condition | Mode | Frequency (MHz) | Max Value (dBc) | Limit (dBc) | Verdict |
| NVNT | b | 2412 | -54.47 | -20 | Pass |
| NVNT | b | 2437 | -54.11 | -20 | Pass |
| NVNT | b | 2462 | -53.8 | -20 | Pass |
| NVNT | g | 2412 | -51.01 | -20 | Pass |
| NVNT | g | 2437 | -49.46 | -20 | Pass |
| NVNT | g | 2462 | -49.95 | -20 | Pass |
| NVNT | n20 | 2412 | -50.29 | -20 | Pass |
| NVNT | n20 | 2437 | -49.64 | -20 | Pass |
| NVNT | n20 | 2462 | -51.86 | -20 | Pass |
| NVNT | n40 | 2422 | -45.14 | -20 | Pass |
| NVNT | n40 | 2437 | -45.85 | -20 | Pass |
| NVNT | n40 | 2452 | -46.21 | -20 | Pass |
| NVNT | ax20 | 2412 | -49.91 | -20 | Pass |
| NVNT | ax20 | 2437 | -50.91 | -20 | Pass |
| NVNT | ax20 | 2462 | -48.28 | -20 | Pass |
| NVNT | ax40 | 2422 | -46.56 | -20 | Pass |
| NVNT | ax40 | 2437 | -46.28 | -20 | Pass |
| NVNT | ax40 | 2452 | -44.52 | -20 | Pass |
