## 7.6 Conducted RF Spurious Emission

## Appendix B: photographs of test setup

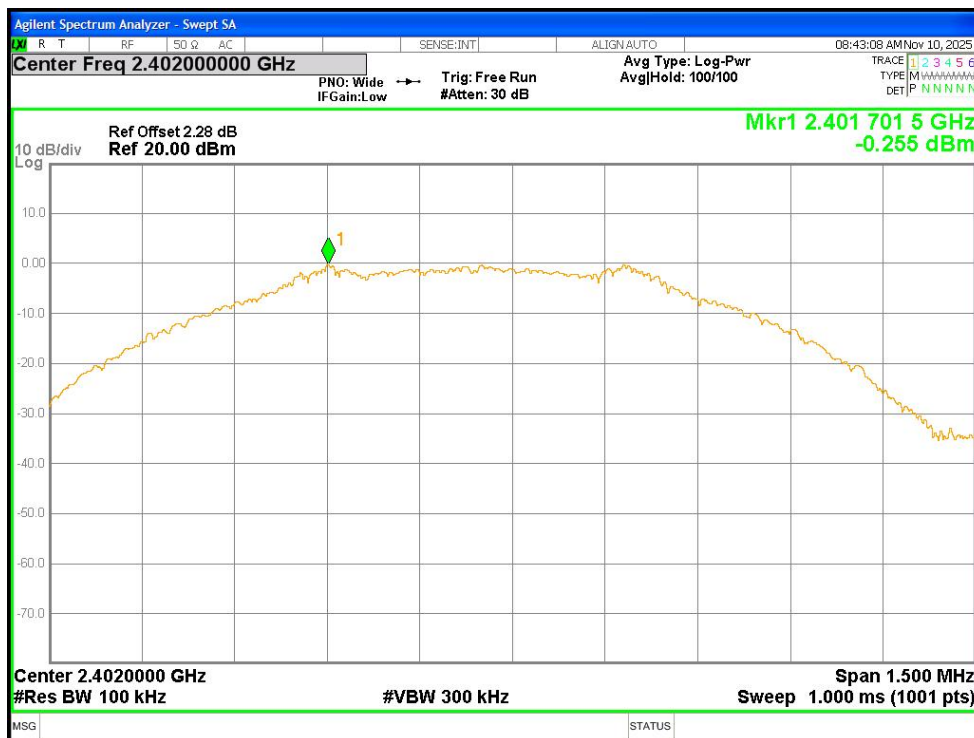
Tx. Spurious NVNT BLE 1M 2402MHz Ant1 Ref

| Condition | Mode | Frequency (MHz) | Antenna | Max Value (dBc) | Limit (dBc) | Verdict |
|---|---|---|---|---|---|---|
| NVNT | BLE 1M | 2402 | Ant1 | -45.41 | -20 | Pass |

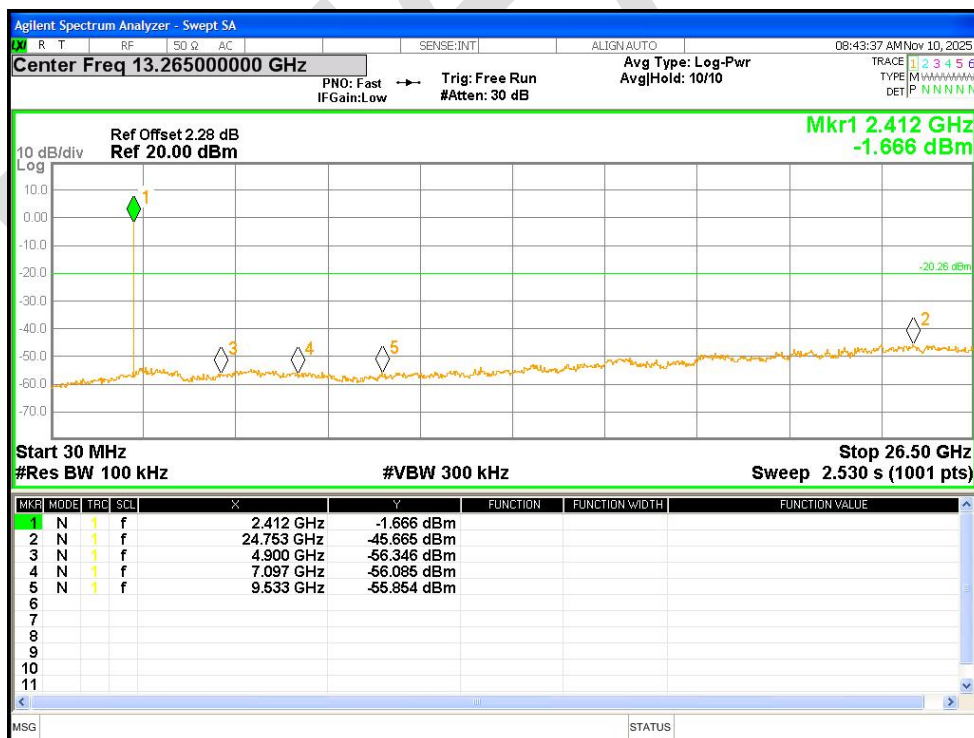
Tx. Spurious NVNT BLE 1M 2402MHz Ant1 Emission

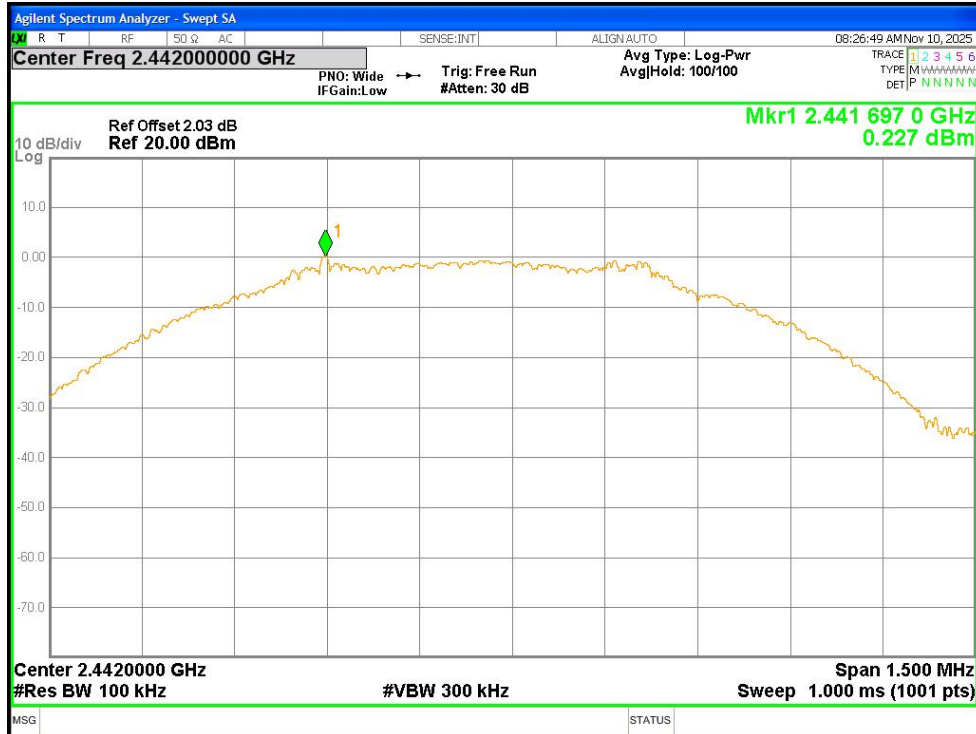
Tx. Spurious NVNT BLE 1M 2442MHz Ant1 Ref

| Condition | Mode | Frequency (MHz) | Antenna | Max Value (dBc) | Limit (dBc) | Verdict |
|---|---|---|---|---|---|---|
| NVNT | BLE 1M | 2442 | Ant1 | -45.84 | -20 | Pass |

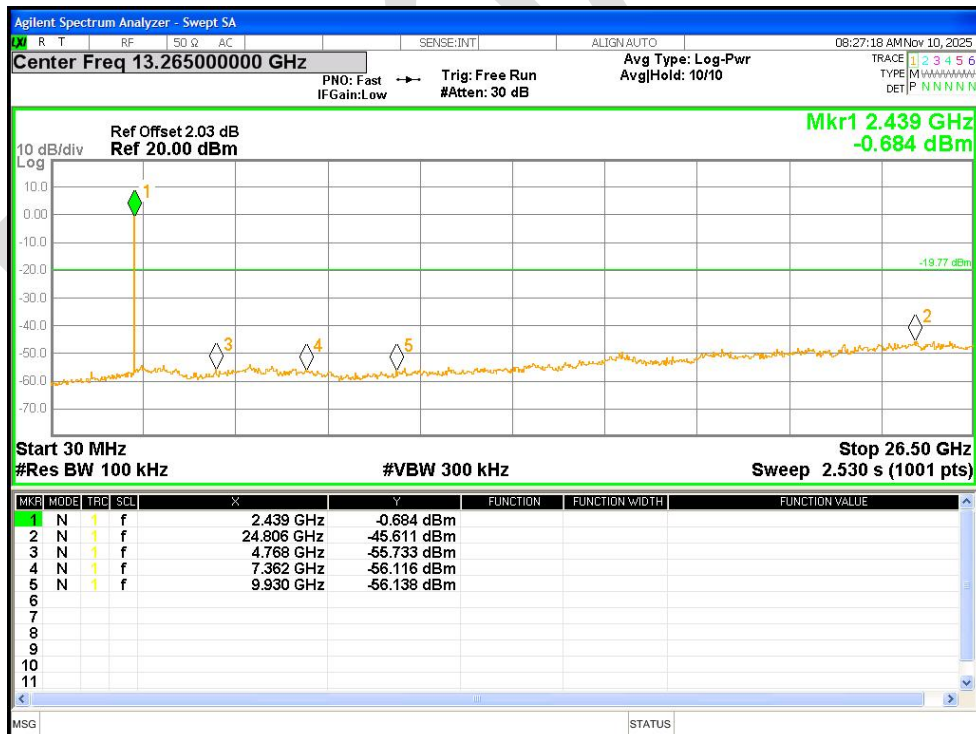
Tx. Spurious NVNT BLE 1M 2442MHz Ant1 Emission

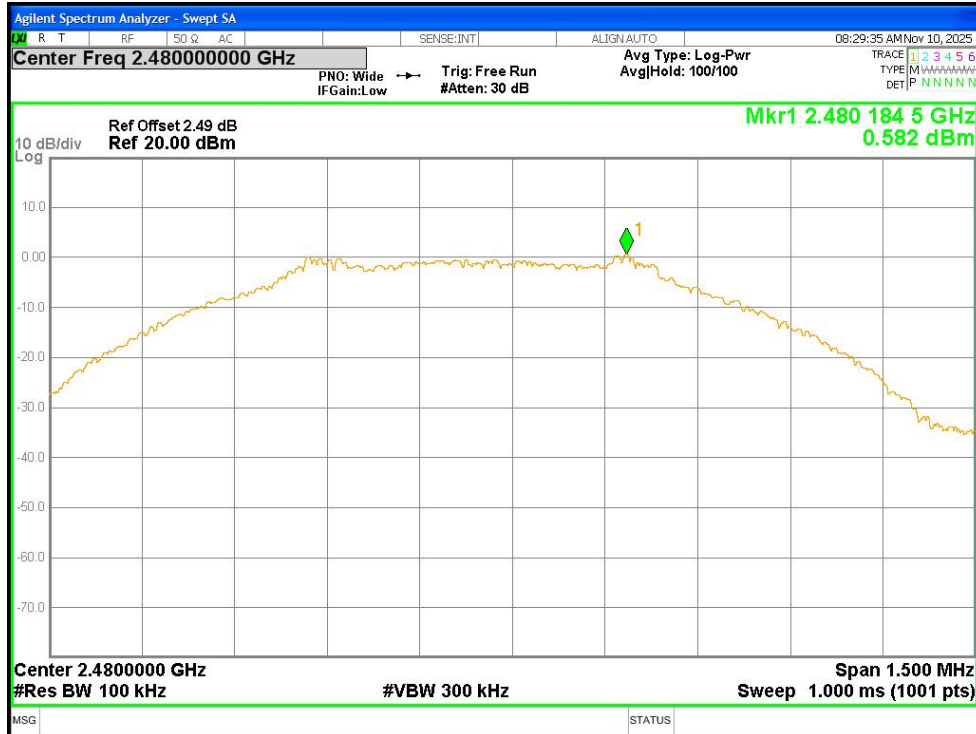
Tx. Spurious NVNT BLE 1M 2480MHz Ant1 Ref

| Condition | Mode | Frequency (MHz) | Antenna | Max Value (dBc) | Limit (dBc) | Verdict |
|---|---|---|---|---|---|---|
| NVNT | BLE 1M | 2480 | Ant1 | -45.73 | -20 | Pass |

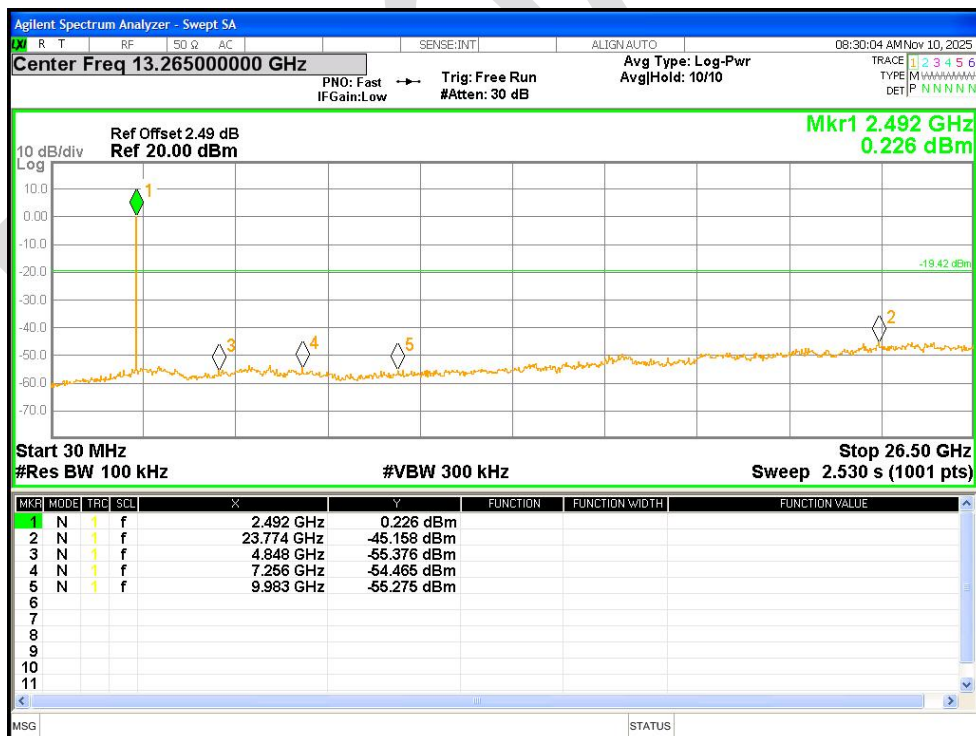
Tx. Spurious NVNT BLE 1M 2480MHz Ant1 Emission

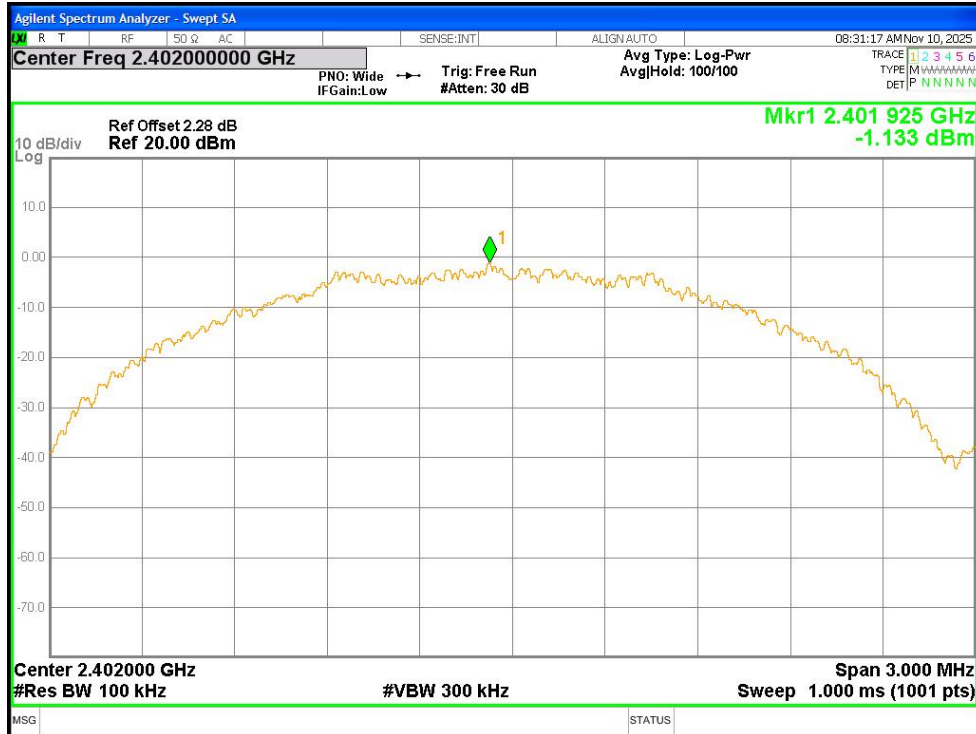
Tx. Spurious NVNT BLE 2M 2402MHz Ant1 Ref

| Condition | Mode | Frequency (MHz) | Antenna | Max Value (dBc) | Limit (dBc) | Verdict |
|---|---|---|---|---|---|---|
| NVNT | BLE 2M | 2402 | Ant1 | -44.59 | -20 | Pass |

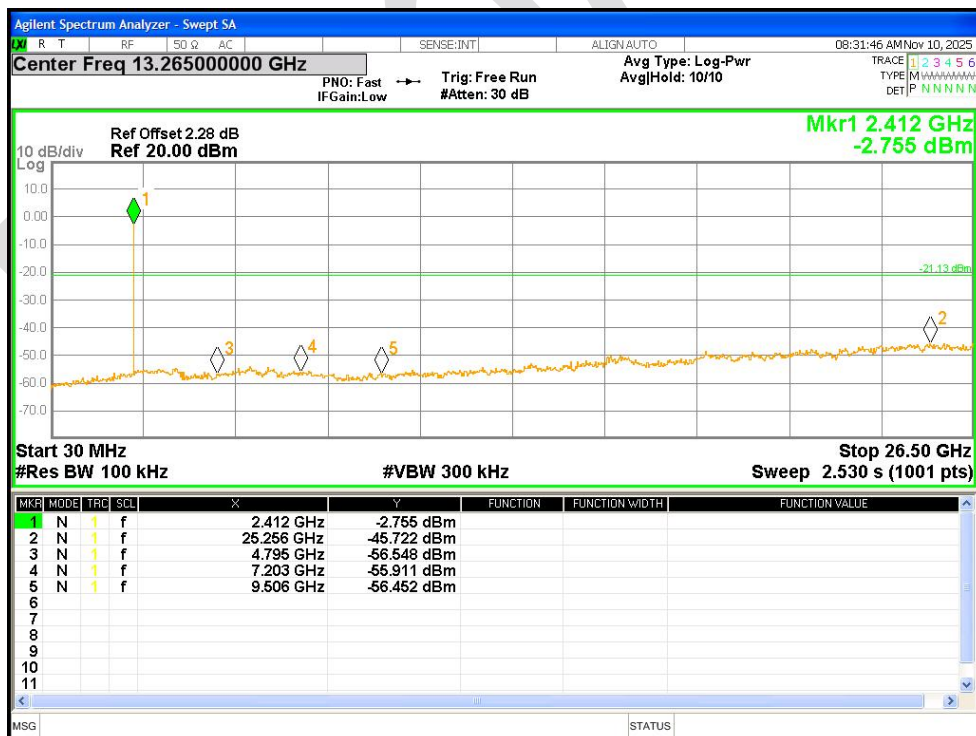
Tx. Spurious NVNT BLE 2M 2402MHz Ant1 Emission

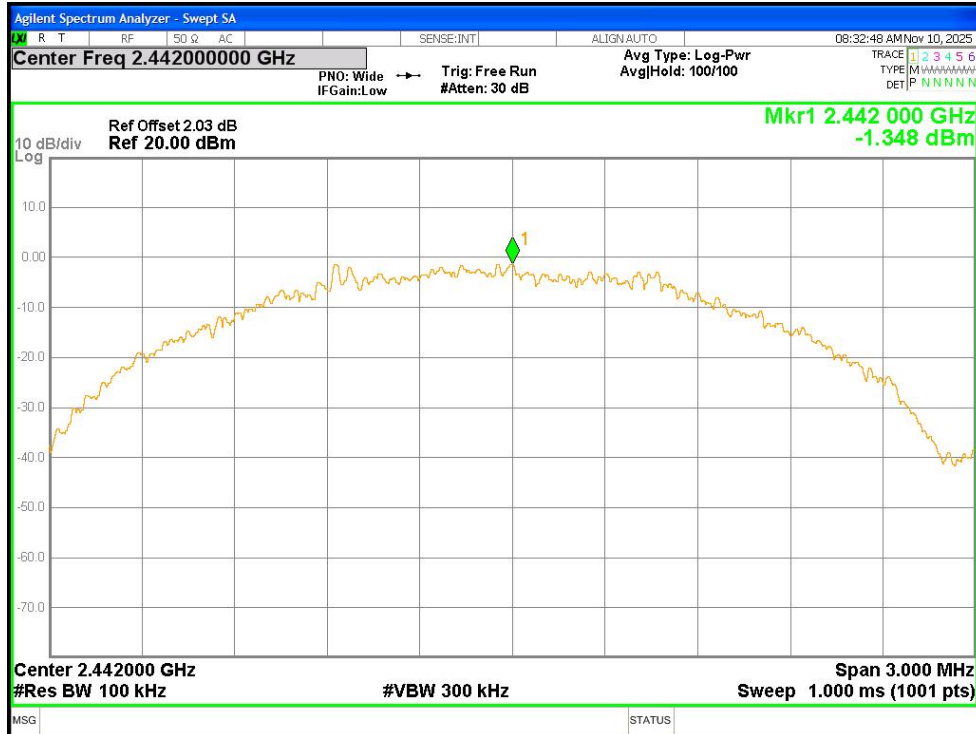
Tx. Spurious NVNT BLE 2M 2442MHz Ant1 Ref

| Condition | Mode | Frequency (MHz) | Antenna | Max Value (dBc) | Limit (dBc) | Verdict |
|---|---|---|---|---|---|---|
| NVNT | BLE 2M | 2442 | Ant1 | -44.14 | -20 | Pass |

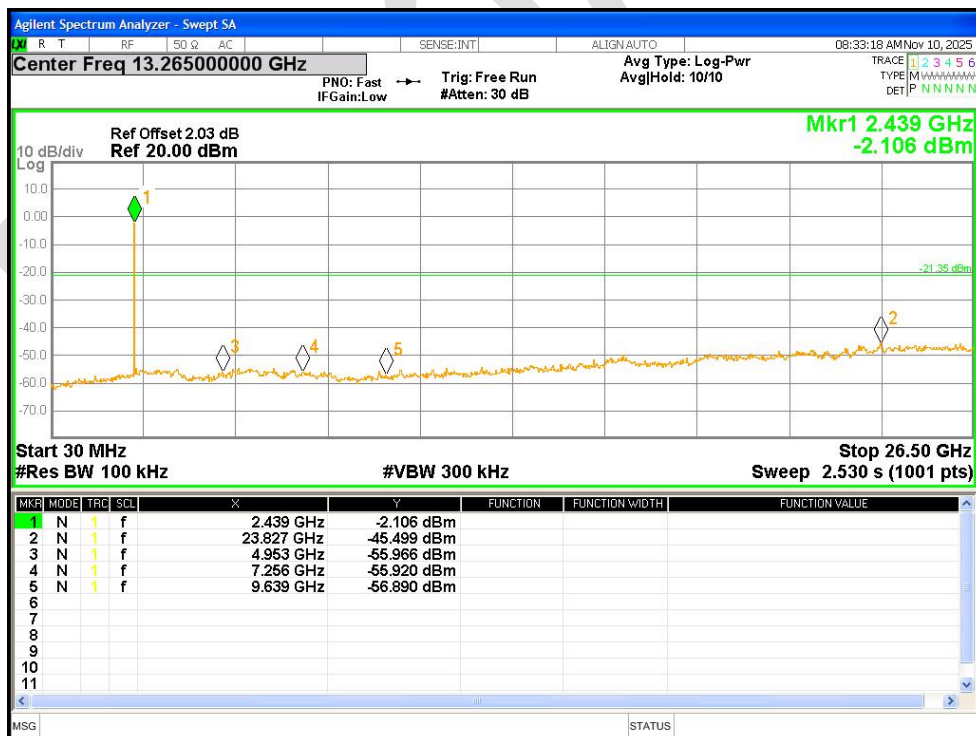
Tx. Spurious NVNT BLE 2M 2442MHz Ant1 Emission

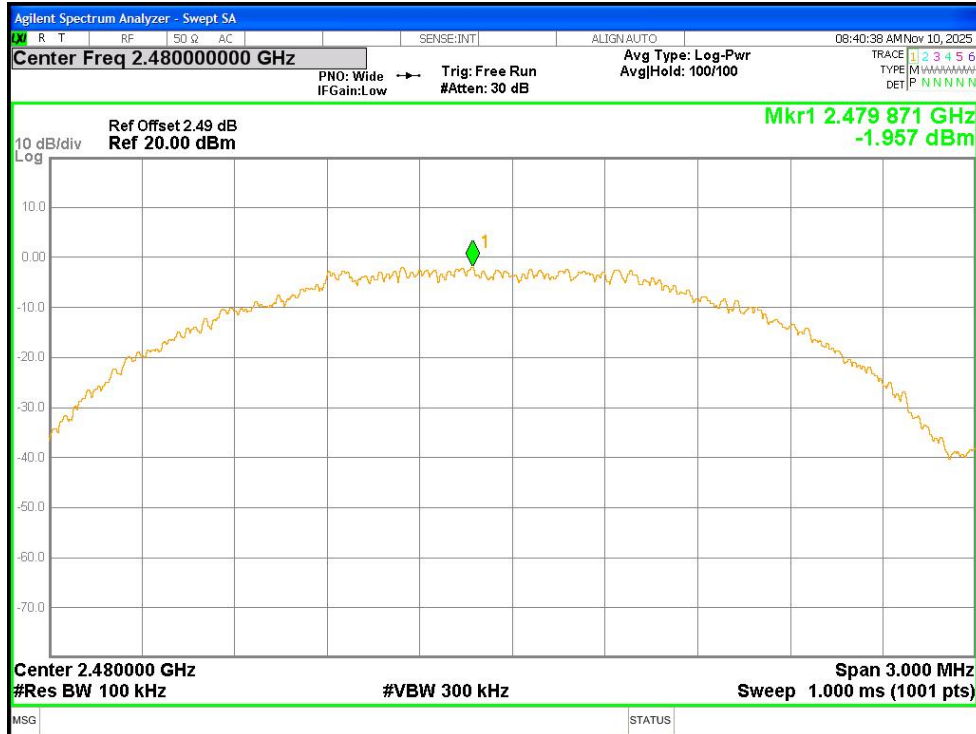
Tx. Spurious NVNT BLE 2M 2480MHz Ant1 Ref

| Condition | Mode | Frequency (MHz) | Antenna | Max Value (dBc) | Limit (dBc) | Verdict |
|---|---|---|---|---|---|---|
| NVNT | BLE 2M | 2480 | Ant1 | -43.29 | -20 | Pass |

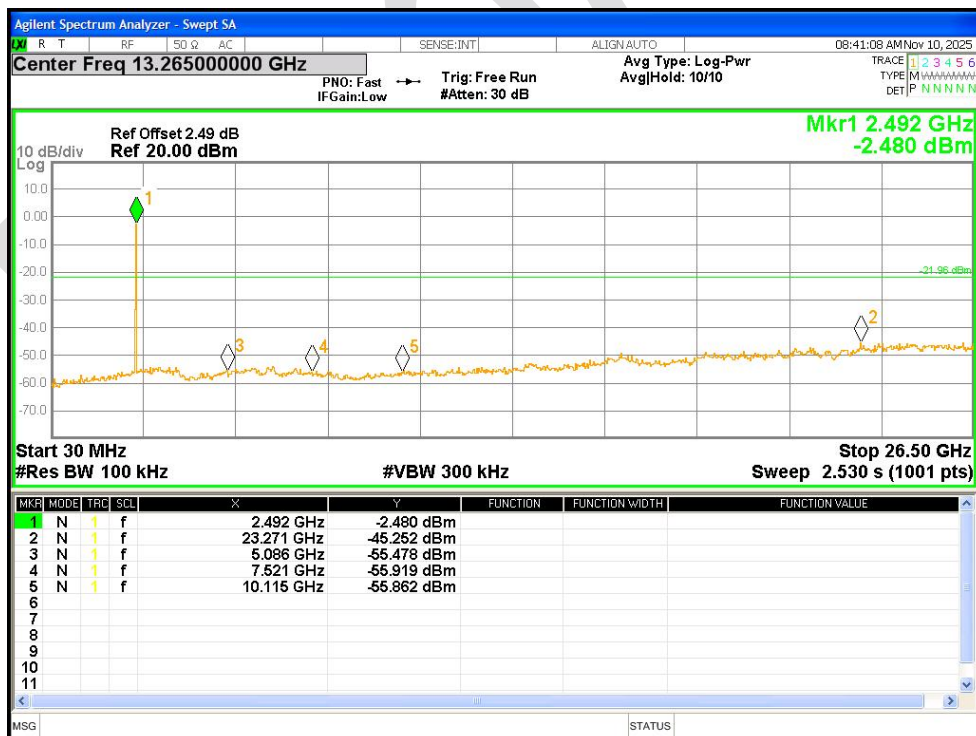
Tx. Spurious NVNT BLE 2M 2480MHz Ant1 Emission

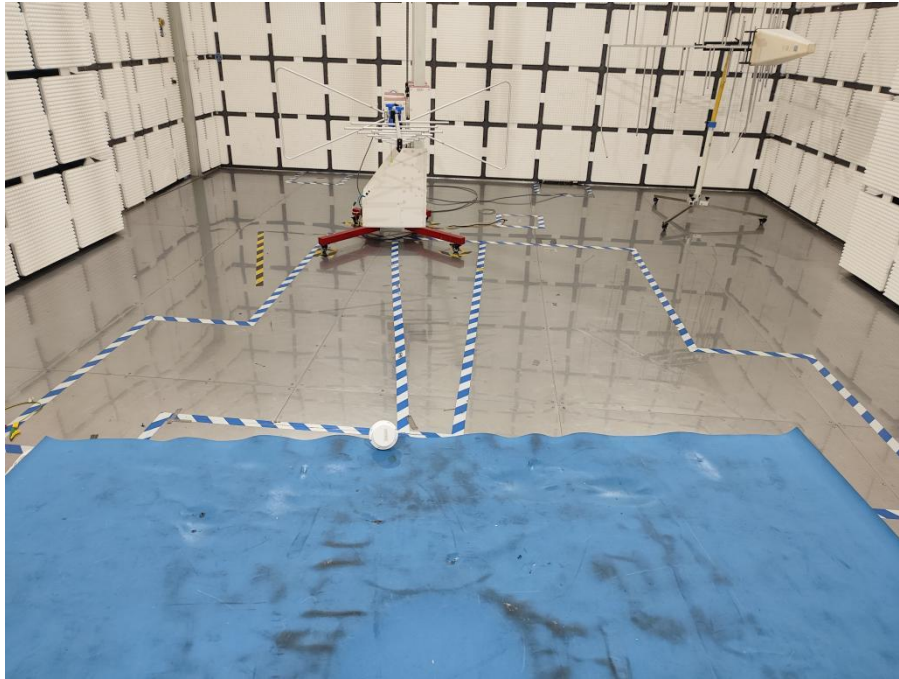
Radiated Emissions (30MHz-1GHz)

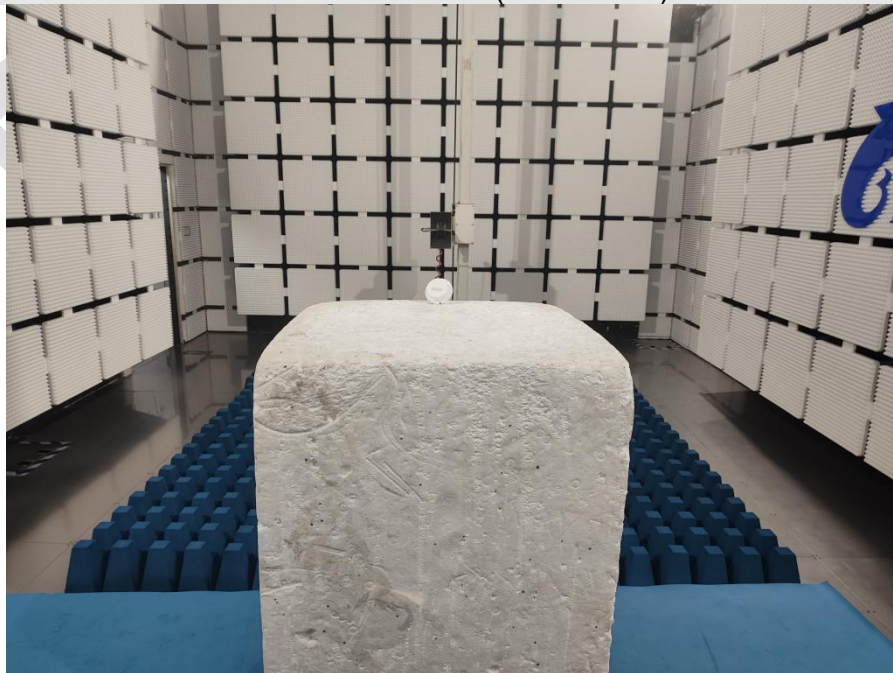
Radiated Emissions (above 1GHz)
