## Radiated Emission Measurement

Condition : FCC\_part 15 RE-Class C\_30-1000MHz

EUT : W6M22201-21487

Test Mode : TX 802.11b CH1

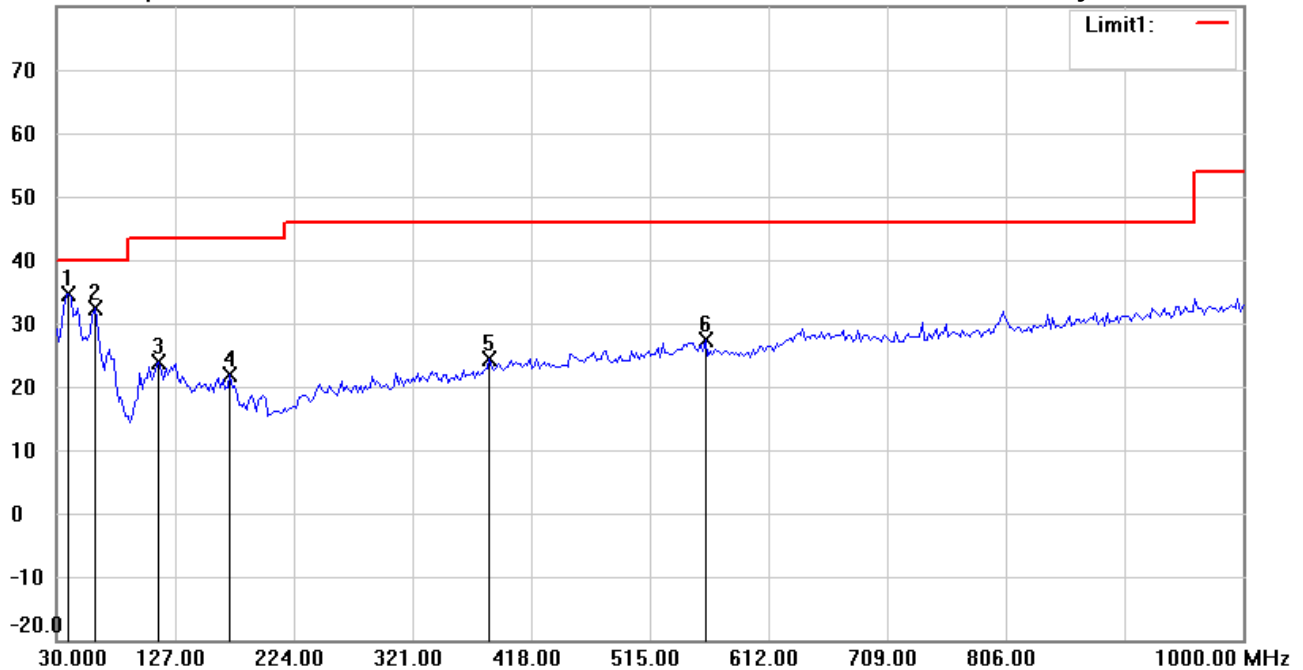
Condition : FCC\_part 15 RE-Class C\_30-1000MHz

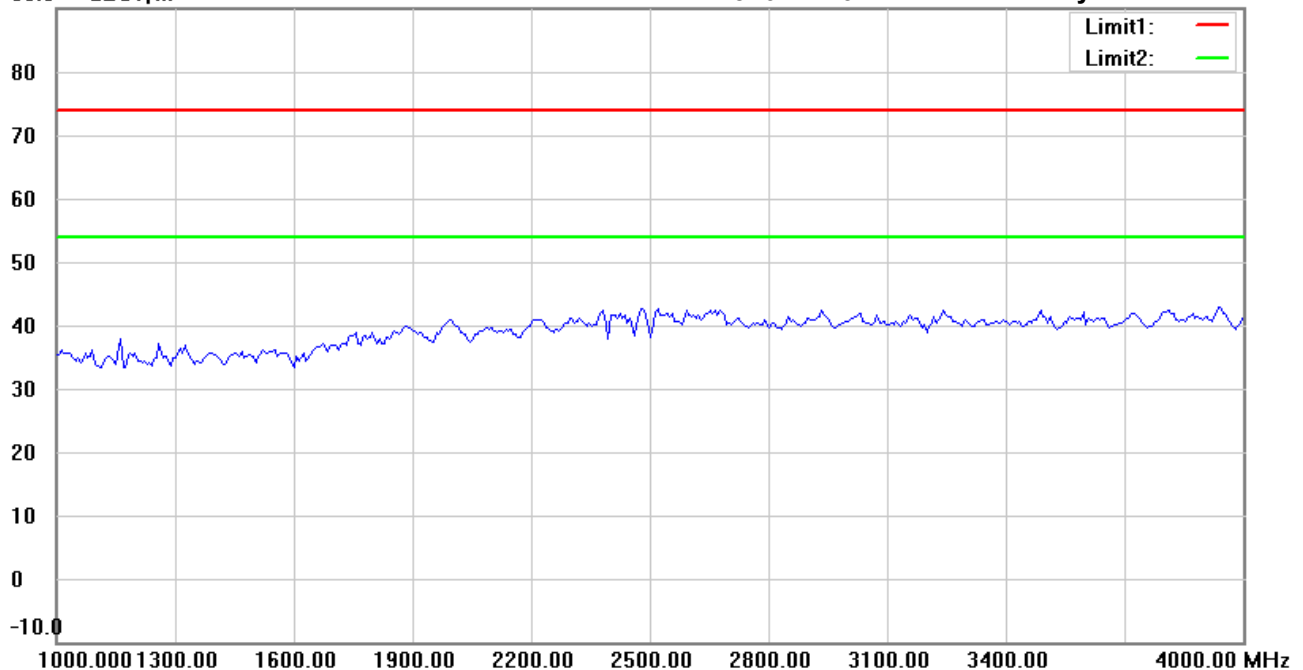
Condition : FCC\_part 15 RE-Class C\_Above 1GHz\_PK

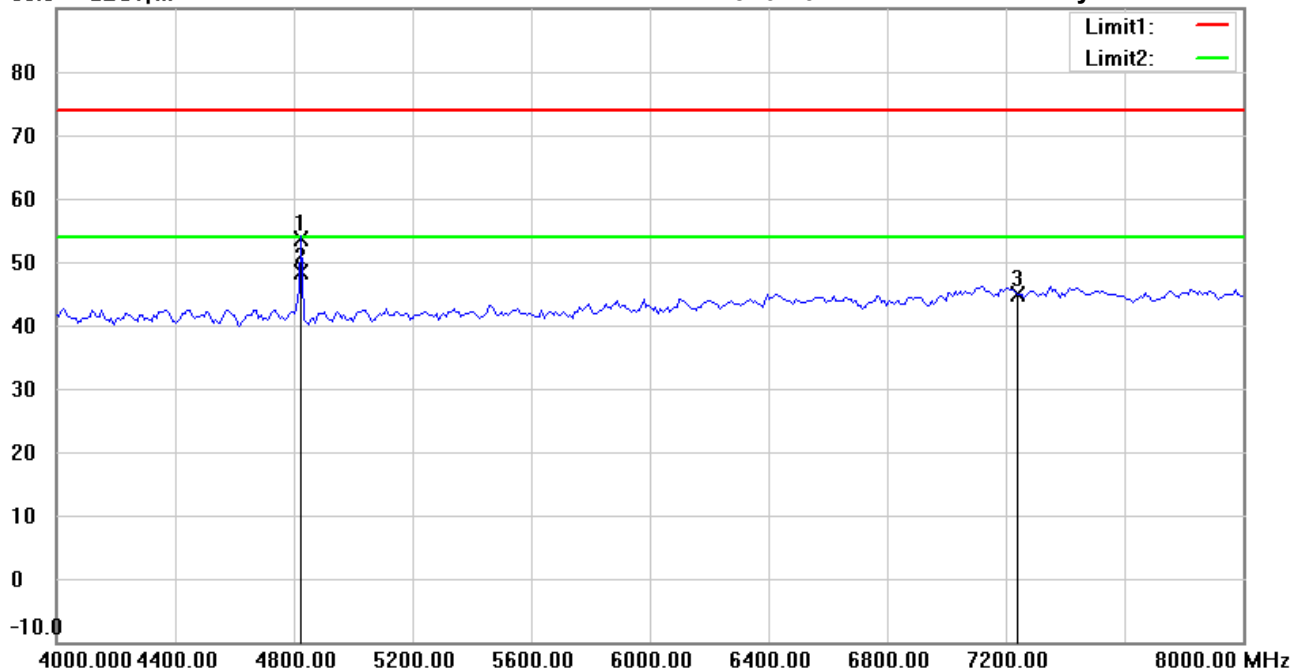
Condition : FCC\_part 15 RE-Class C\_Above 1GHz\_PK

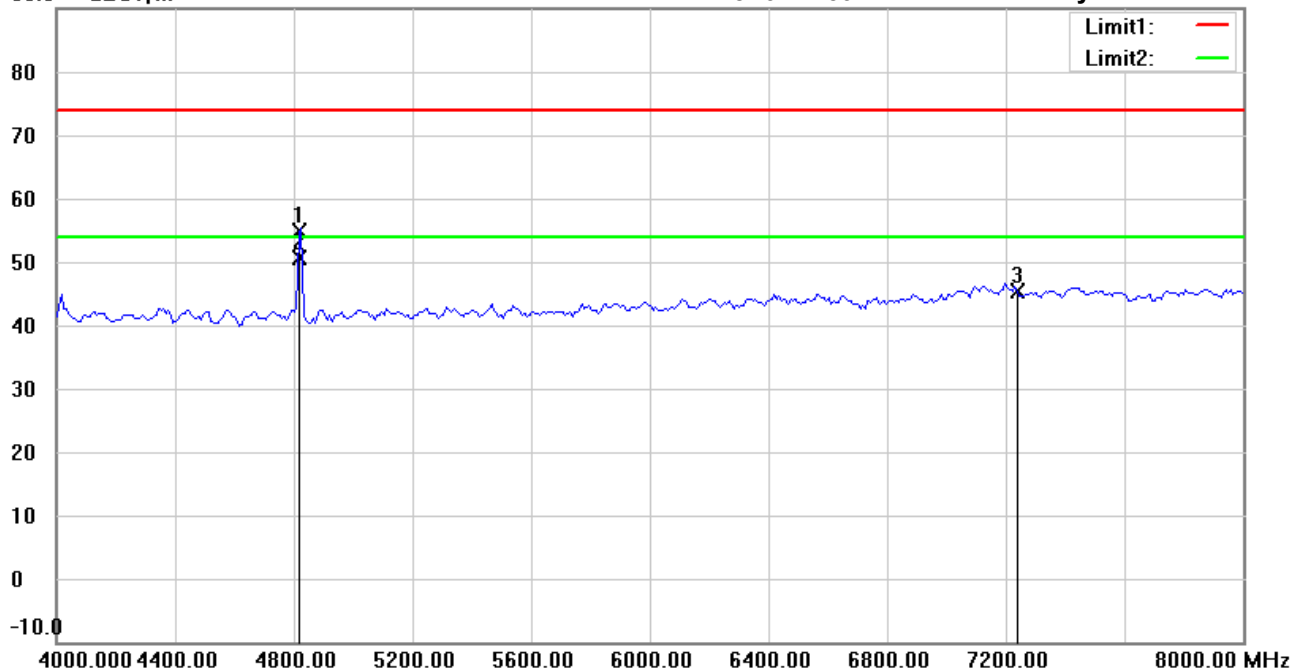
Condition : FCC\_part 15 RE-Class C\_Above 1GHz\_PK

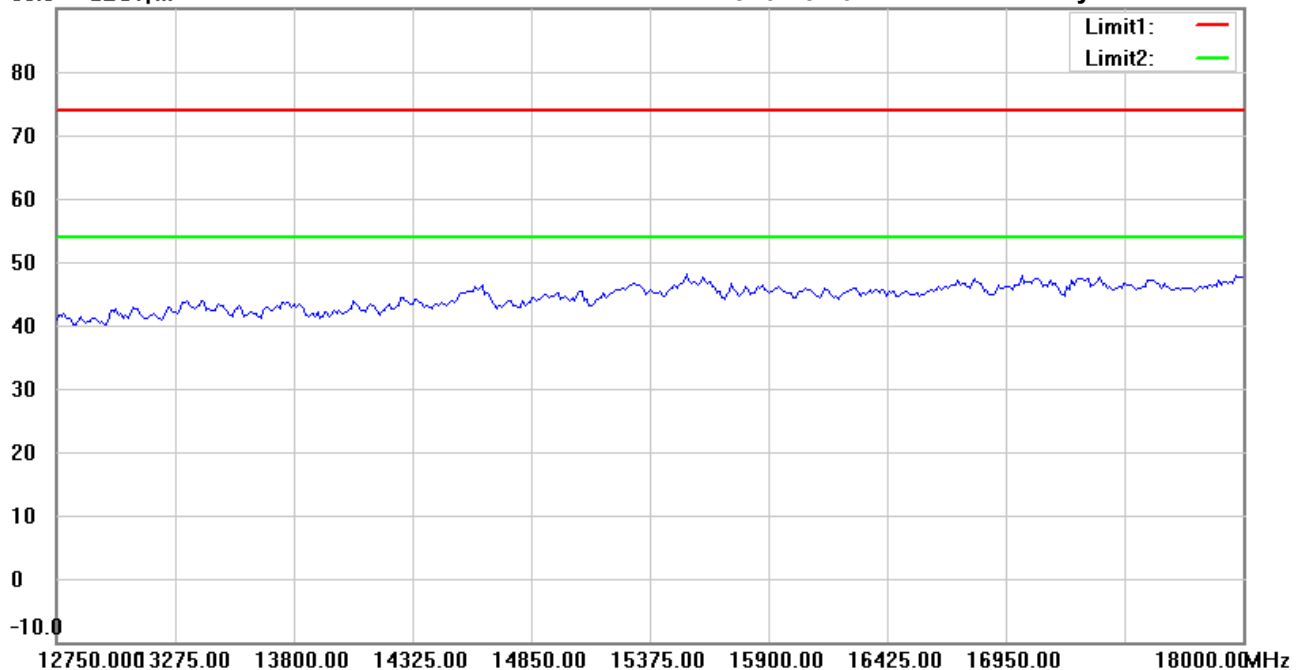
Condition : FCC\_part 15 RE-Class C\_Above 1GHz\_PK

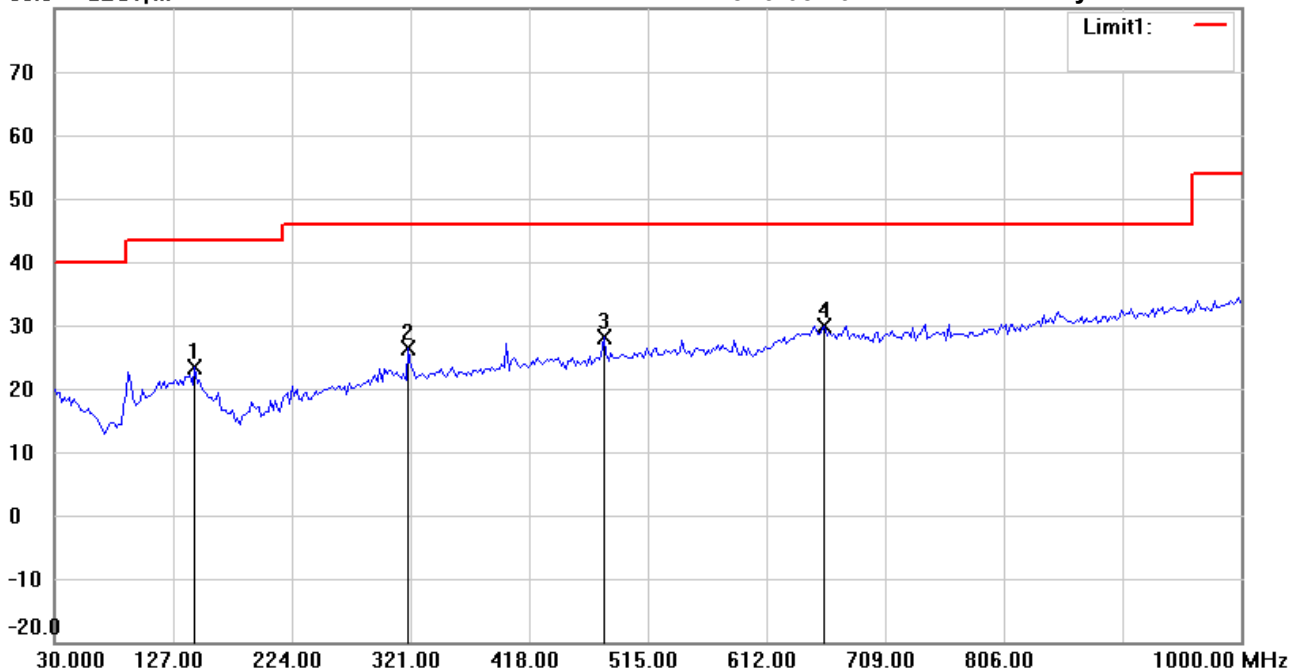
Condition : FCC\_part 15 RE-Class B\_30-1000MHz
